BASILICA MINOR THE VISITATION OF THE VIRGIN MARY, SVATÝ KOPEČEK NEAR OLOMOUC

SADOVÉ NÁMĚSTÍ 1/1, OLOMOUC

CONTRACTOR: GEMA ART GROUP A.S.

IMPLEMENTATION: 05/2007 – 01/2010

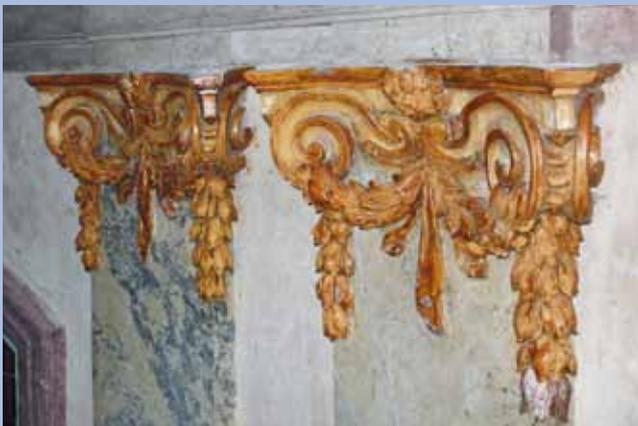
Decorative elements – before restorations

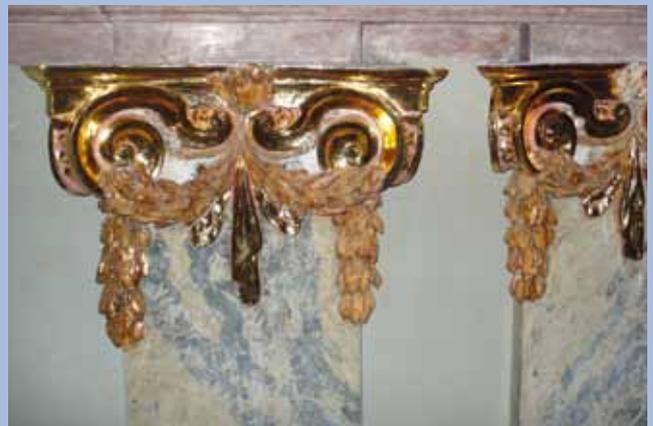
Decorative elements – work in progress

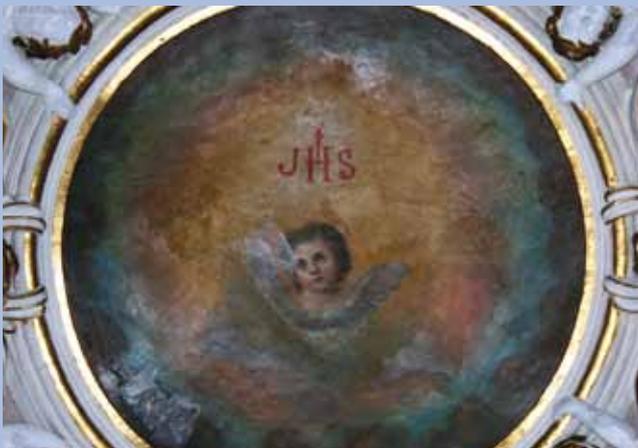
Painting in the Chapel – before restoration

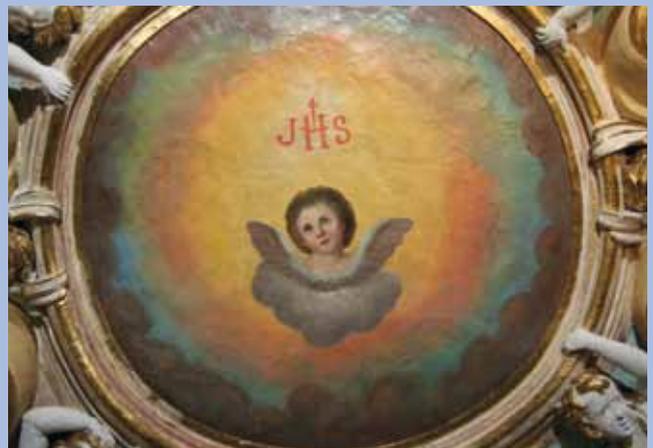
Painting in the Chapel – after restoration

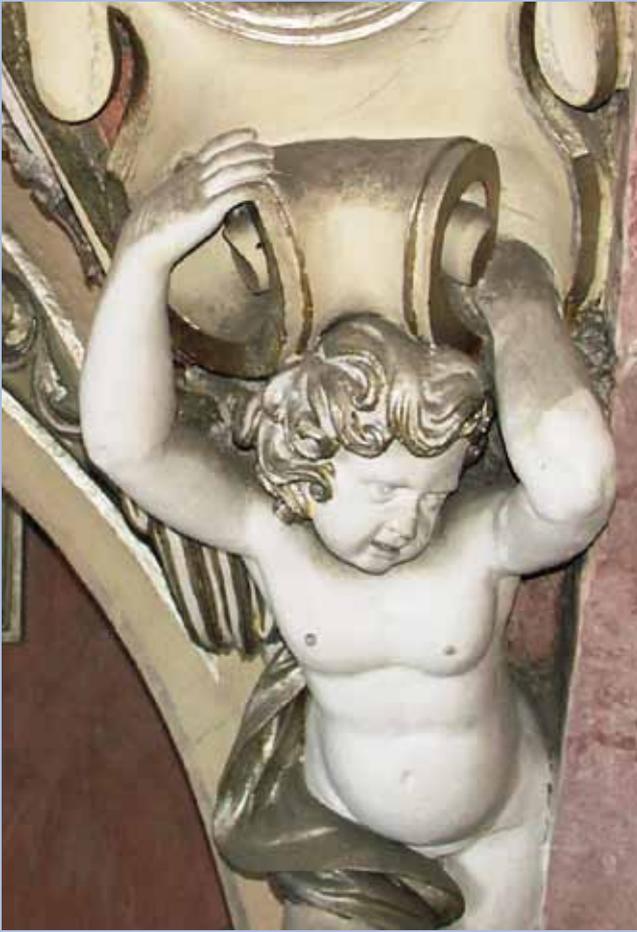
Some sculptures also suffered localized damage. Pieces were broken off and due to the dampness in the chapels and the main nave the iron armatures holding parts of the sculptures together (such as the head, arms and legs) corroded away and the sculptures fell apart. It was necessary to take them to pieces, which were reconstructed, treated with an anti-corrosive agent and then glued back into the original form. Some later alterations were removed to restore the sculptures to their original appearance. The six sculptures of angels – cherubs, six putti on the cloud and the dove in the lantern of the dome were also restored back to their original form. The later-added silver paint was removed and replaced by the original ornamentation using pure gold.

Stucco sculpture – before restoration

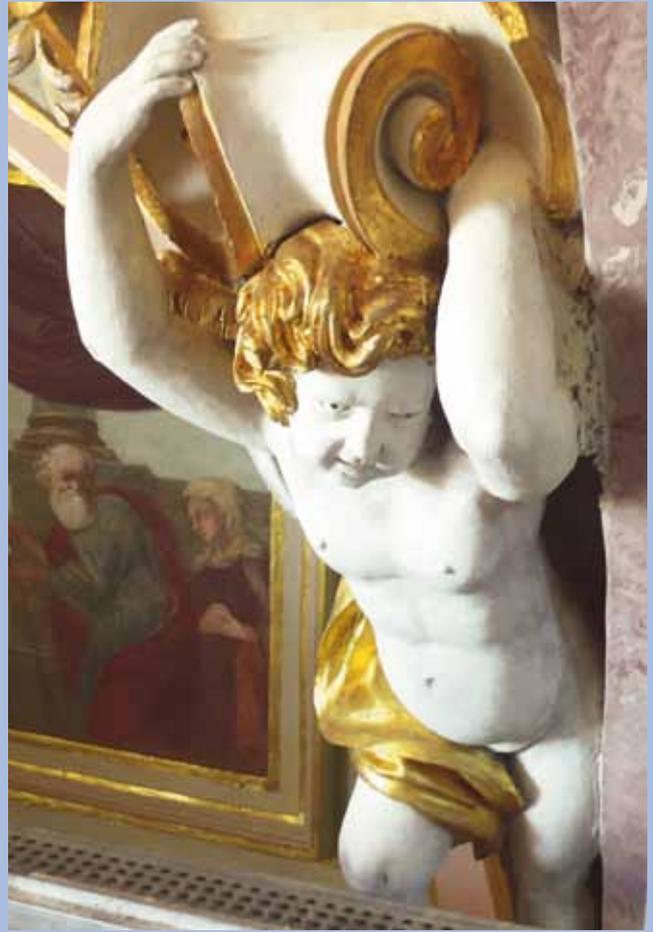
Stucco sculpture – after restoration

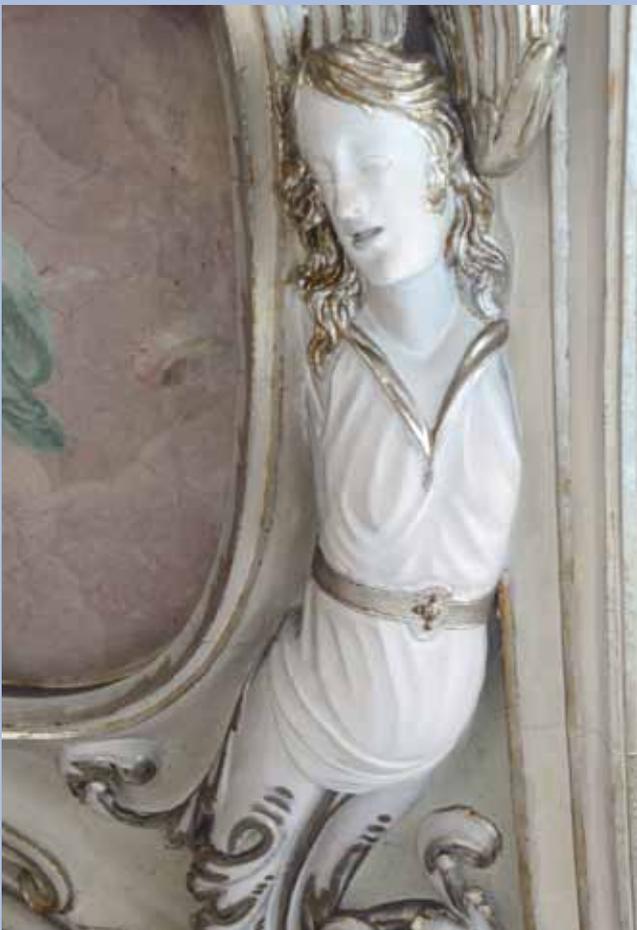
Stucco sculpture – before restoration

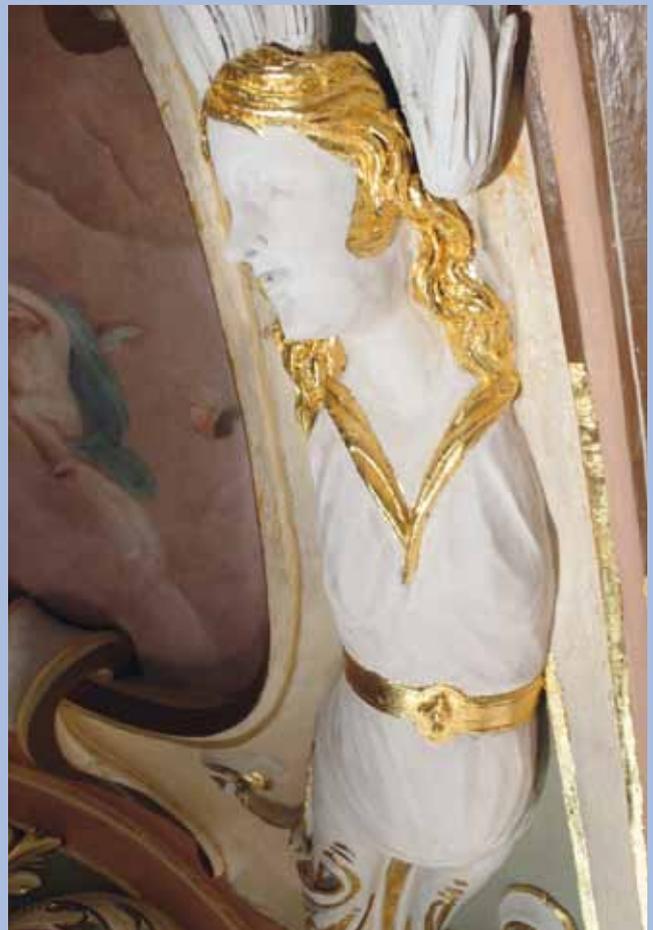
Stucco sculpture – after restoration

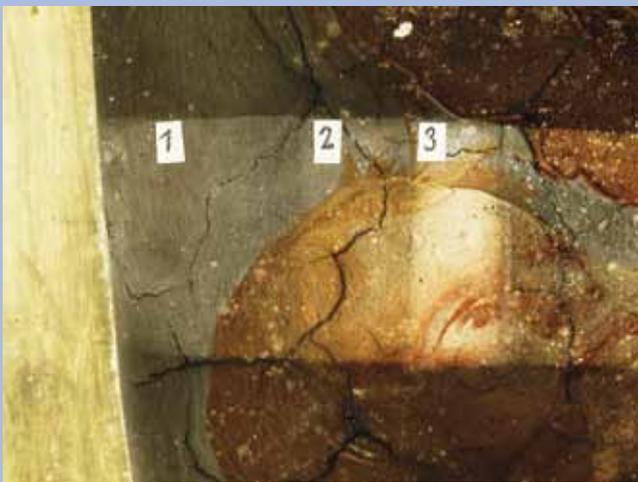
Cleaning test paintings

The surface of the frescoes was first mechanically cleaned using distilled water and a special India Rubber sponge suitable for dry cleaning of the frescoes. Disintegrated parts were consolidated using a water acrylic dispersion over Japanese tissue paper. In some parts of the paintings the application had to be repeated several times.

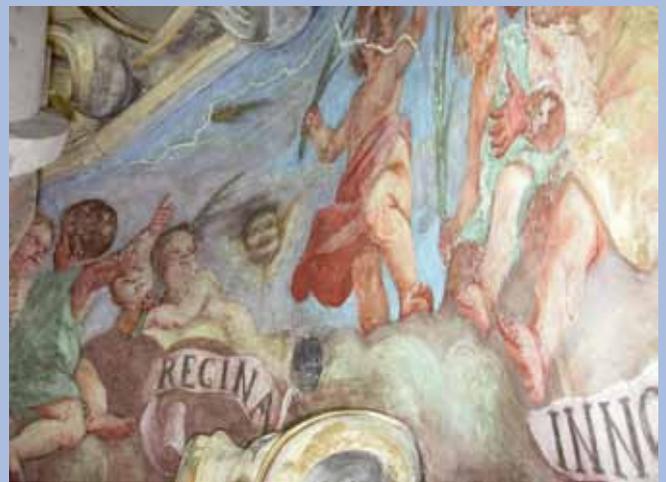
Paintings after cleansing and puttying

In some cases it was decided to remove more recent layers of over painting in order to preserve the original style of the interior. Defects were in-filled and re-touched using mineral pigments or oil paints.

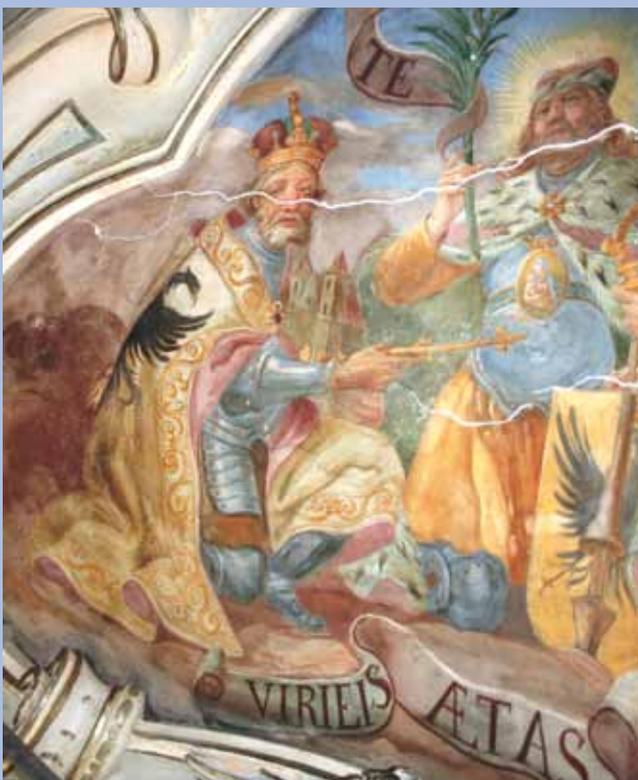
Lunets after puttying

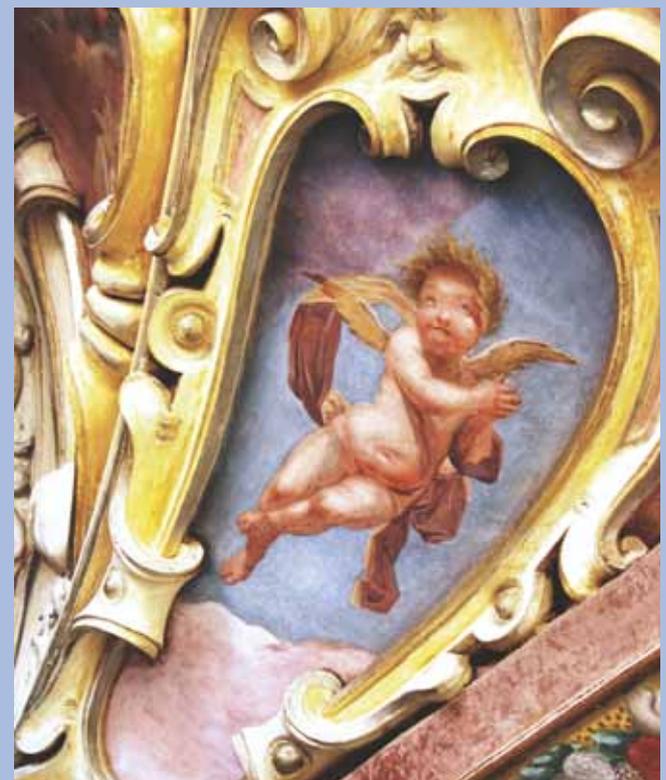
Paintings in the Chapels of st. Joachim after restoration

A somewhat different approach was applied to the fresco restoration in the side chapels, which were more extensively damaged, for two main reasons: oil paint had been used during latter restorations and the roofs of the chapels suffered more damage than the roof over the main body of the church, which led to greater leakage of rain water and residual dampness inside the chapels which continued even after the roofs were repaired. The restorers first undertook a several weeks long dehumidification process using electric dehumidifiers. During the actual restoration of the frescoes in the chapels it became necessary to secure the worst affected parts right back to the foundation. The oil paint was consolidated using synthetic resins and a power spatula. All defects were in-filled in a similar way to the rest of the restored frescoes in the church.
