CATHEDRAL OF SAINT BARBARA IN KUTNÁ HORA

BARBORSKÁ UL., KUTNÁ HORA

CONTRACTOR: GEMA ART GROUP A.S.

IMPLEMENTATION: 07/2003–11/2012

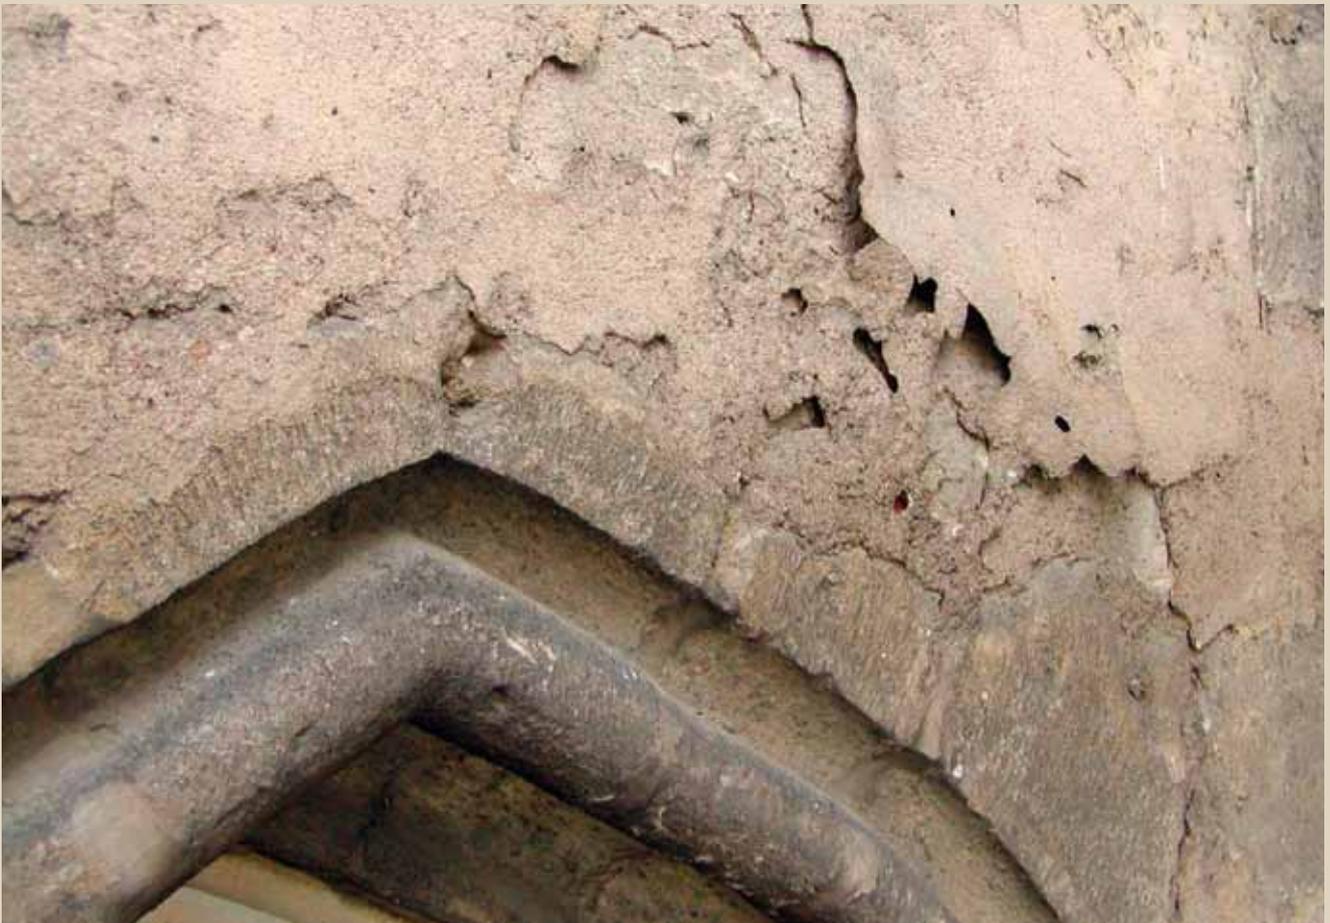
The masonry bore signs of damage such as missing pointing mortar between the stone blocks, cracks, loss of stone mass, gypsum crusts and pollution by moss and lichen.

The stone casing – destruction of the stone

The stone was first mechanically rid of dirt and organic matter by water steam jet. Gypsum crusts were eliminated by hand using scalpels and abrasives. At some points the crust was up to 3 mm deep. The interstices where the pointing had crumbled away were re-pointed using more flexible lime mortar. As a preventive measure against further stone loss, some parts of the masonry were injected with a special fortifying substance. After cleaning and re-pointing, localized colour retouching was carried out to achieve visual uniformity of the building.

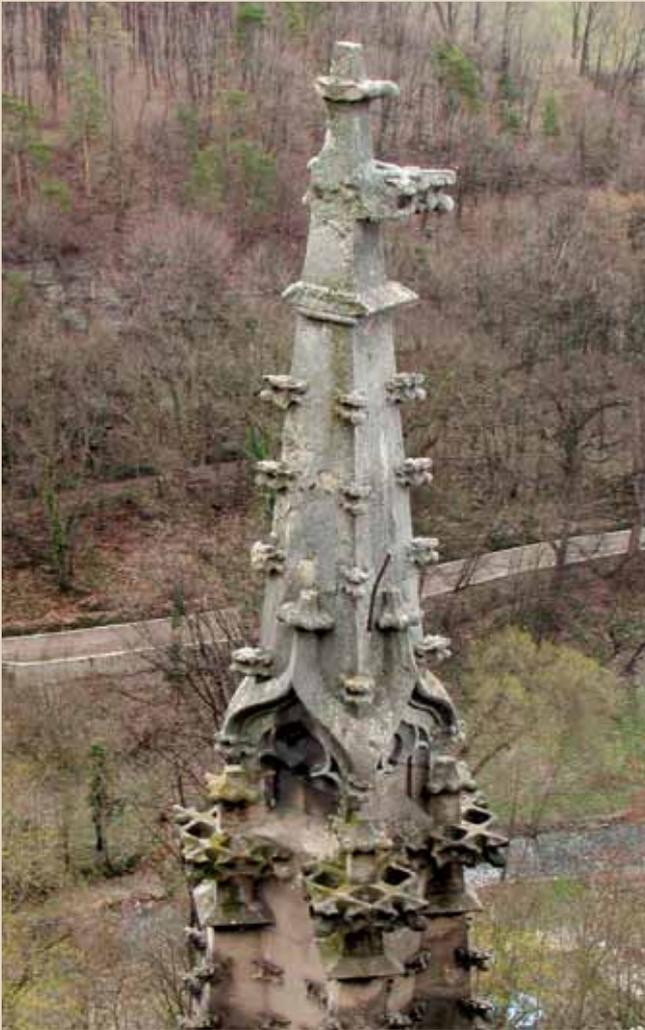
Ornamental parts of the support system (especially the flower bouquets) were often in a critical state and had to be replaced by copies made from Mušlov limestone, imported from Austria. The corrosion and decayed condition of the stone were caused by the use of Hořice sandstone.

Gothic pinnacle – before restoration

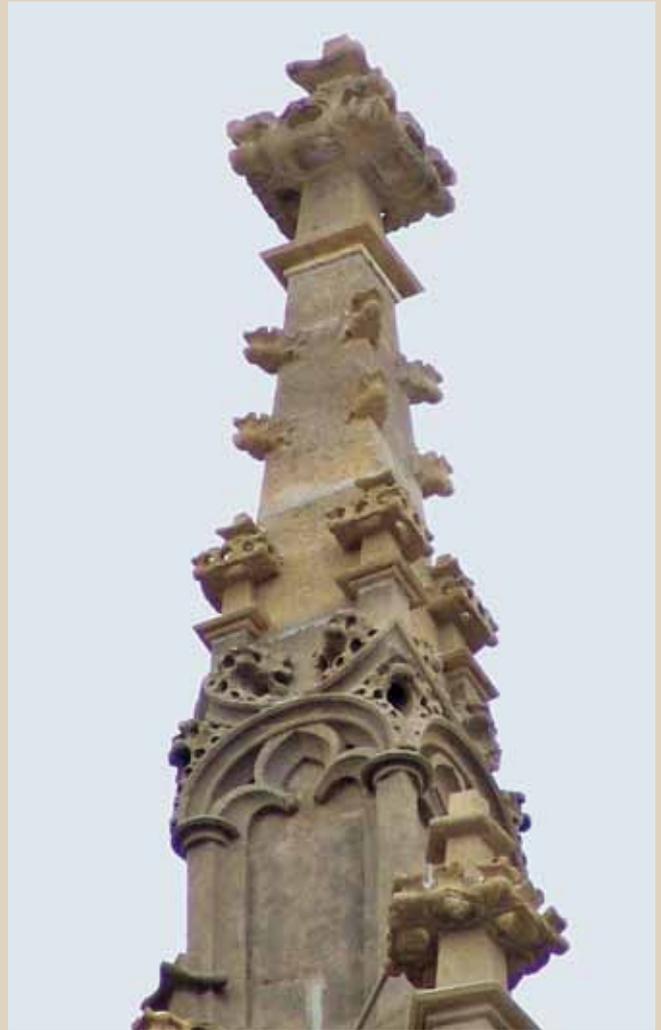
Gothic pinnacle – imitation

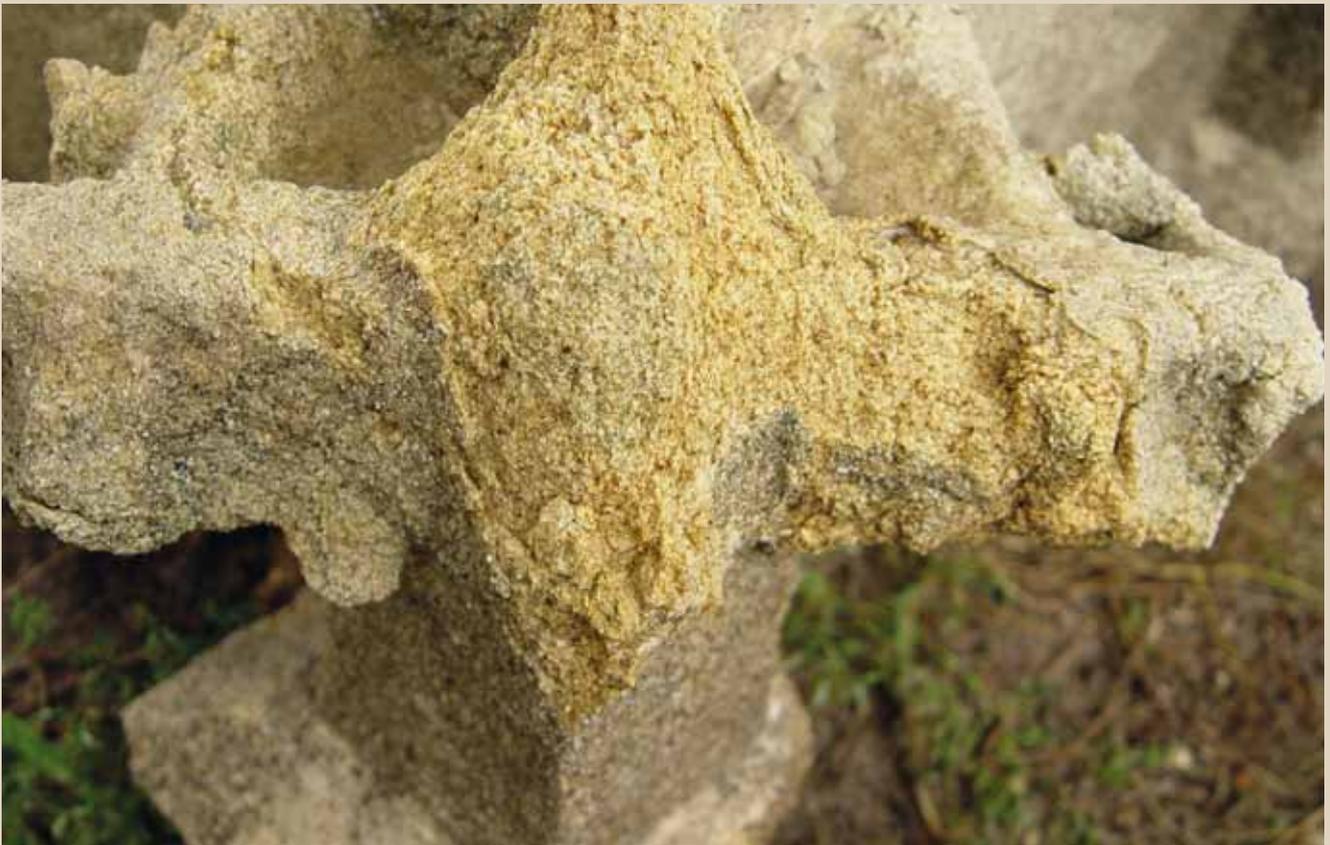
Detail of pinnacles – destruction

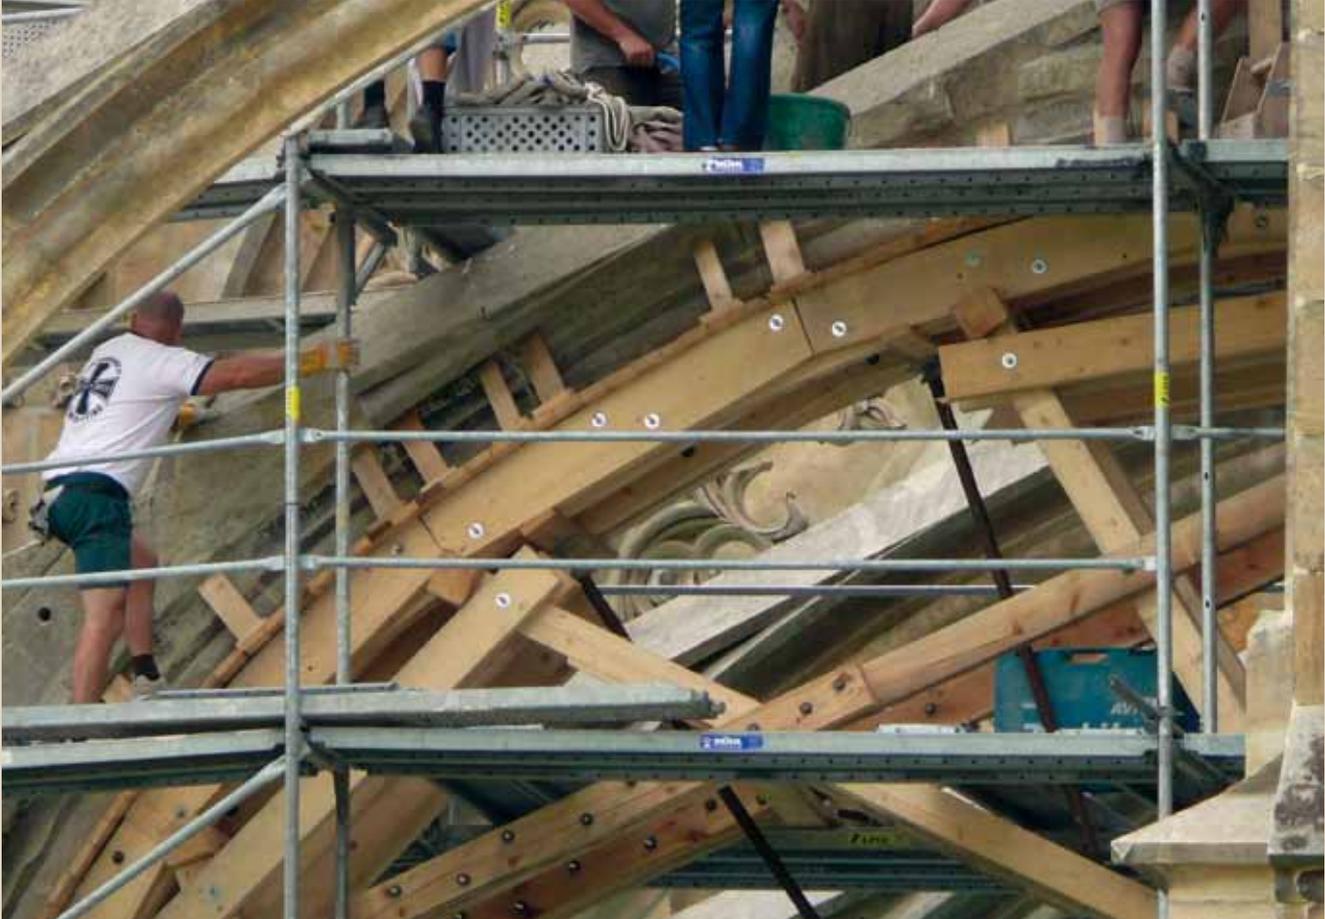
The main aim here was to remedy the precarious state of the support system. Some buttressing was in danger of actual collapse. After consultations with experts in structural analysis the decision was taken to fix the stone with rustproof pegs and individual blocks of the arches were returned to acceptable positions using pulleys and tows. In the case of one of the arches on the north side of the church it was necessary to undertake the complex task of replacing a whole part of the arch with a new one. The bases of some of the flying buttresses were also damaged by stone corrosion and the relevant parts were secured with a sealer.

Securing of buttressing system

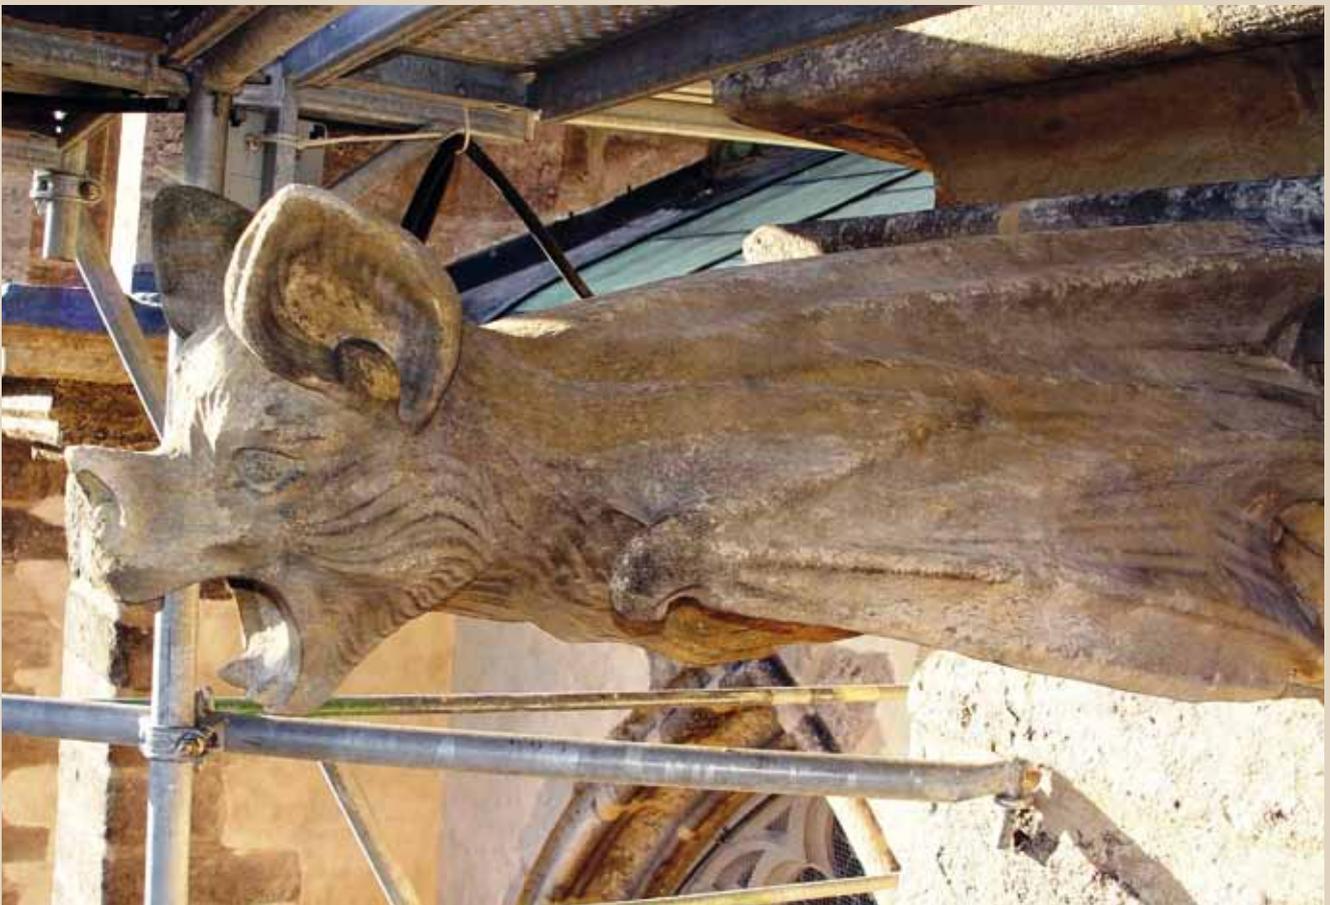
Stone belcher – before restoration

While restoring the stone components of the Church of St Barbara's exterior, priority was given to restoration of the parts in a critical state, to conservation of the authentic Gothic elements and to treatment of the stone surface. Gothic originals such as maskarons under the main cornice of one of the aisles as well as the 19th century copies of gargoyles and statues were restored. The last remaining Gothic gargoyle was removed, deposited in a lapidarium and replaced by an exact copy. The surface of the stone was cleaned of organic matter such as moss and lichen and of gypsum crust. Missing and irretrievably decayed stones were in-filled or replaced. As a preventative measure a strengthening substance was inserted into the stone.

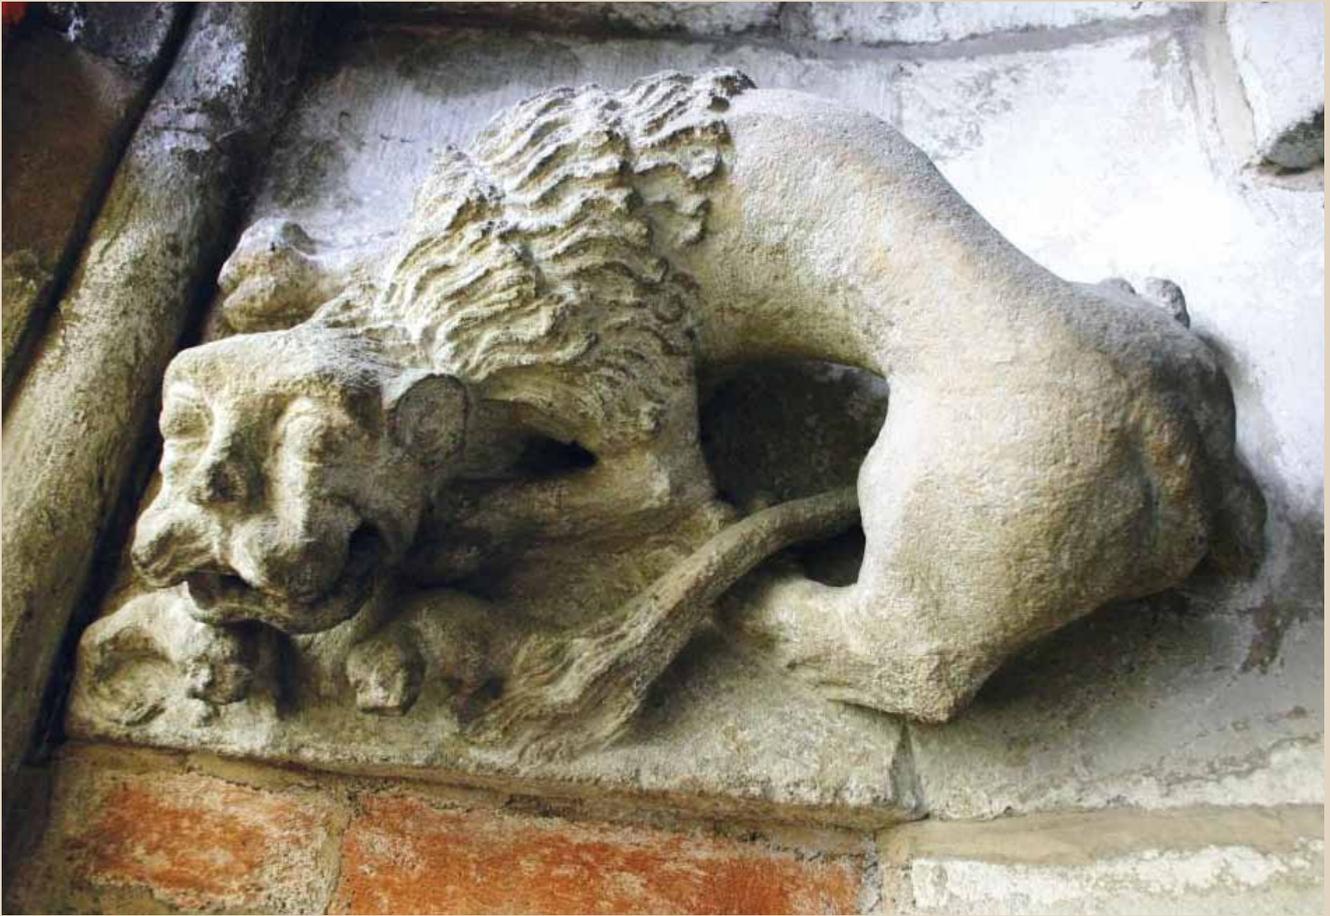
Stone elements – before restoration

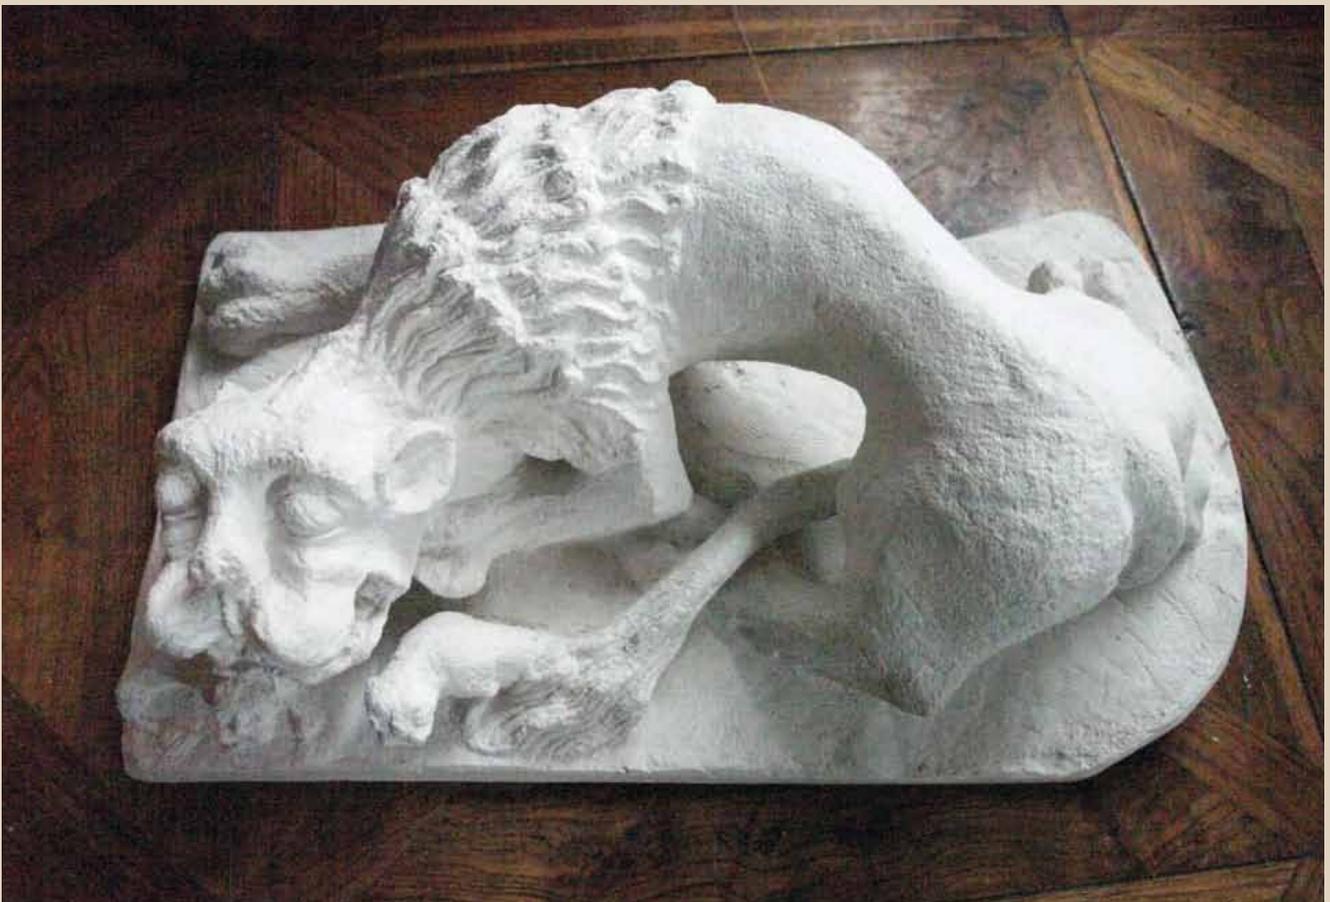
Stone elements – after restoration

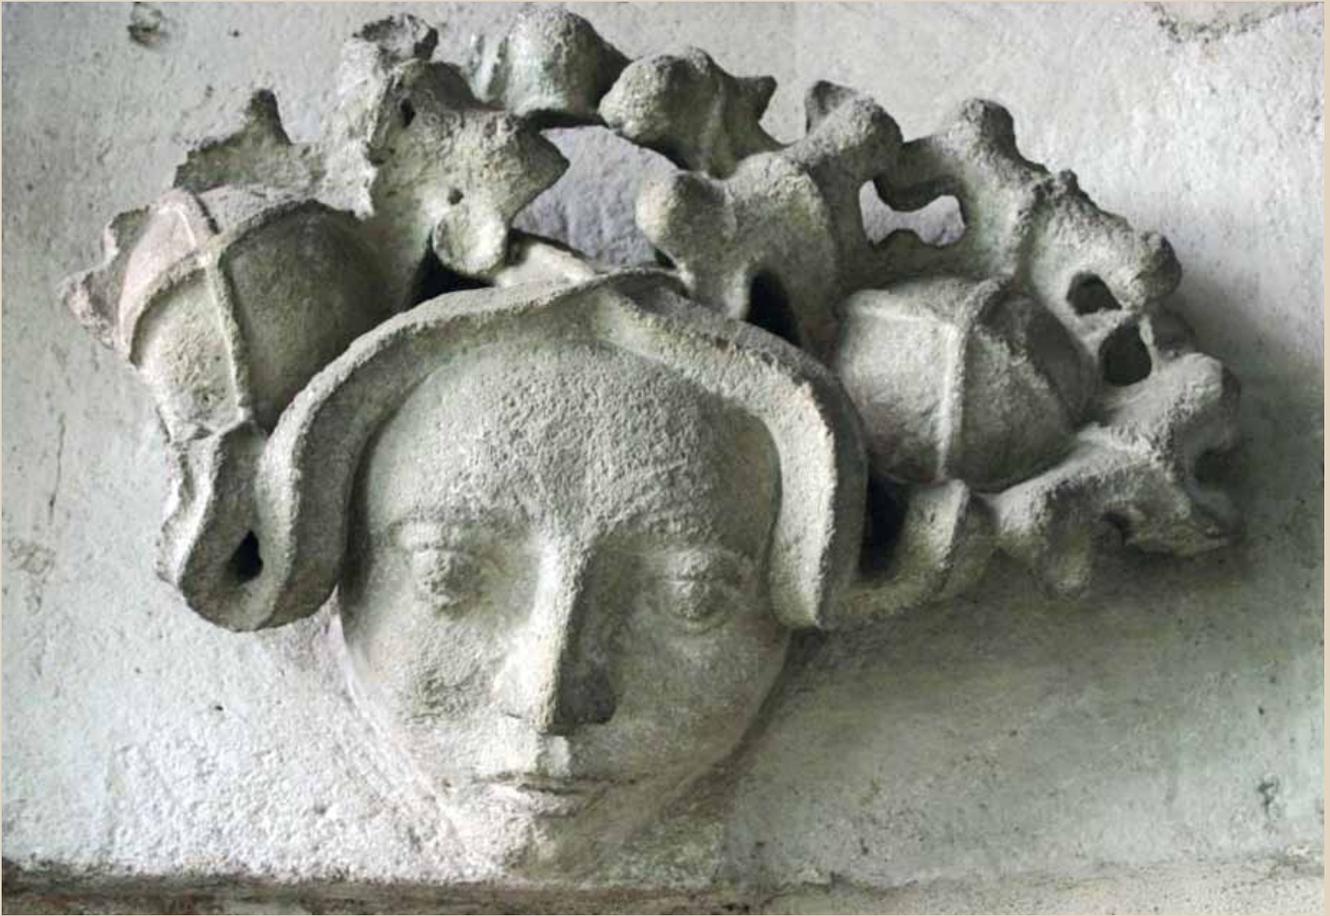
Stone elements – before restoration

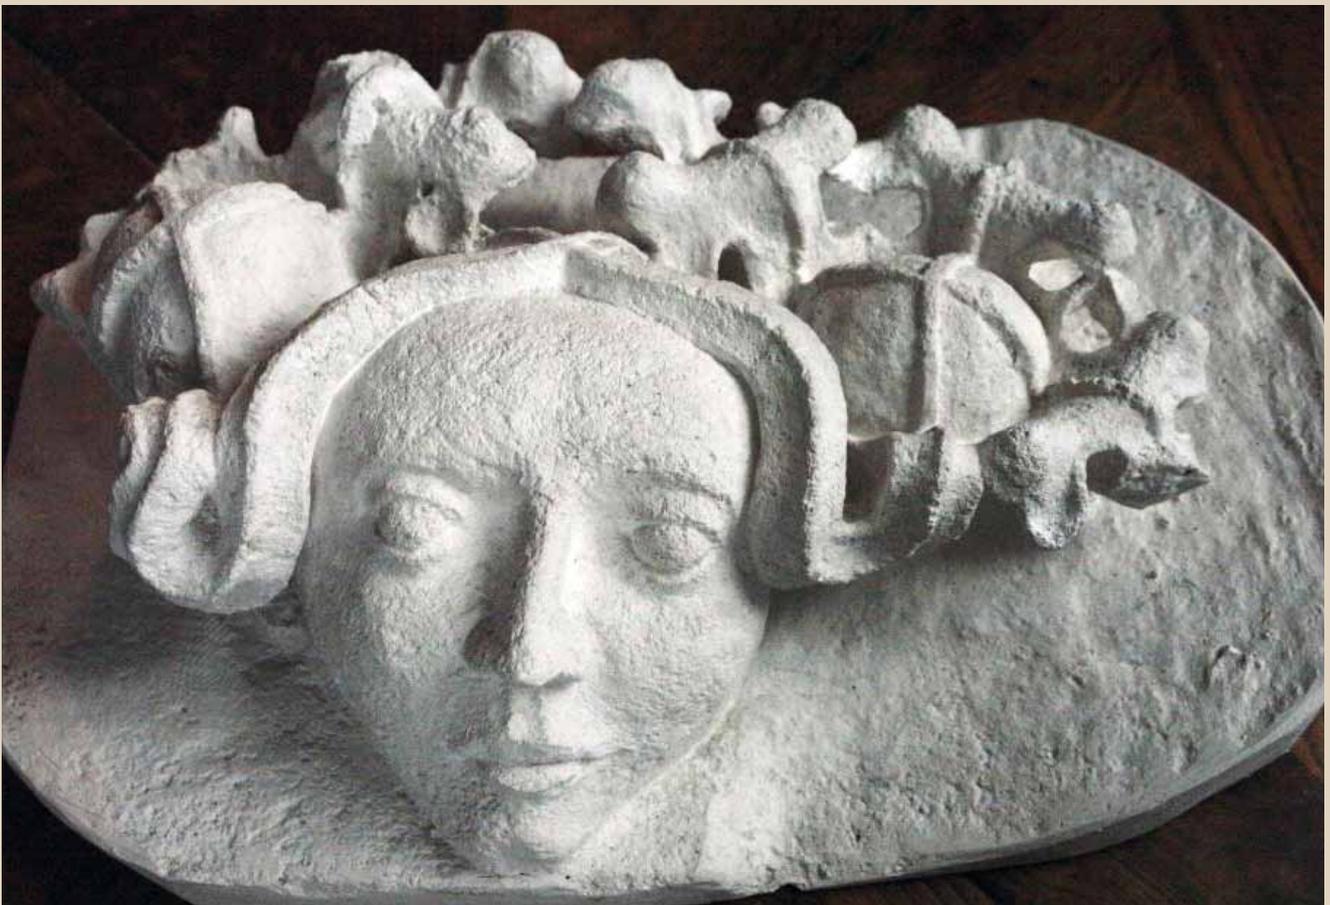
Stone elements – after restoration

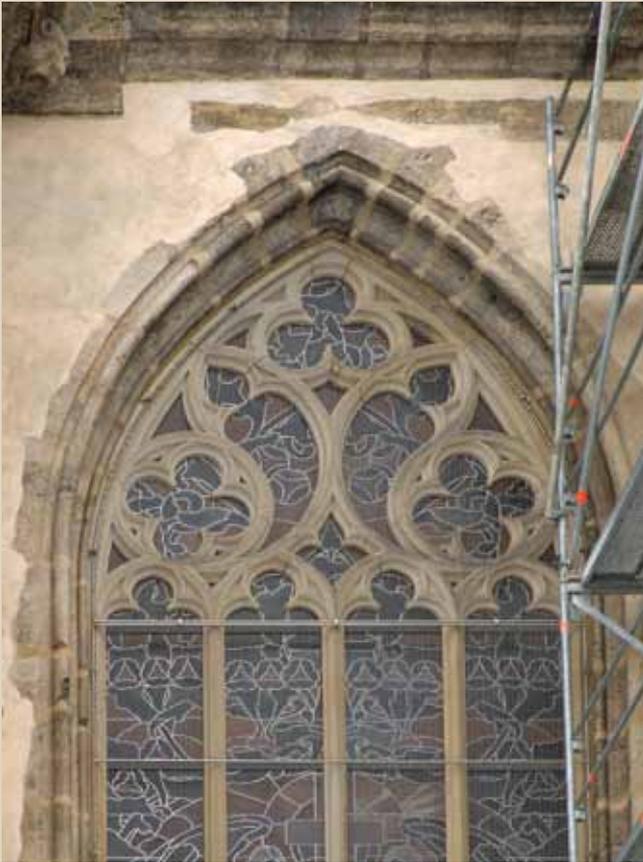
Stained glass – work in progress
