## VILLA BÍLEK, PRAGUE-HRADČANY, CZECH REPUBLIC

INVESTOR: CITY GALLERY PRAGUE

CONTRACTOR: GEMA ART GROUP A.S.

IMPLEMENTATION: 08/2008–09/2010

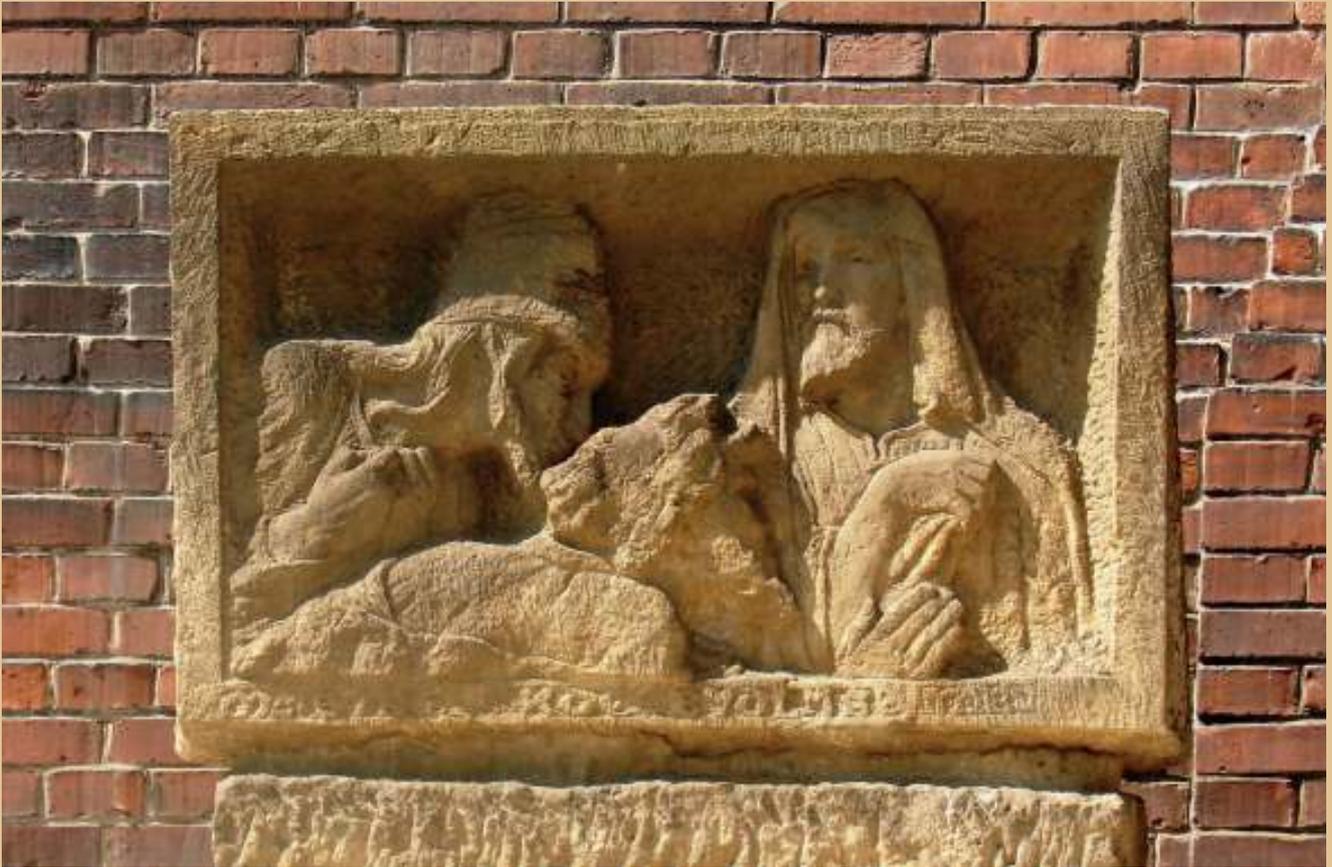
The exterior of the villa is decorated by several important bas-reliefs, among them a statue of the Virgin Mary and the bas-relief with a group of male heads. The bas-reliefs had a thick surface layer of dust deposits, which was removed by a water steam. The bas-relief of the Virgin Mary was covered by a patina intended to resemble argillite, but the surface of the patina was disturbed and the middle of the bas-reliefs significantly cracked. The bas-reliefs of the male heads exhibited damage by gypsum crusts.

Sculpture with religious motives

All damaged areas were fortified using a silicon acid based preparation and individual cracks injected with a man made mineral based filler. To achieve optimum colour tones, ferrous pigments were added to the filler. Finally, the stone was treated with a hydrophobic agent.

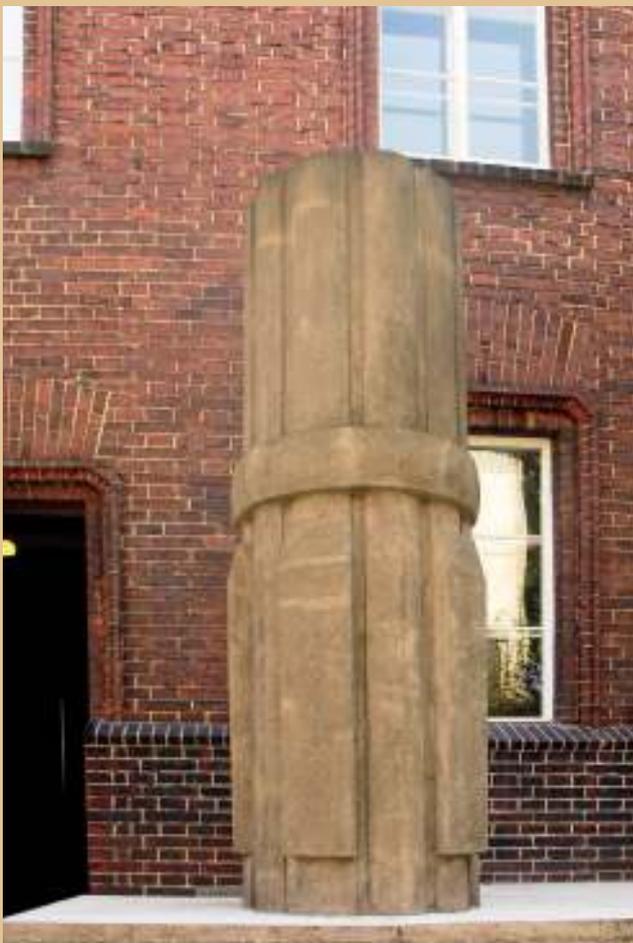
The concrete columns representing wheat sheaves were in places cracked and covered by dust deposits. On the eastern side the columns were marked by occurrences of salt efflorescence. During restoration, the columns were firstly cleaned by steam jet. Where the cracks were deeper, a probe was inserted into the core of the column to establish the cause of the damage. The cracks were cleaned and then in-filled. Mechanically broken off parts were re-attached using polyester glue. The whole surface of each column was then toned to achieve a unity of colour.

Concrete column after restoration

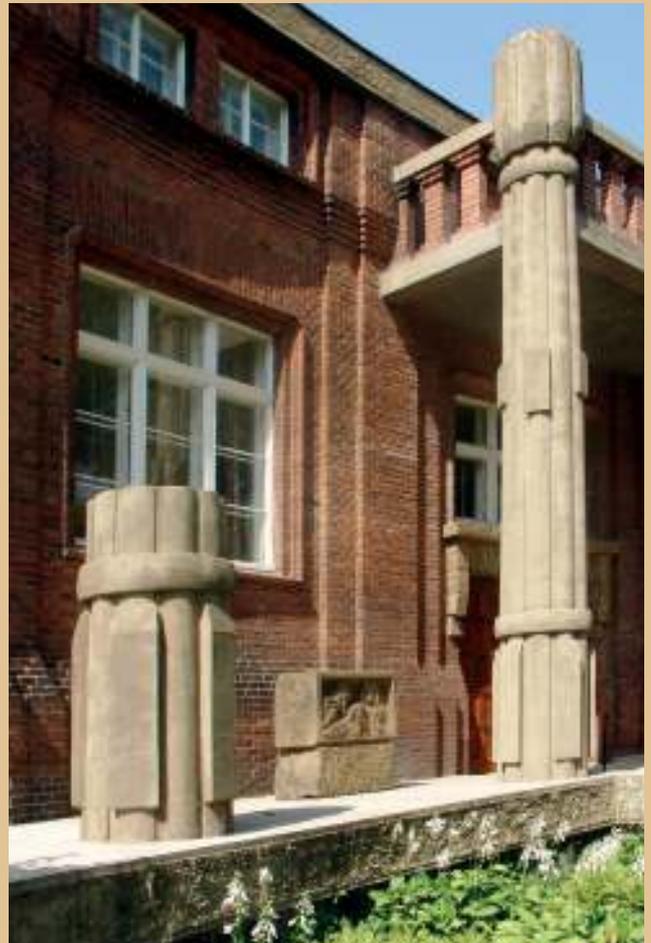
Concrete columns evocating ears of corn

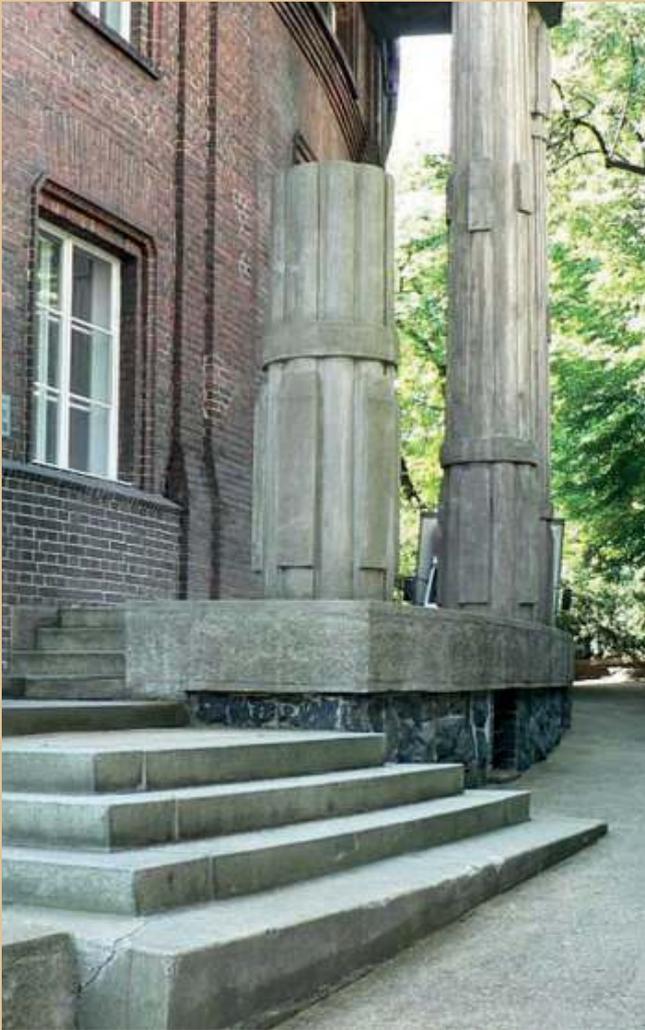
Stairs before restoration

With the consent of the National Heritage Institute the banisters of the balcony and the whole entrance staircase were completely dismantled after having been found in a nearly critical state. Prior to dismantling, detailed photo documentation was carried out, and subsequently guided the experts. At the request of the conservationists, only historic building material from the beginning of the 20th century was used, namely bricks from a disused old grain store from the Krušovice area. Both the balcony banisters and the staircase were completely rebuilt, colour toned to fit in with the surroundings and finally treated with a hydrophobic agent.

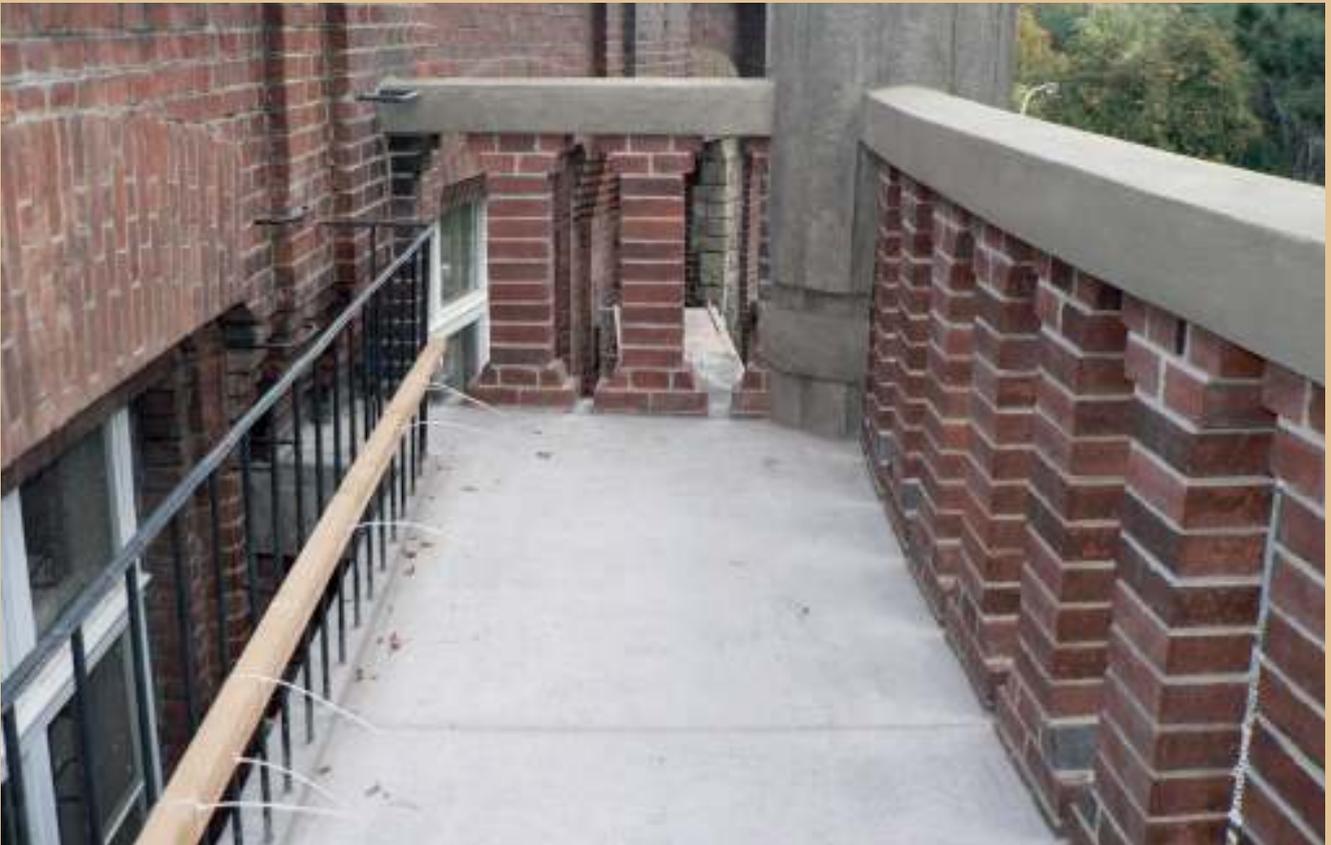
Balcony - after reconstruction

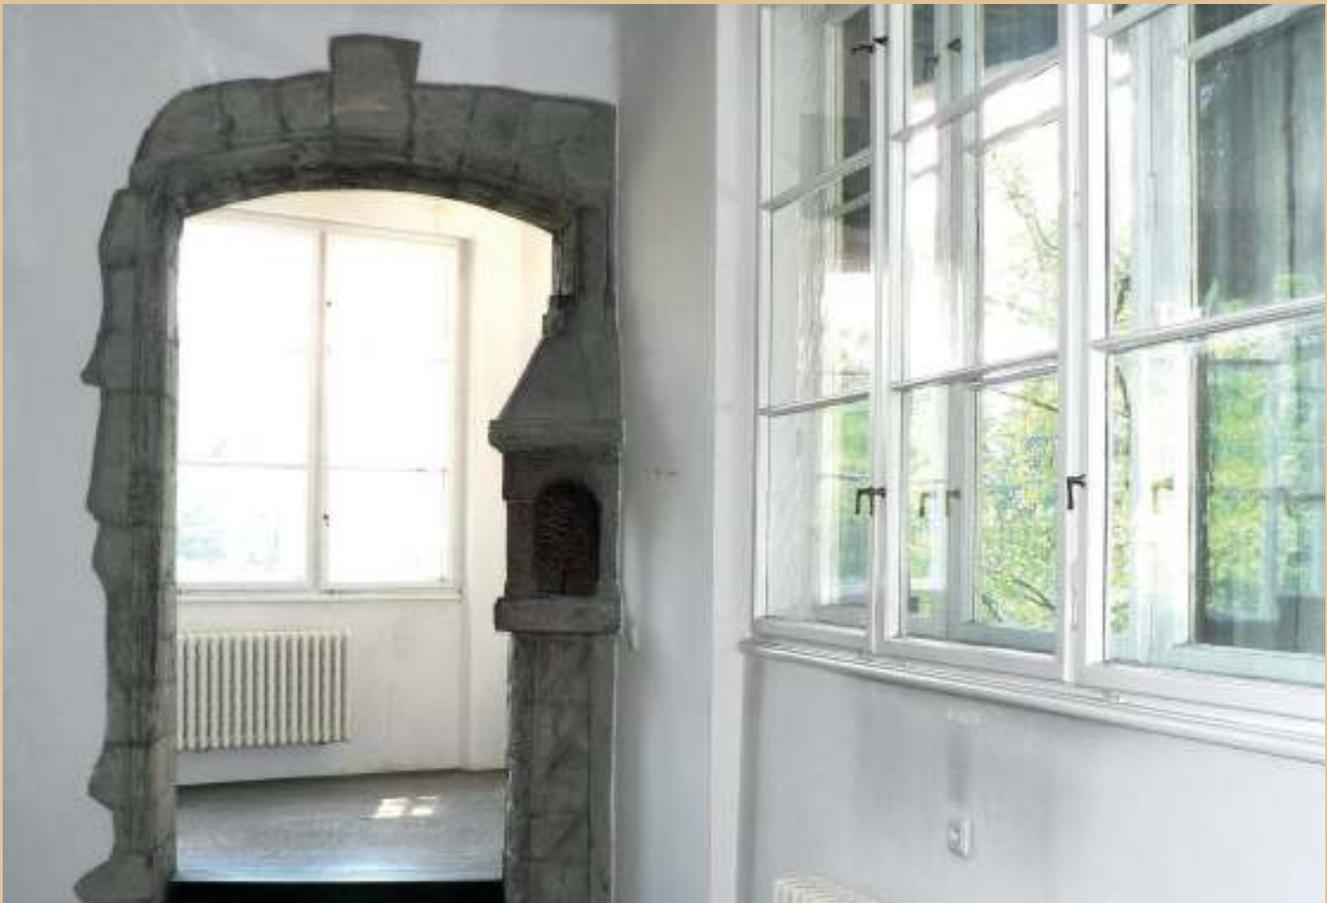
Argillite parts

As part of the work the argillite stone areas in the interior of the František Bílek studio on the ground floor and areas on the first floor were restored. The surface of the stone was covered by a layer of dust, which was removed using sponges and nylon brushes. Where the dust layer was deep, a weak detergent and steam jet were employed. The cement pointing between the individual argillite blocks was in places damaged or altogether missing. Both the portals and the stone cladding were covered by a whitewash, which was removed. Filler was injected into cracks and missing parts of the stone were replaced by mineral based substance. Re-pointing was carried out using appropriate materials. After consultations with conservationists, preventative treatment with a hydrophobic agent was abandoned.
