GOČÁR HOUSES IN THE ZOOLOGICAL GARDEN OF THE CAPITAL CITY OF PRAGUE

ZOOLOGICKÁ ZAHRADA HL. MĚSTA PRAHY,
U TROJSKÉHO ZÁMKU 3/120, PRAHA 7

CONTRACTOR: GEMA ART GROUP A.S.

IMPLEMENTATION: 04-12/2010

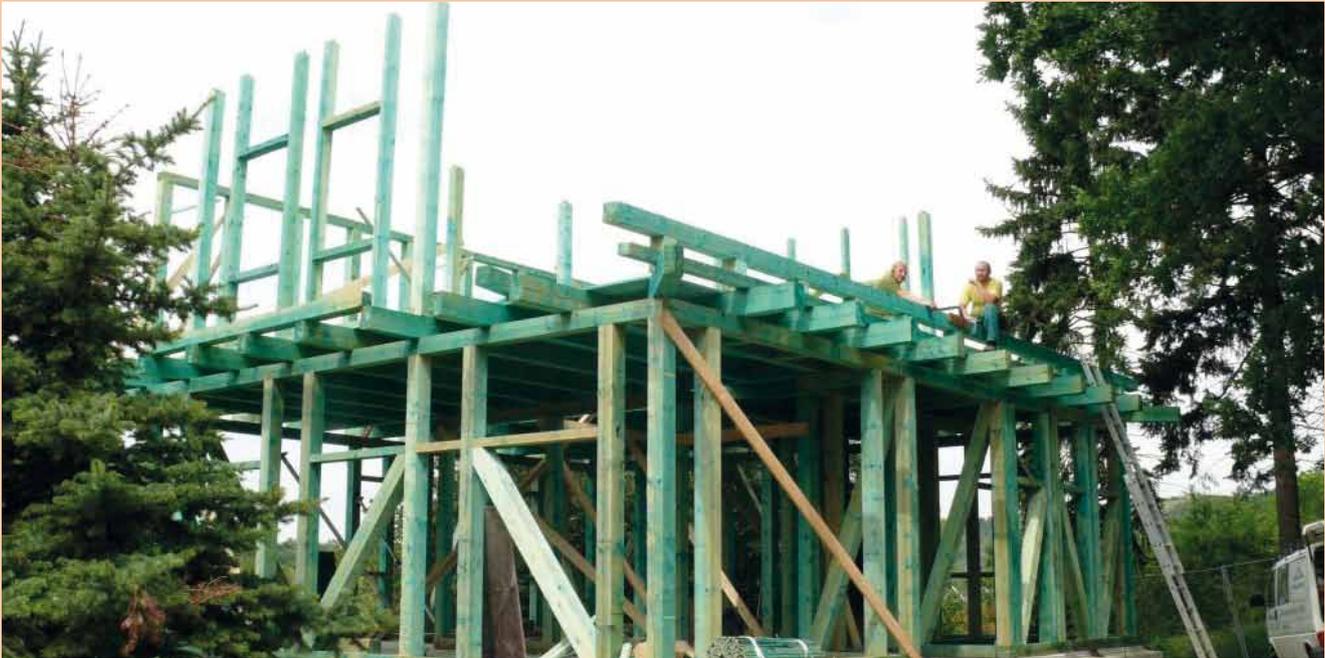
New installation of houses outside of flood area

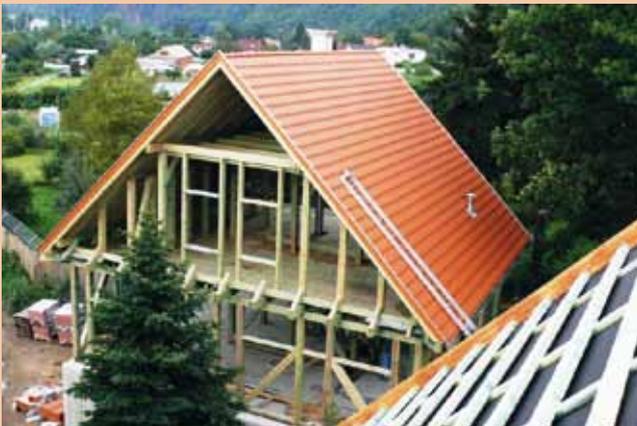
Roofing of tiles

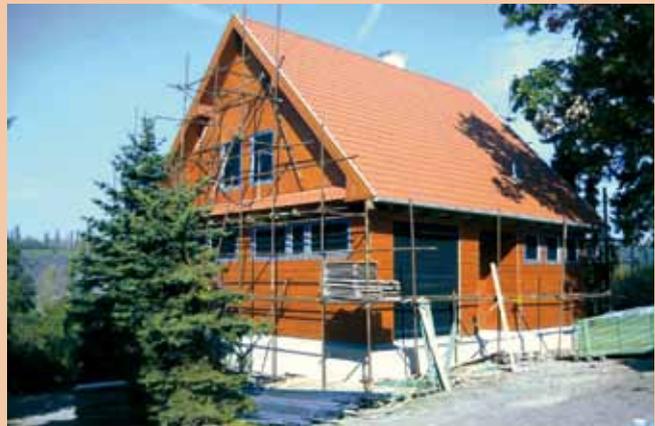
Work in progress

The timber was found to be overall in a very poor state. The boards were rotten, in places disintegrated and mechanically damaged. The edges of the boards had rotted away and had to be sawn off and replaced by copies. Some parts had to be altogether substituted by copies. More recent dark brown layers of paint on the wood surface were removed using vibrating disk sanders. Original wooden parts were treated with fungicides and insecticides. For the final coat of paint the colours red, blue and white were chosen according to the original samples designed by the architect Josef Gočár himself. Some archival drawings suggested green paint for the surfaces of the wooden window claddings but colour probing did not confirm its presence and green colour was not used during the restoration.

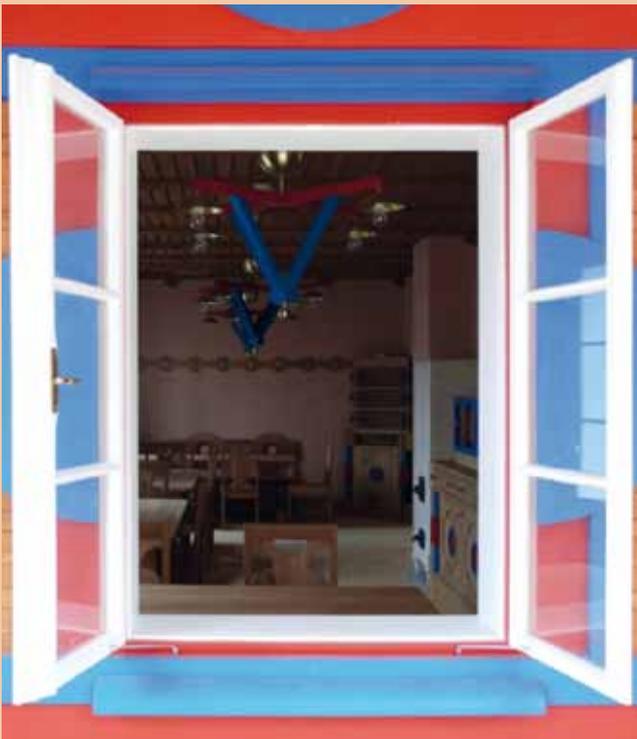
Detail of window - after restoration

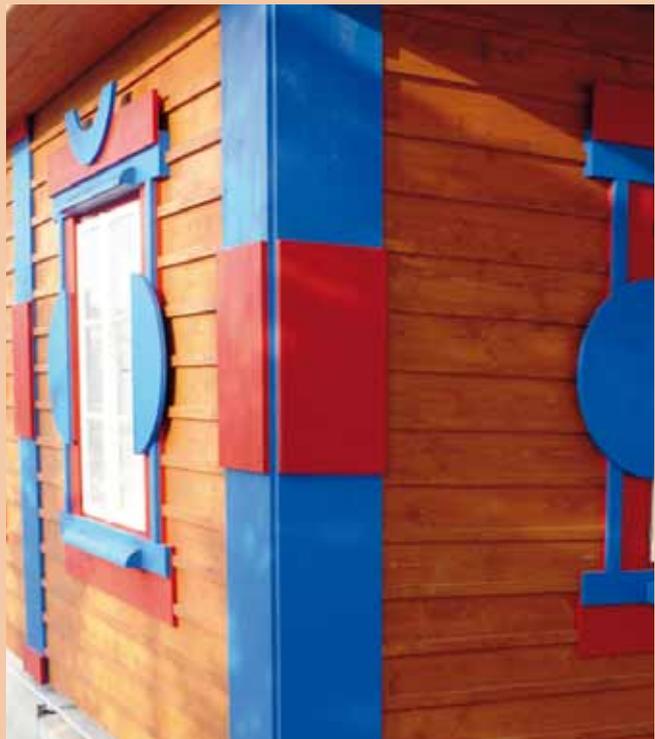
Decorations of exterior - after restoration

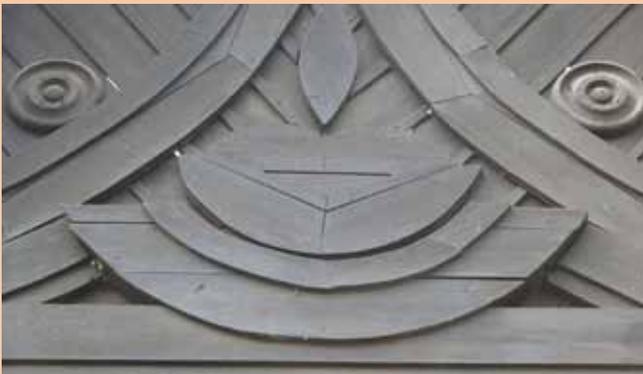
Detail before restoration

The surface of the wood was mechanically sanded using sand paper, sponges and steel wool, followed by an application of insecticides and fungicides. The discs were then coated with suitable synthetic paint materials and alkaline resins.

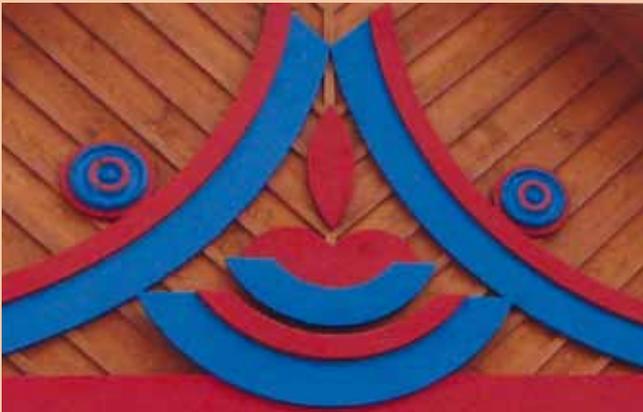
Detail after restoration

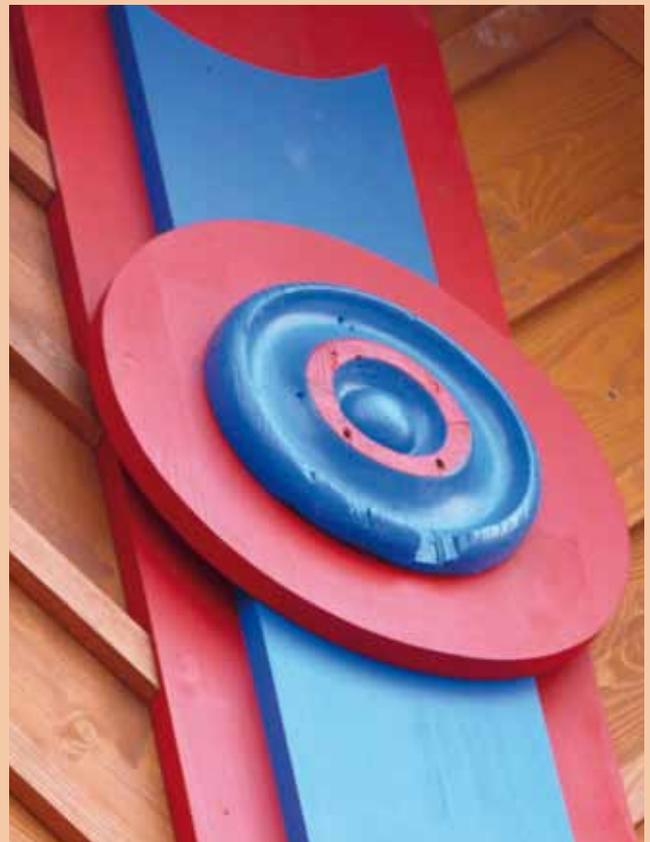
Detail of decorative target – after restoration

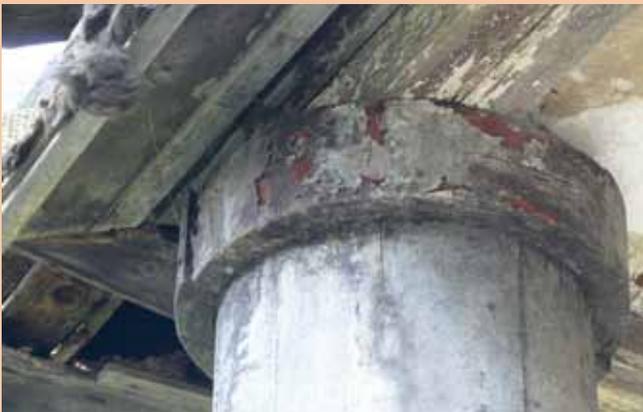
Detail of column - before restoration

The post was dismantled and the later paint layer scraped off. More significant cracks and unevenness between the individual planks were ameliorated using suitably shaped inserts. The timber was treated with insecticides and fungicides and the surface coated with suitable paint materials and synthetic alkaline resins.

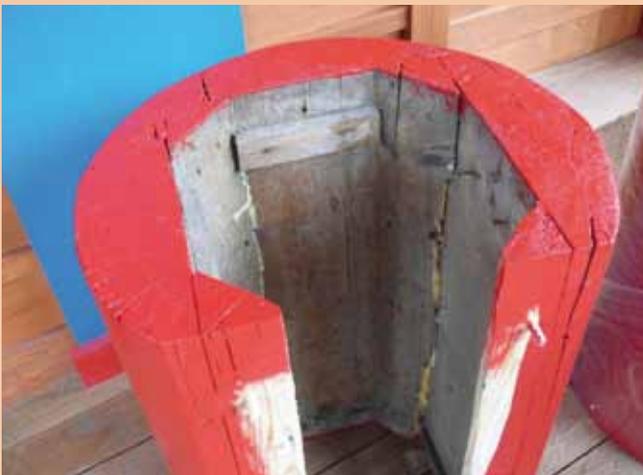
Work in progress

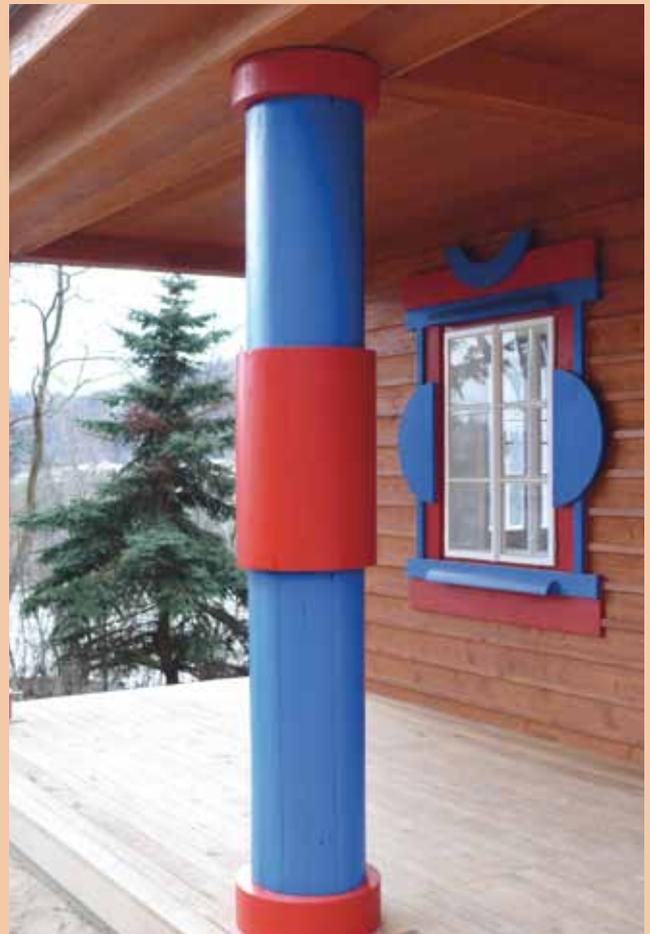
Decorative column - after restoration

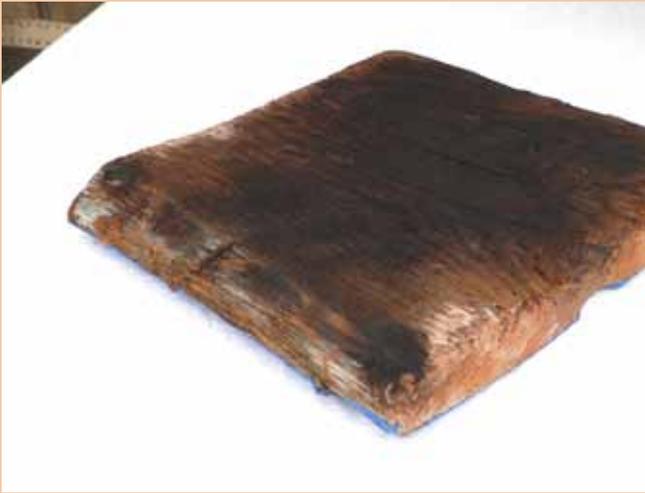
Detail of wooden mass

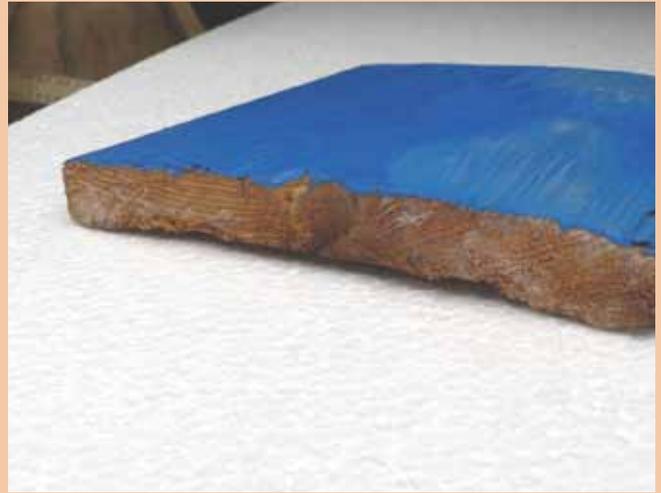
New paint according to the original shade

Both the discs and the post were subjected to detailed research into their colour schemes. After the removal of the dark brown paint from the 1970s, small fragments of the original red and blue paint, oxidized by exposure to the elements, were uncovered. On the foot of the post were remnants of red paint, the post itself had a residual blue coating. The original paint was found mostly in the fissures. The timber would have most likely been painted with an undercoat before the red and blue paint was applied.

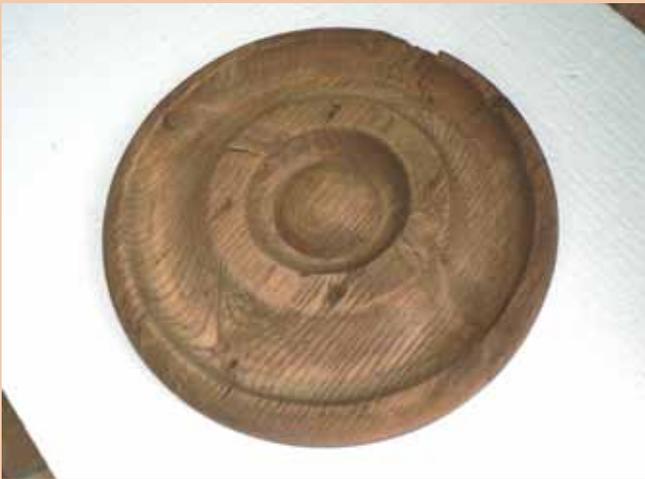
Wooden target before new paint

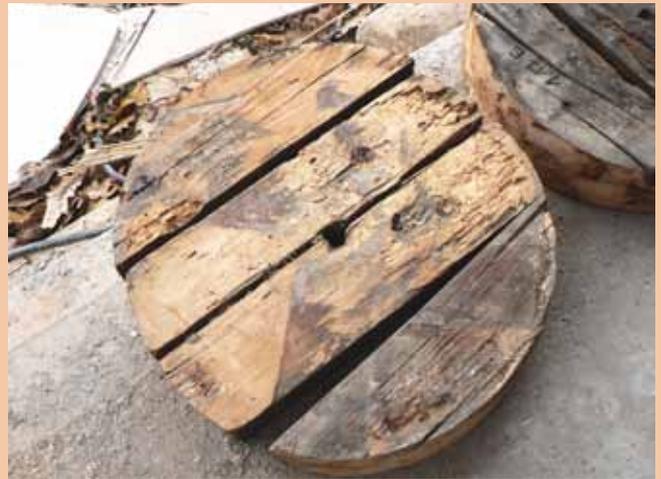
Reverse side of wooden target

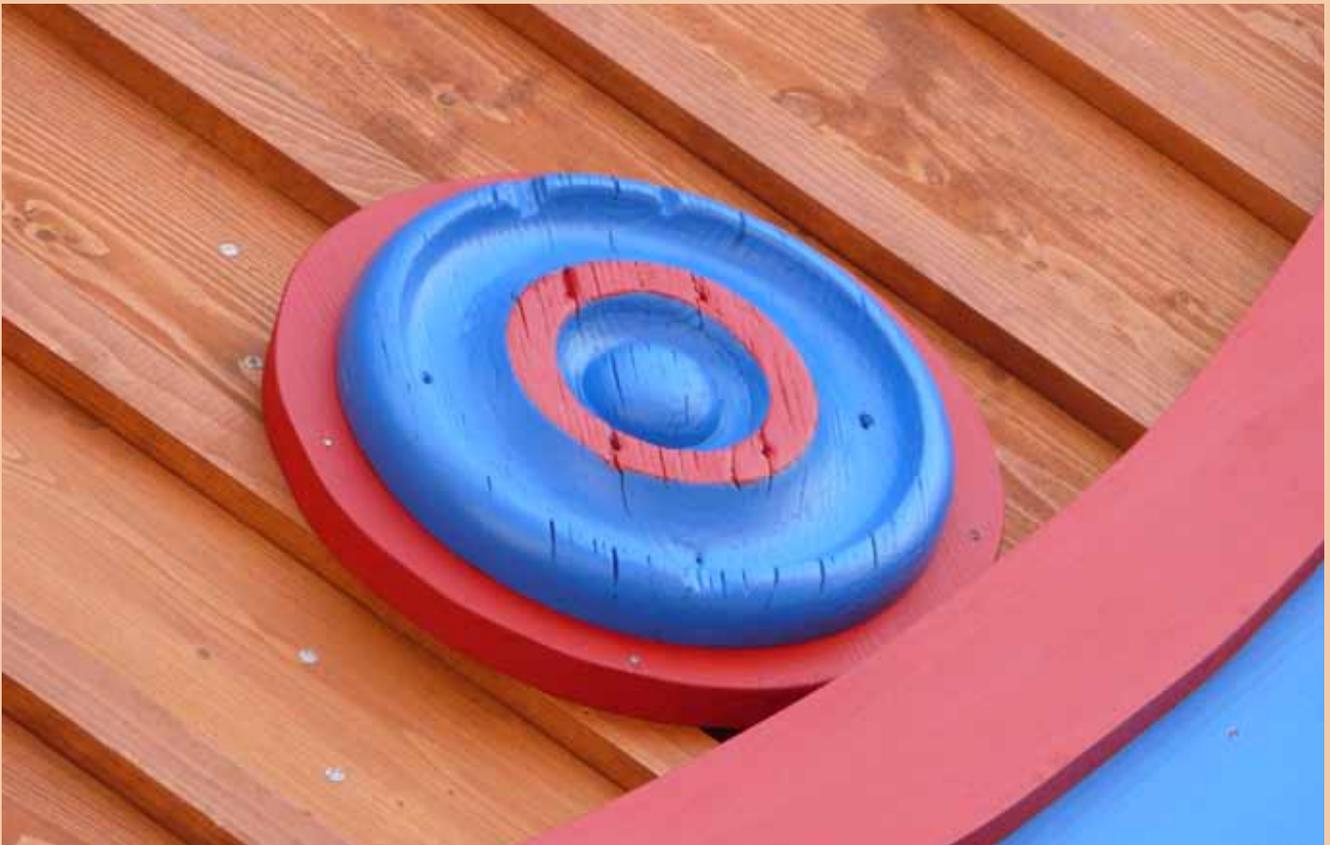
Decorative target - after restoration
