FLORAL GARDEN IN KROMĚŘÍŽ

KVĚTNÁ ZAHRADA, GEN. SVOBODY 1192,
761 01 KROMĚŘÍŽ

CONTRACTOR: GEMA ART GROUP A.S.

IMPLEMENTATION: DECEMBER 2012–APRIL 2014

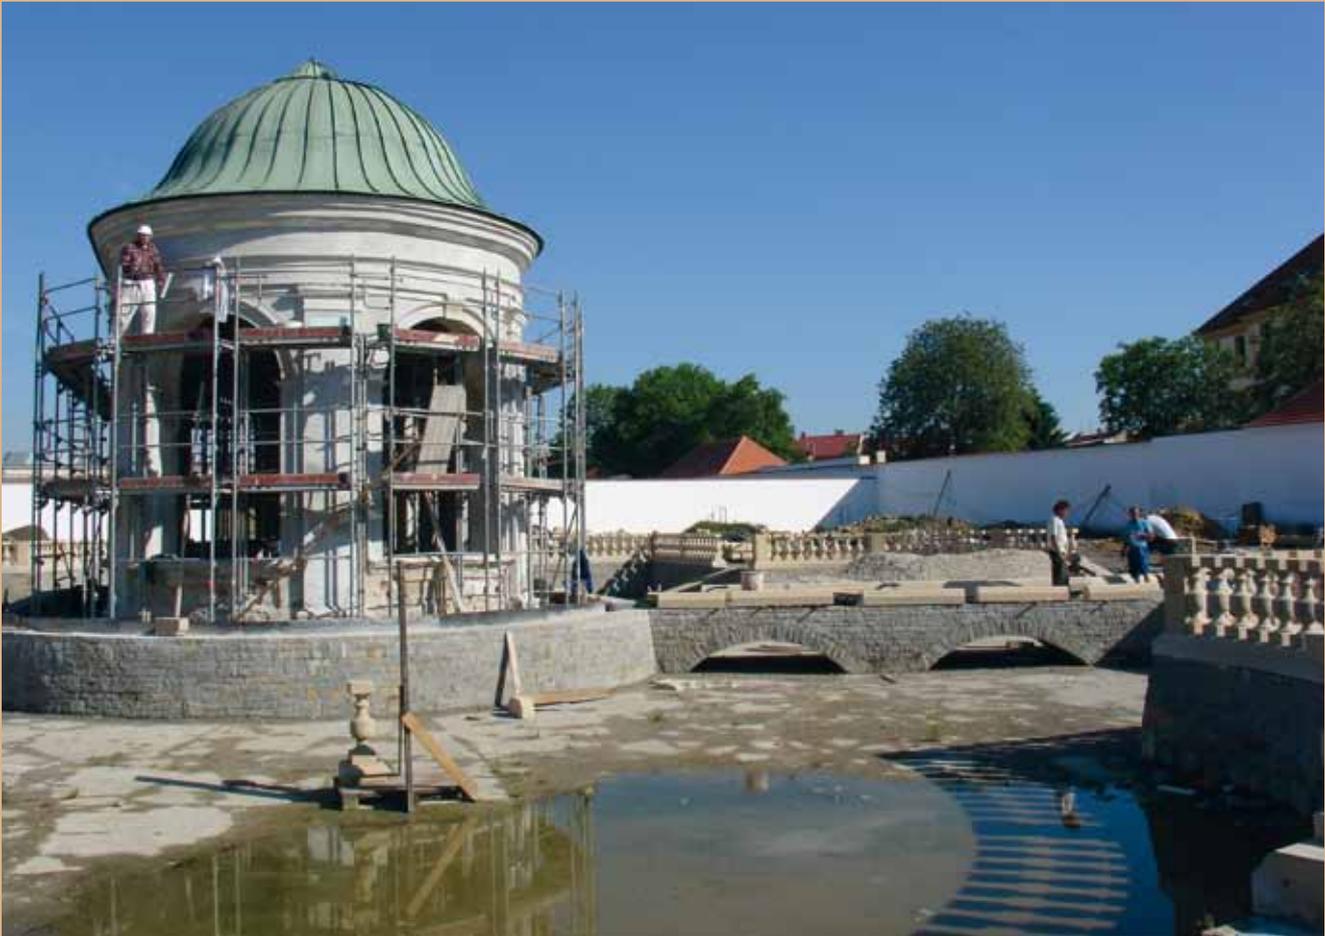
The bridge leading to the Birdhouse – work in progress

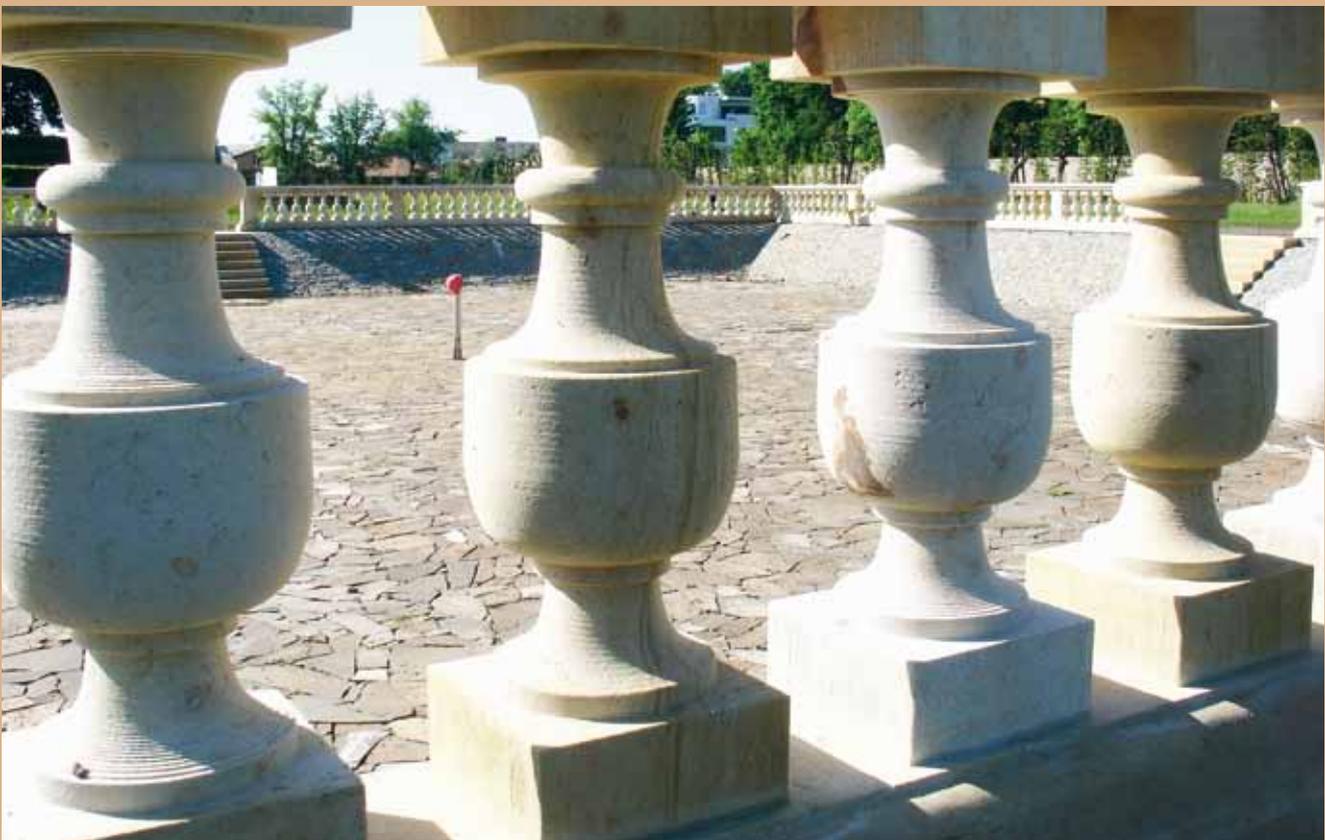
Close-up of the balustrade railing at one of the two Trout Ponds

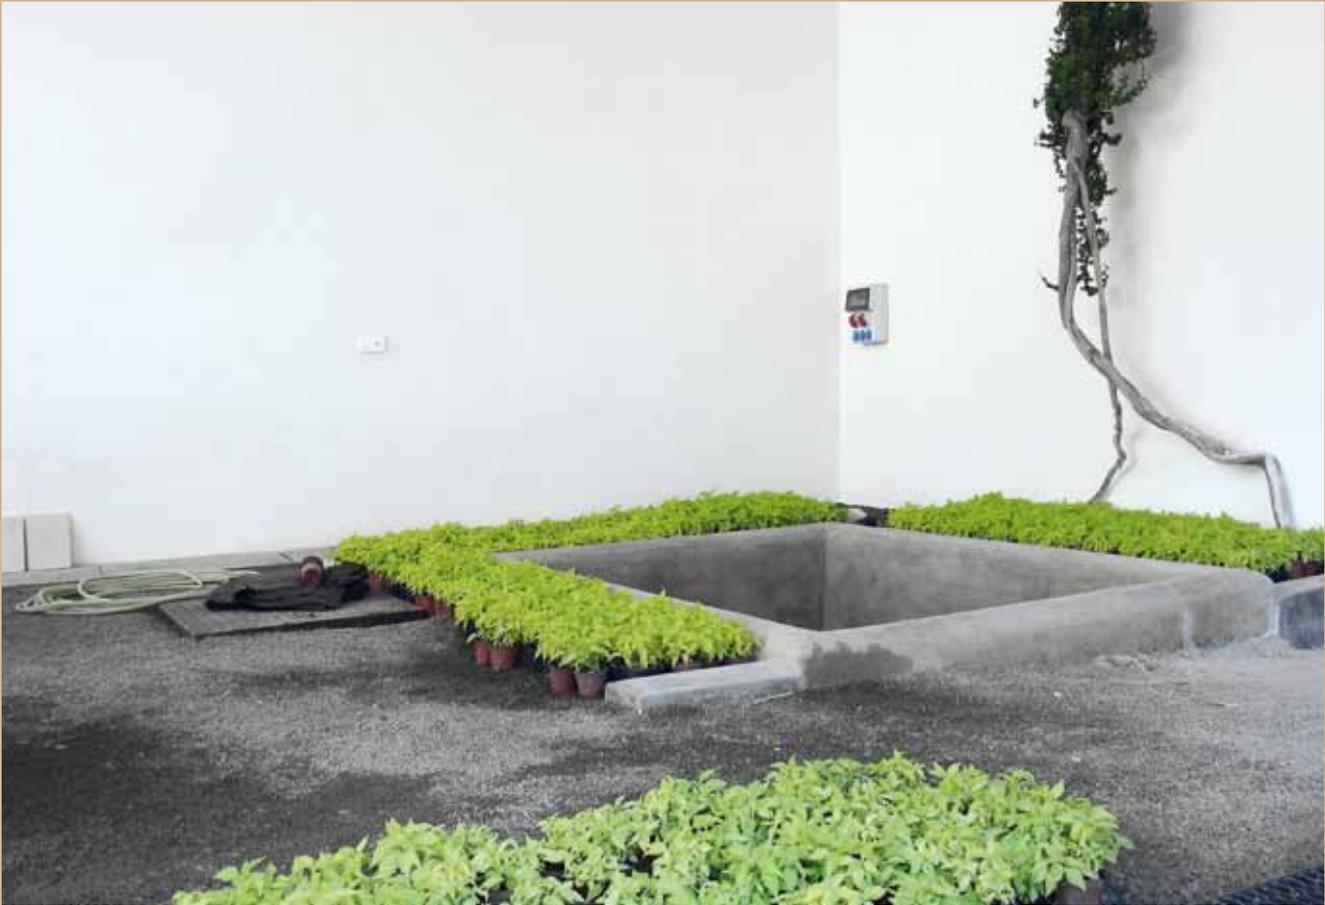
Stone pools in the greenhouses

The stone elements were cleaned and strengthened with organosilicon compounds; broken-off parts were re-moulded. The missing joints were filled with suitable sealants. The surface colours were smoothed out and the surface was hydrophobised. Before cleaning, the historical balustrade was pre-consolidated in the areas surrounding metal parts.

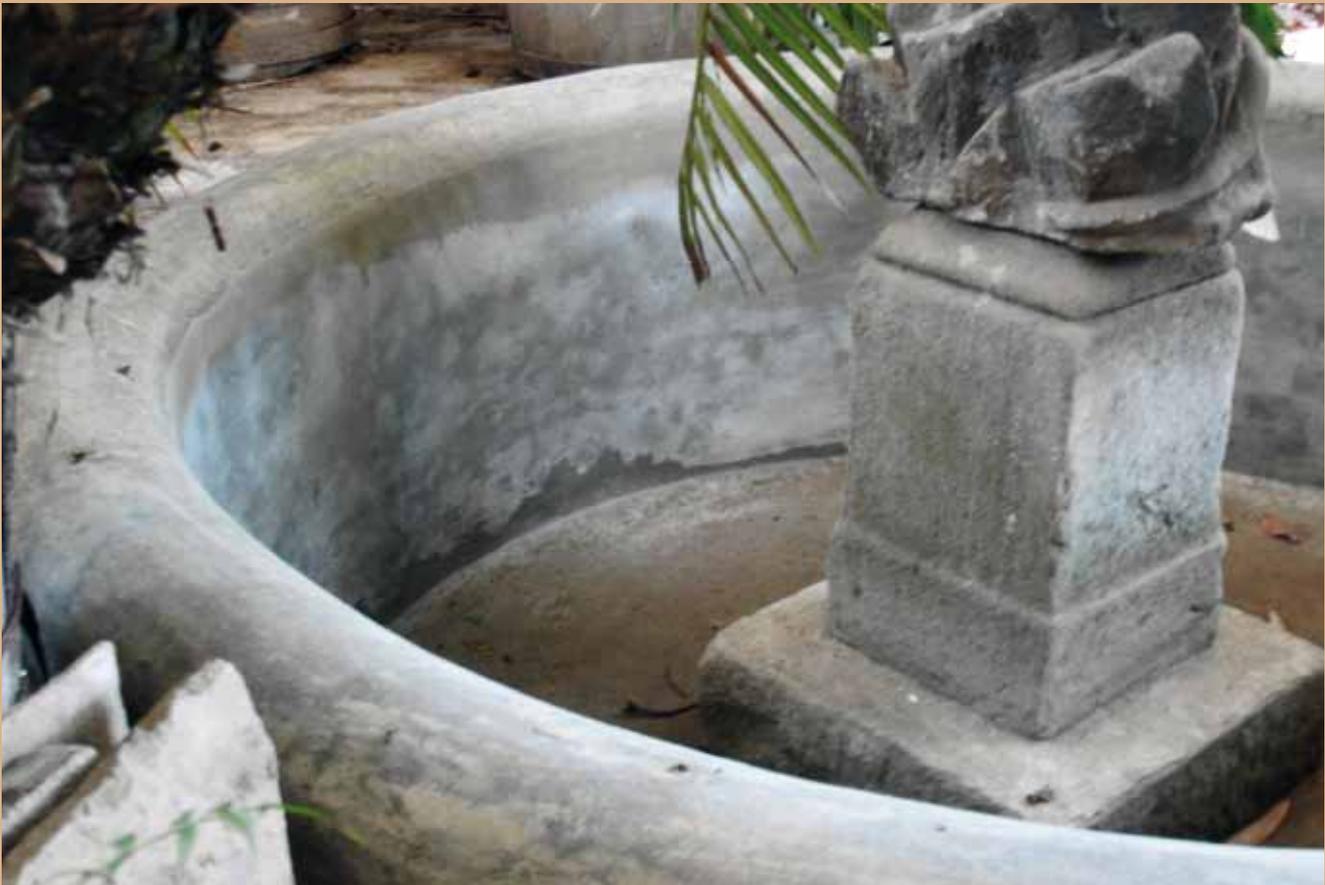
Close-up of a stone pool

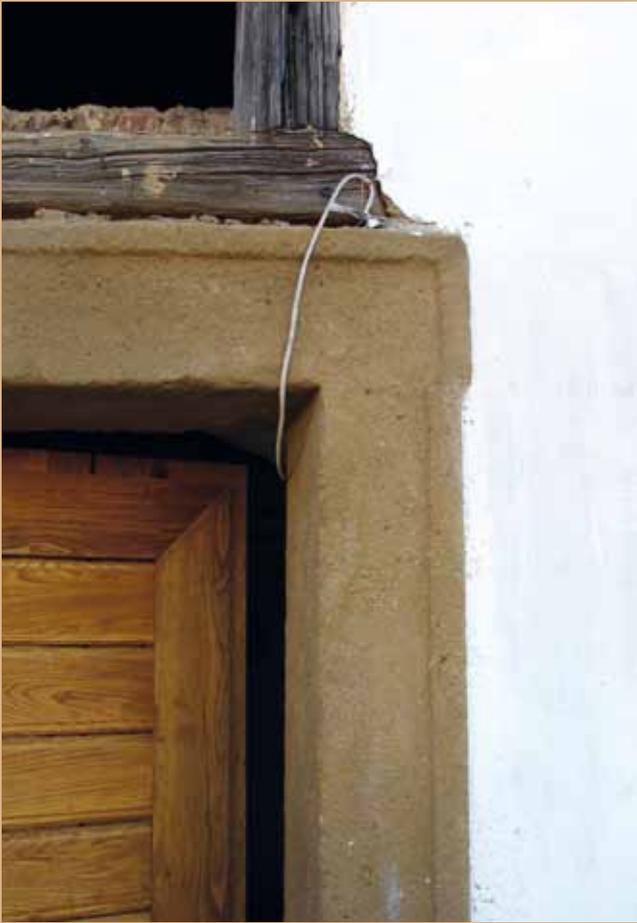
Close-up of a jamb

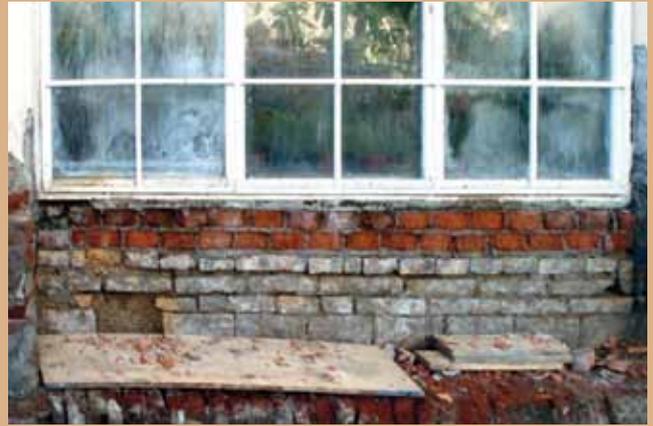
Conditions of the windows in the greenhouse – before restoration

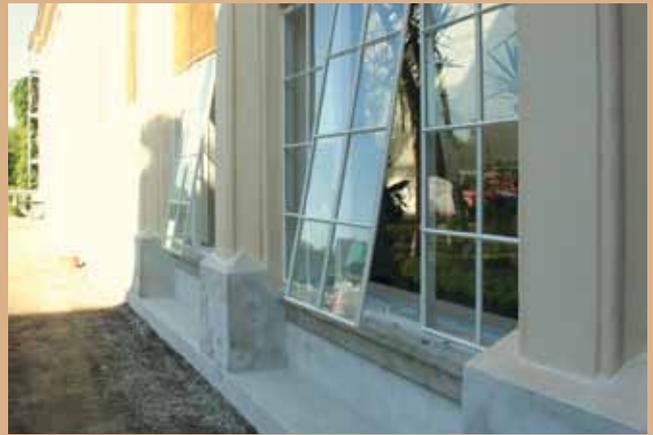
Condition of the windows and parapets – after restoration

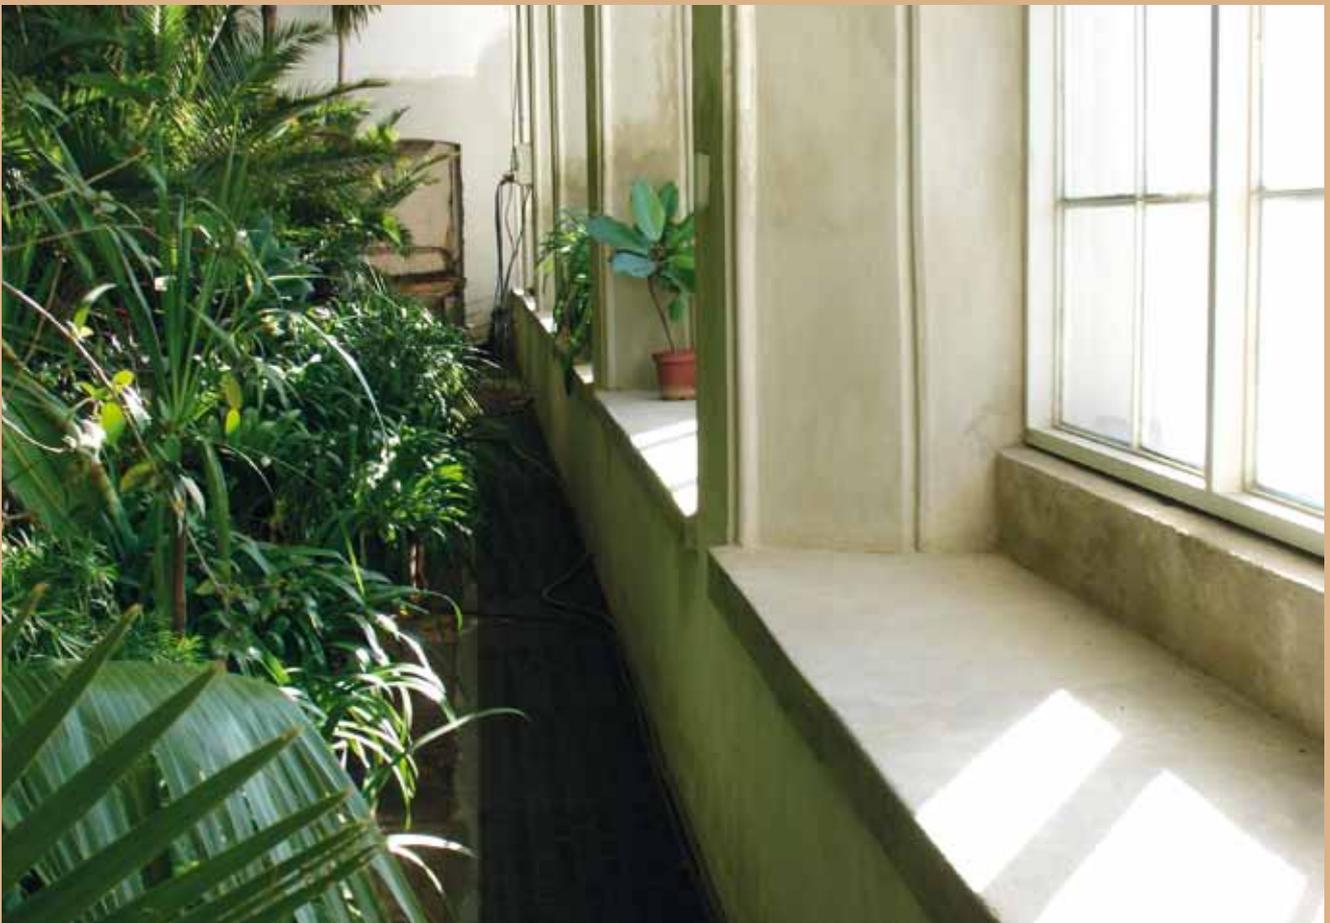
Restoration of the stone parapets in the greenhouse

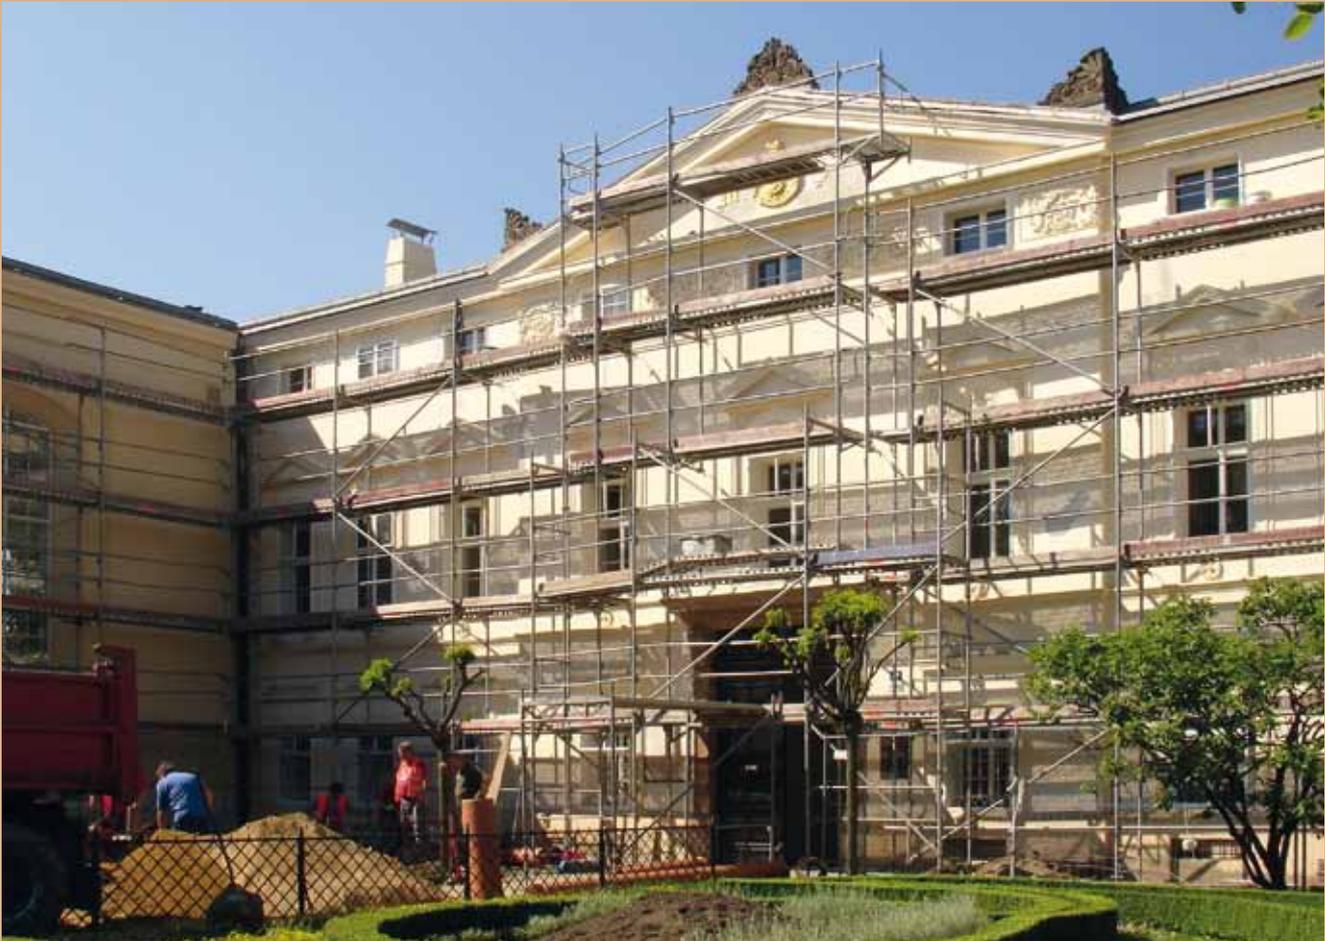
Historical stone details on the entrance building – the course of restoration

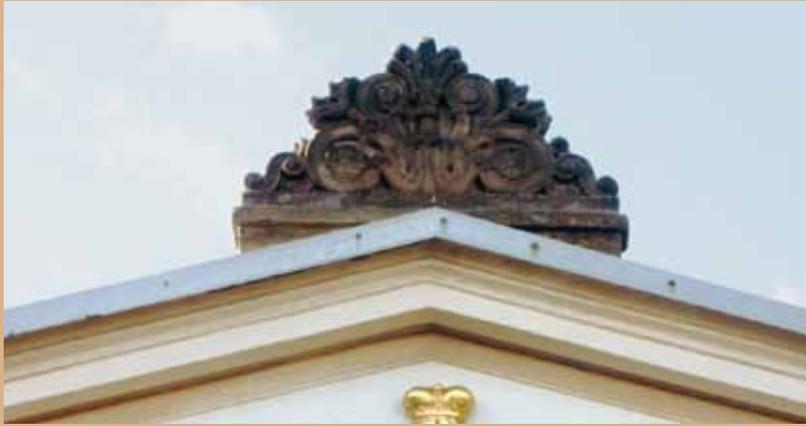
Close-up of the acroterion – before restoration

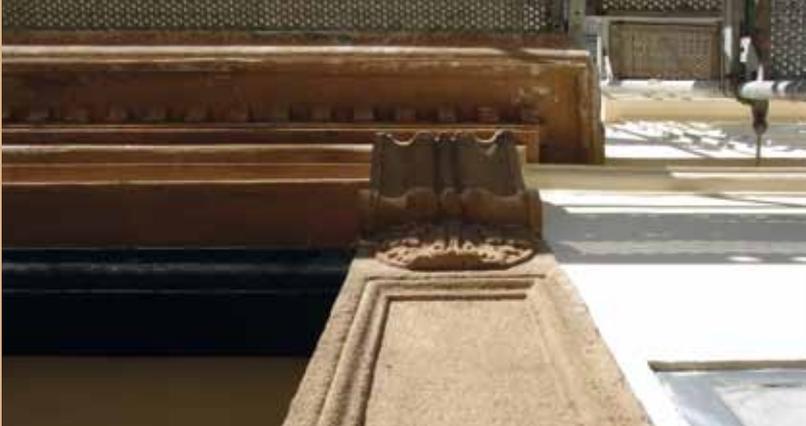
Course of restoration

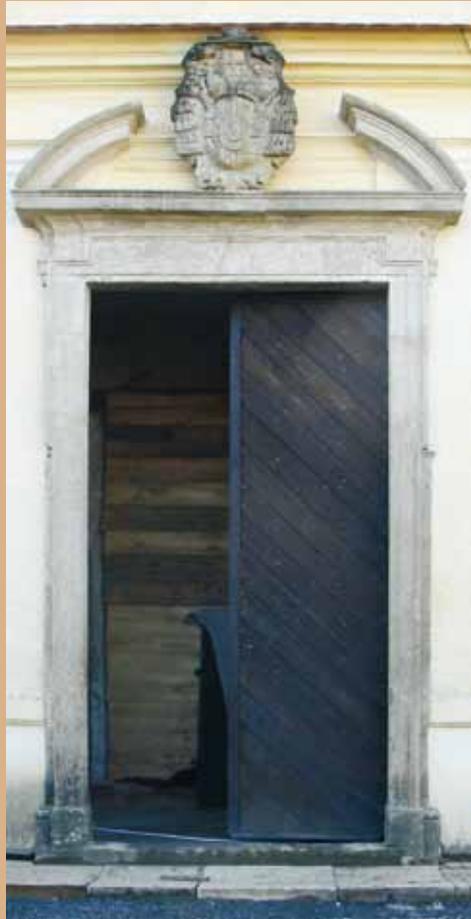
Stone pediment – condition before restoration

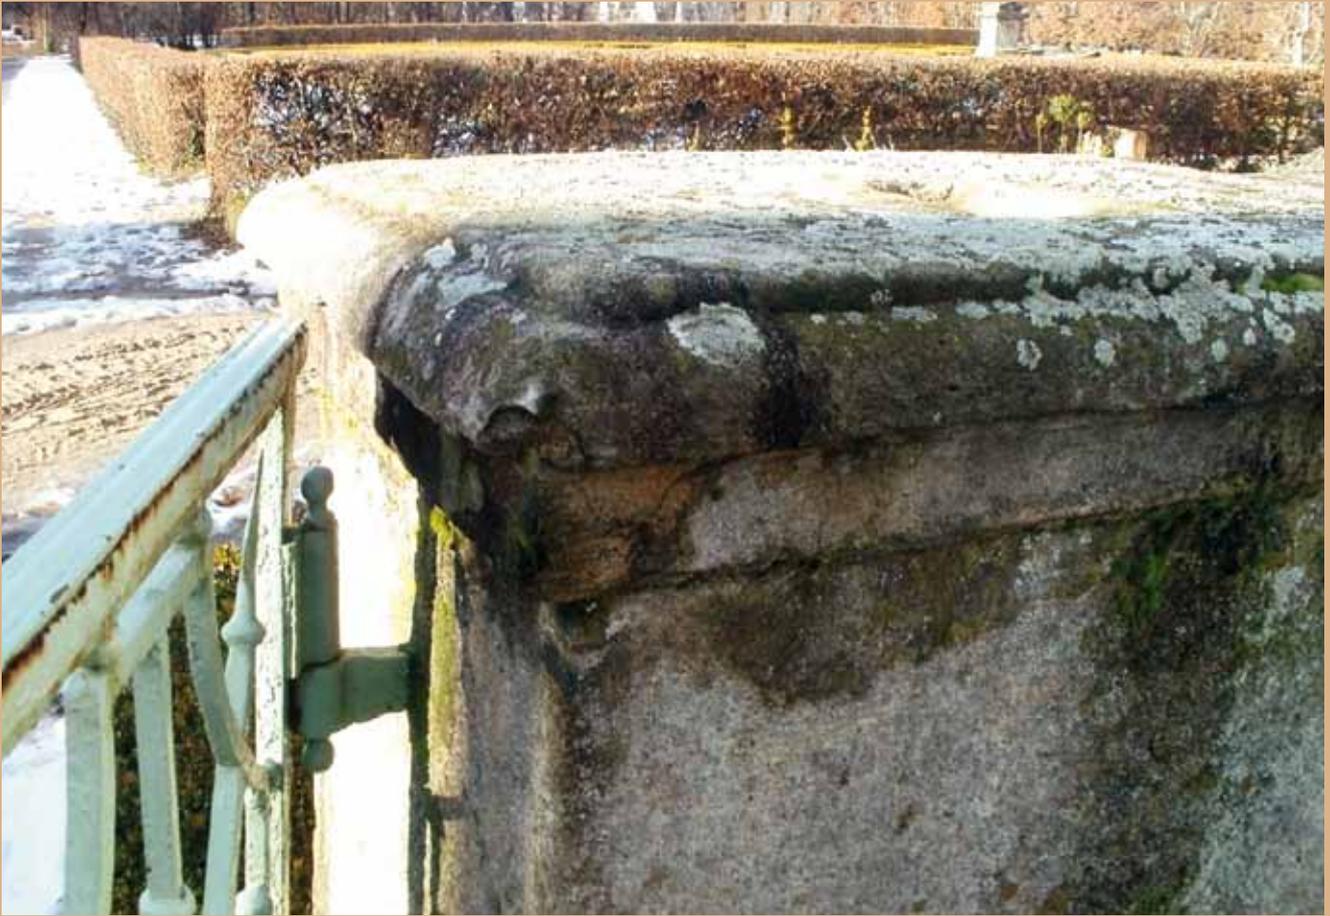
Close-up of the historical railing in the Floral Garden courtyard – condition before restoration

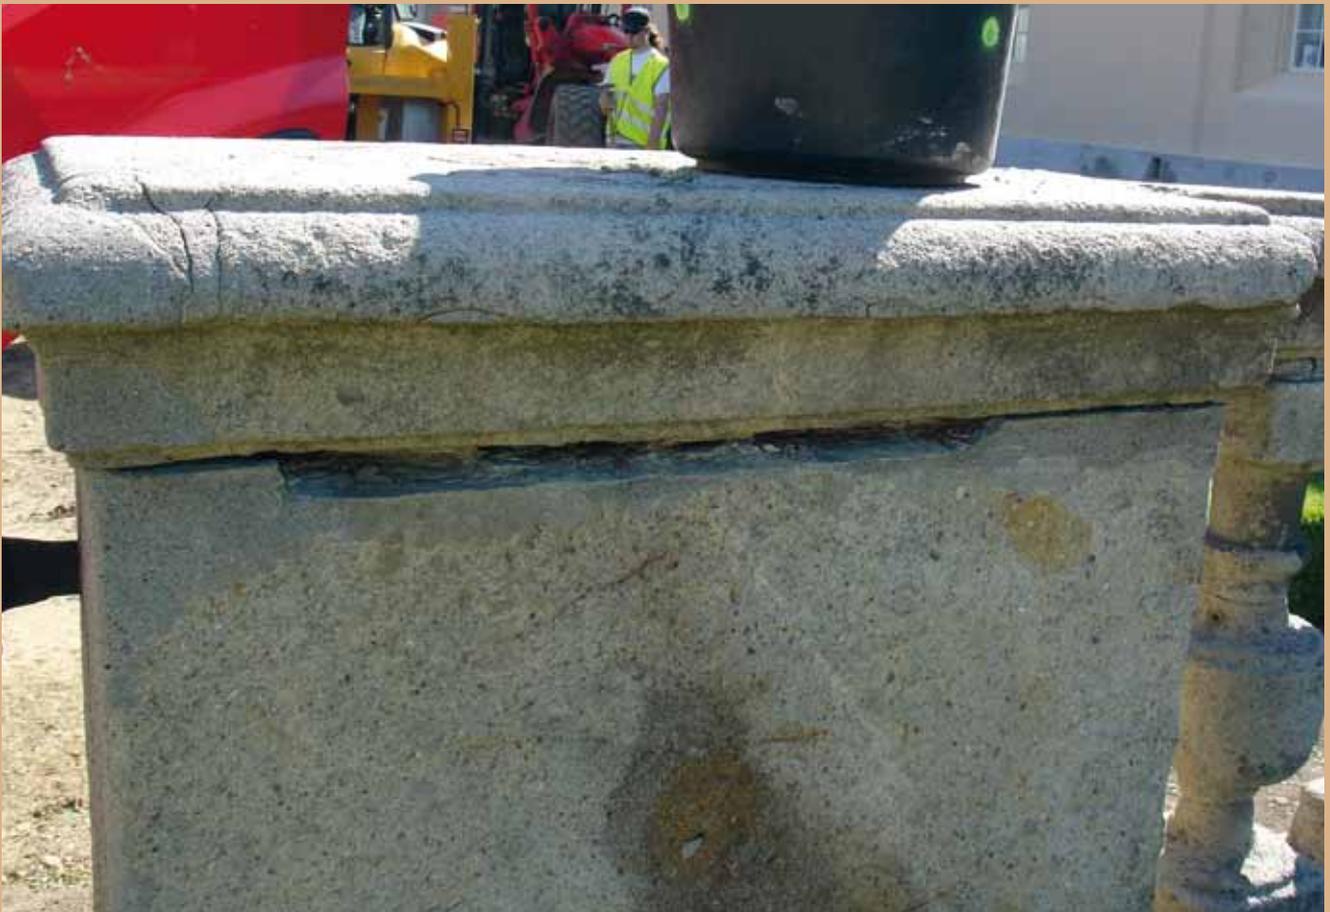
Close-up of the historical railing in the Floral Garden courtyard – the course of restoration

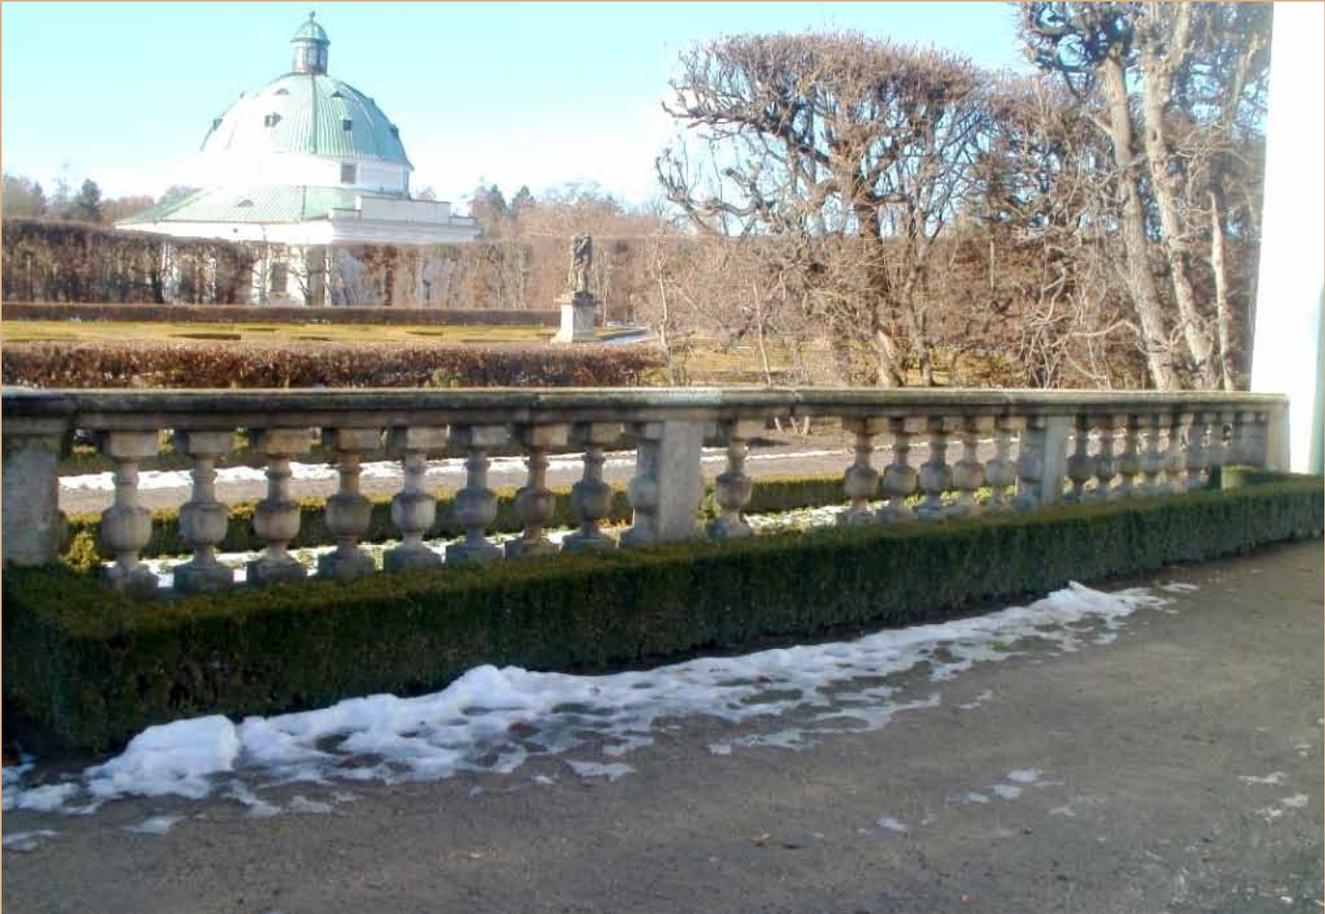
Overall view of the stone balustrade – condition before restoration

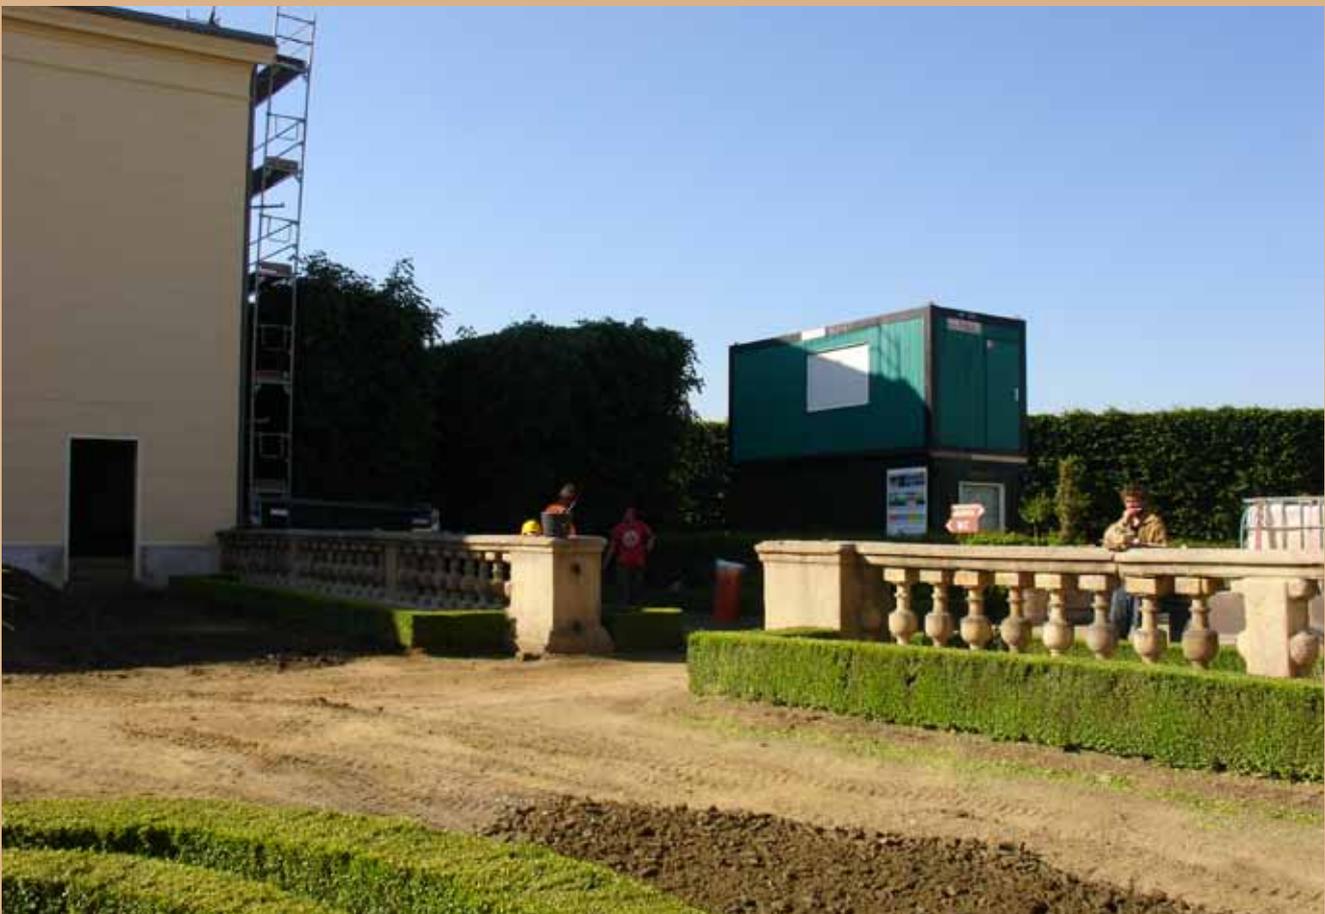
Overall view of the stone balustrade – the course of the works

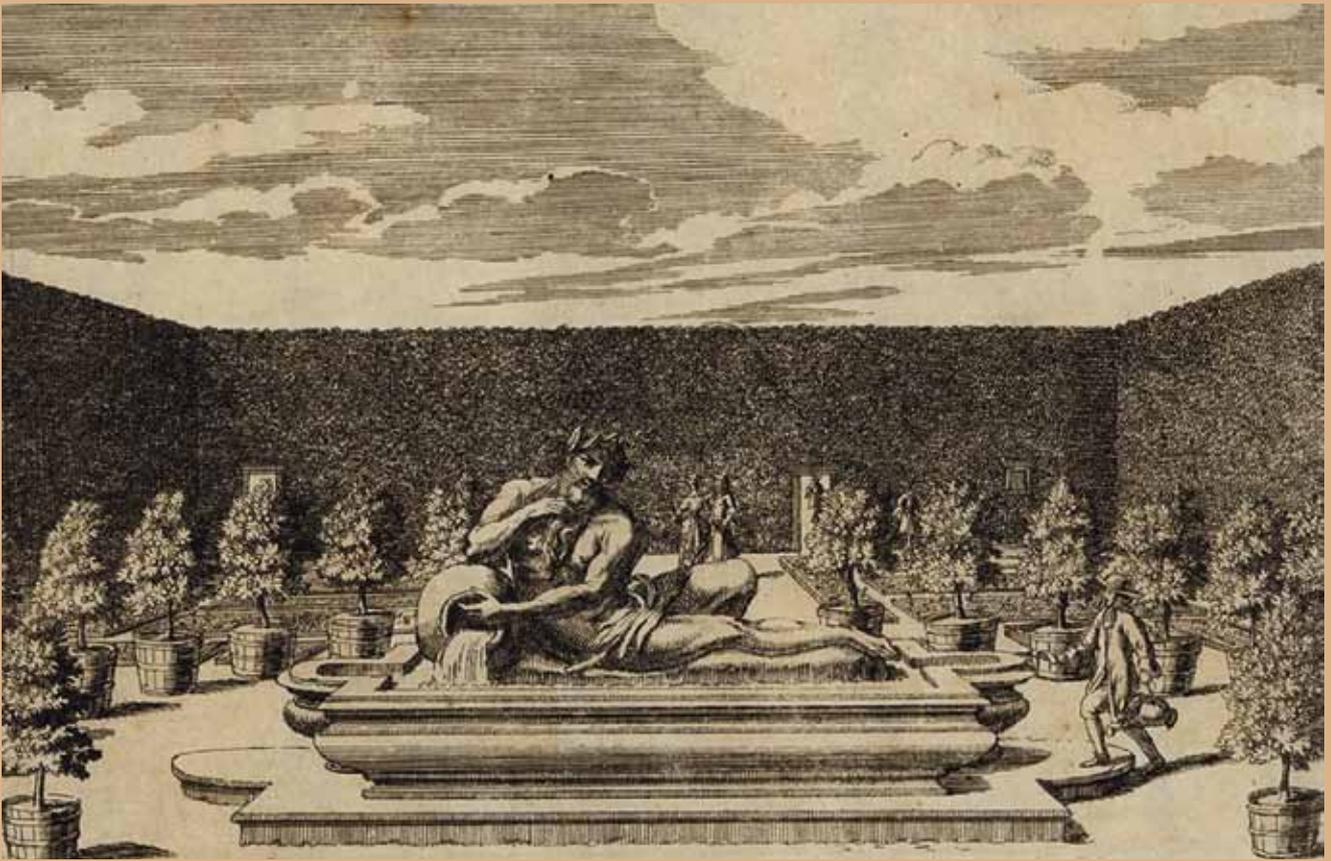
Historical appearance of the baroque fountain with the statue of Neptune

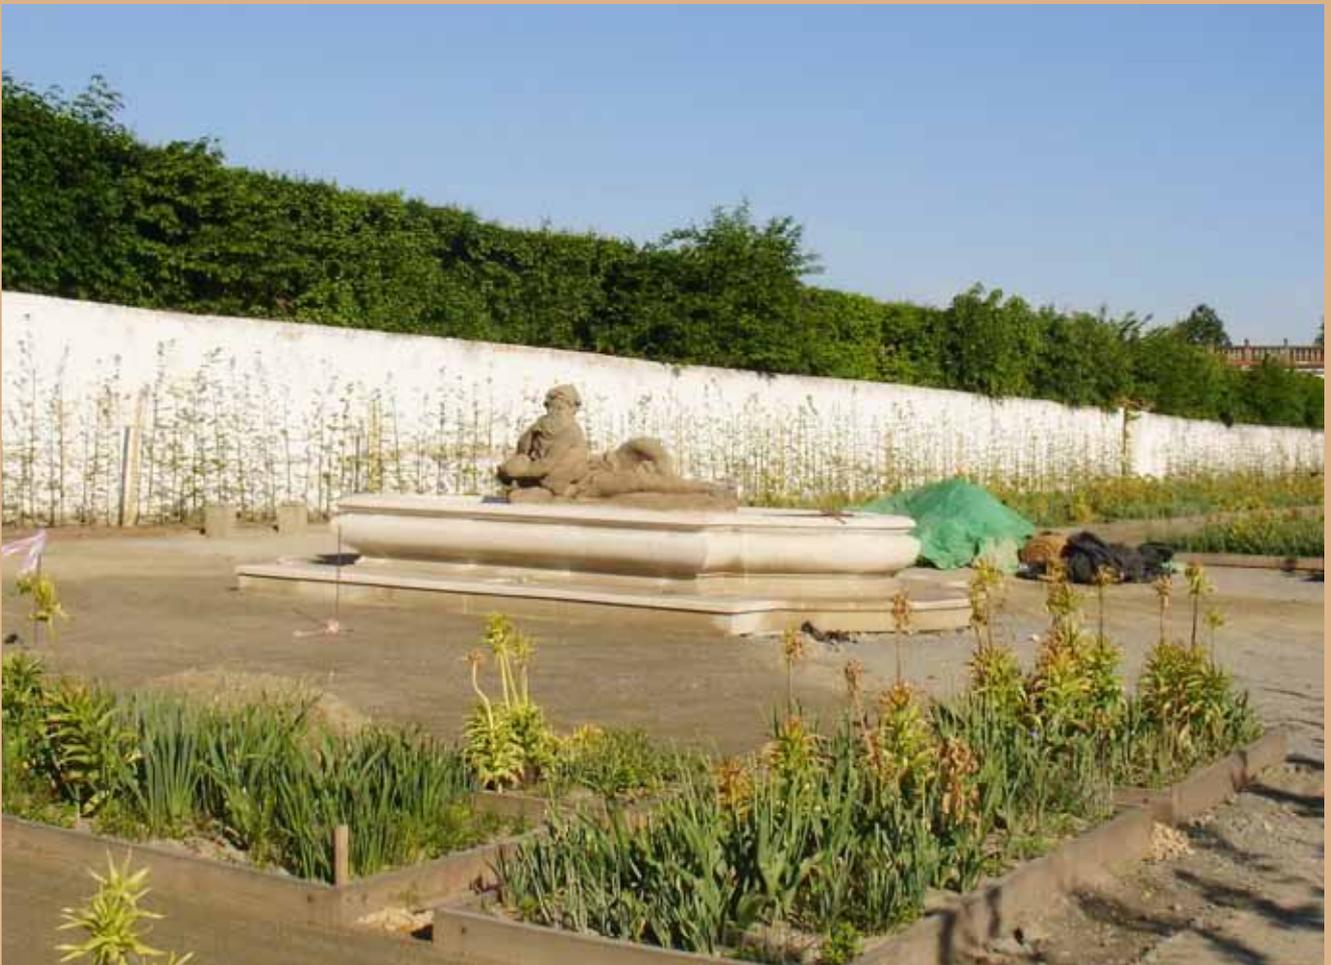
Overall view of the fountain replica and the newly restored statue of Neptune

The statue of Neptune, the Roman god of the seas, was situated on top of a stone fountain. Comprehensive restoration work was performed on the statue already in 2000, therefore only minor works were involved. Cleaning was done by hand. This was followed by the introduction of organosilicate strengthening agents and minor treatments with mineral sealants, colour retouch and hydrophobisation. The statue was fixed on the fountain with chromium-nickel pegs.

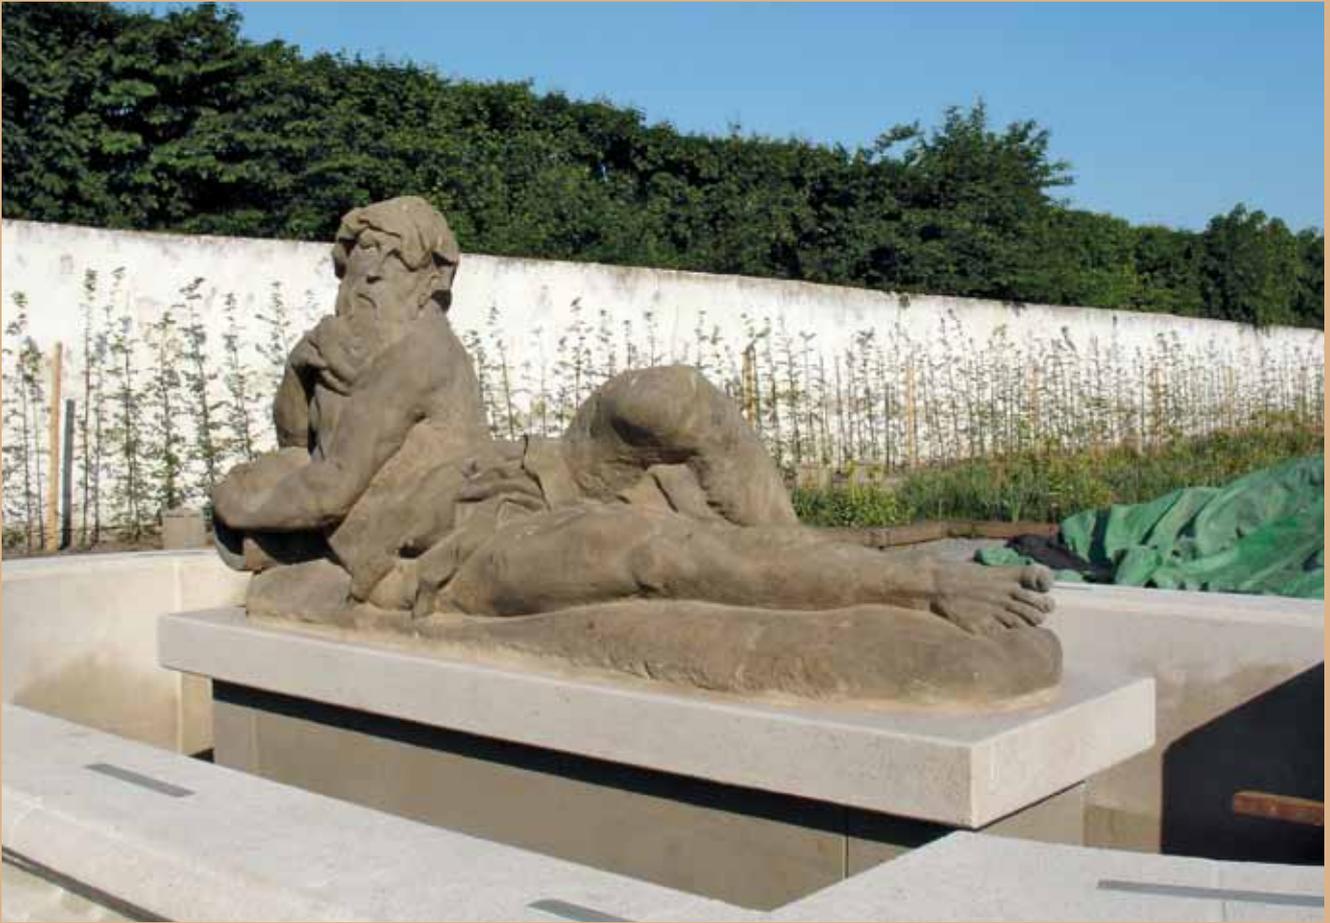
The statue of Neptune – condition after restoration

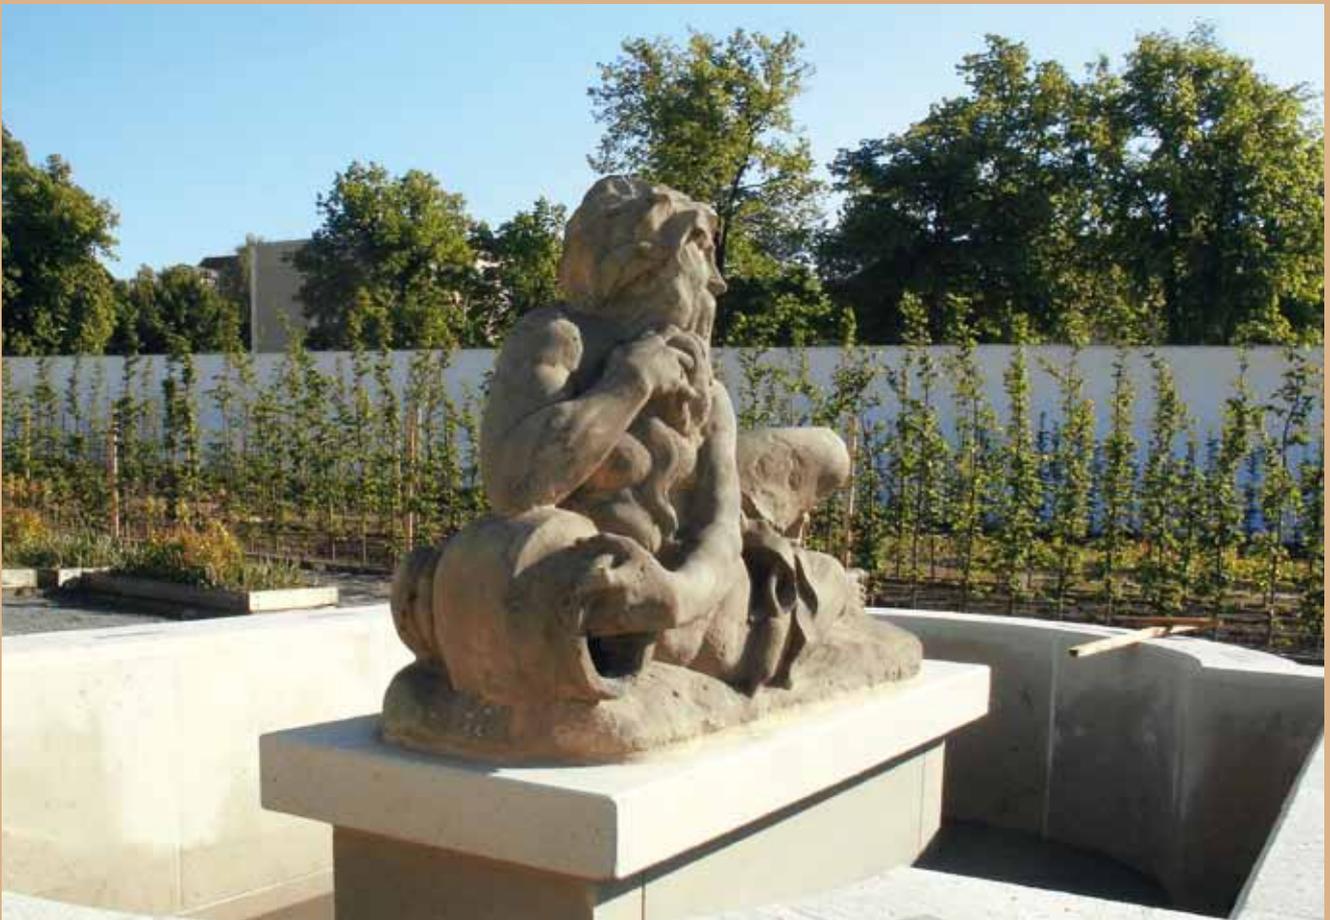
The statue of Neptune – the rear part after restoration

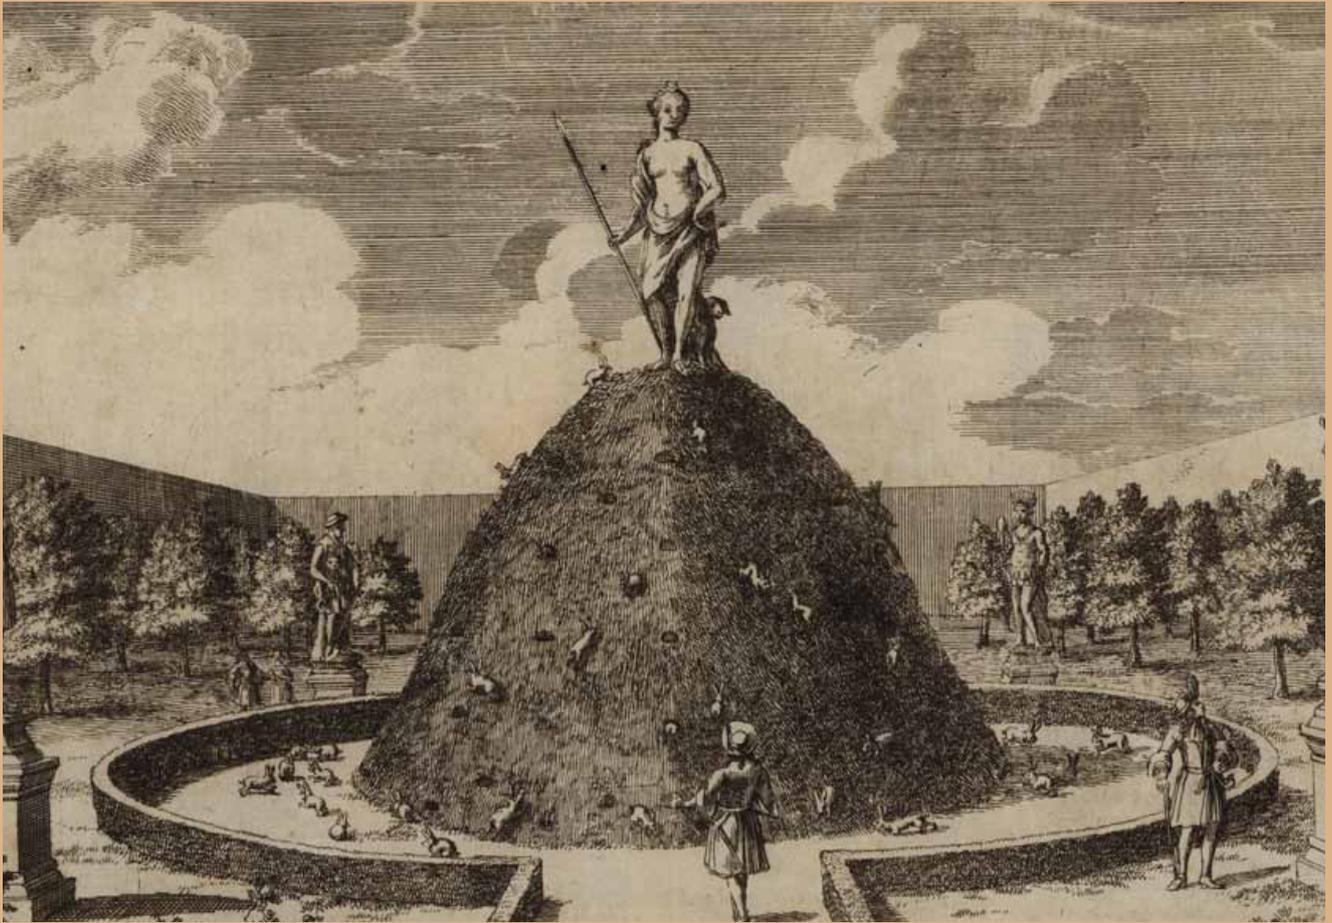
Rabbit Hill with the statue of Diana – original appearance

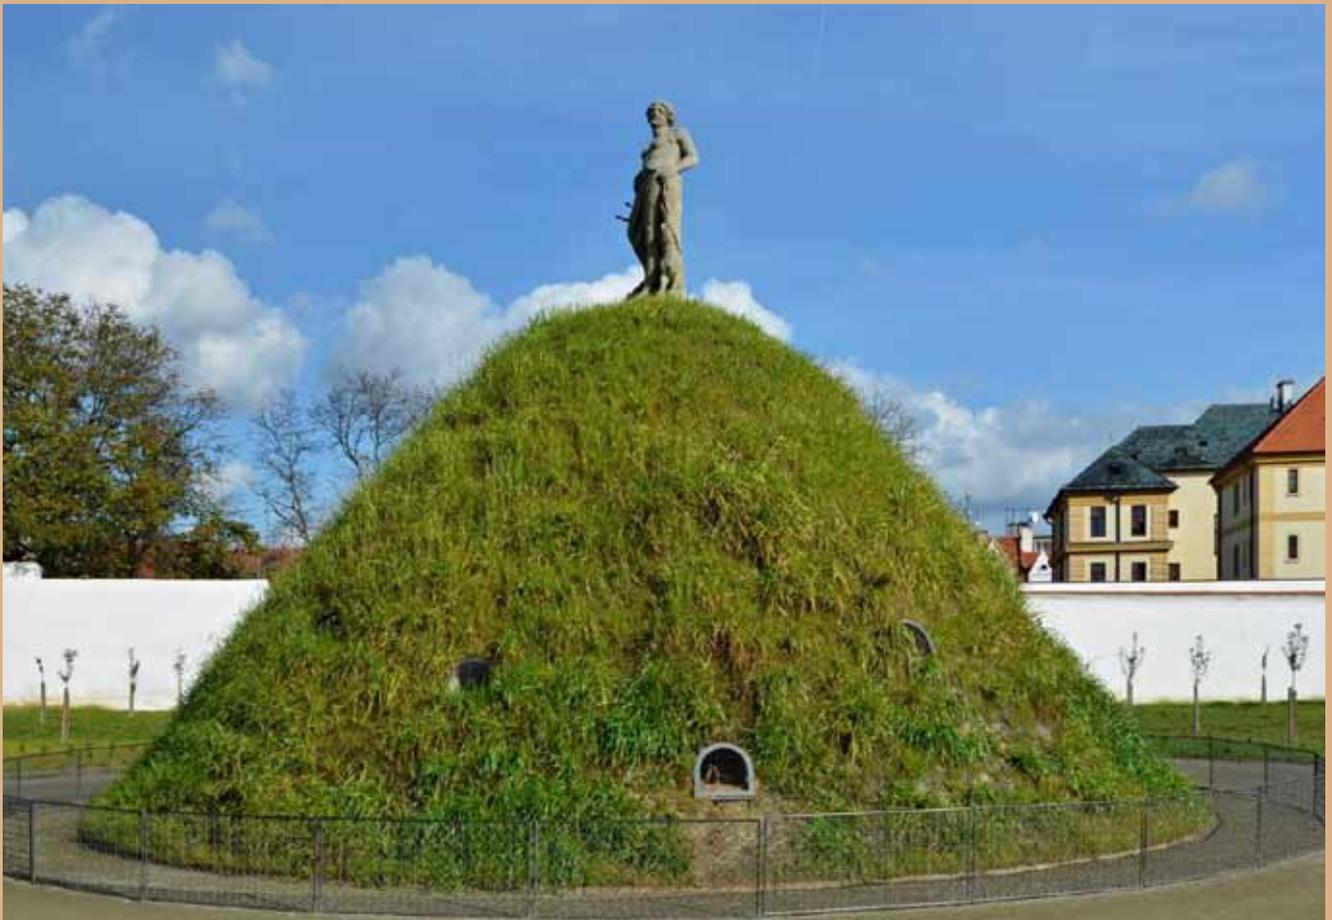
Rabbit Hill with the statue of Diana – condition after restoration

The statue was covered with a thick crust; overall decay of the surface layer was showing especially in fine details. The material suffered from the loss of cohesion and there were a number of cracks in the rear parts of the statue of Diana and also in the head area. The restorers aimed to significantly reduce the effect of the outside environment on the ageing of the statue. The crusts were removed using microjet cleaning with aluminosilicate abrasives. Consolidation of the stone material and restoration works on the missing parts followed. Final hydrophobisation and smoothing out of colours also had to be performed.

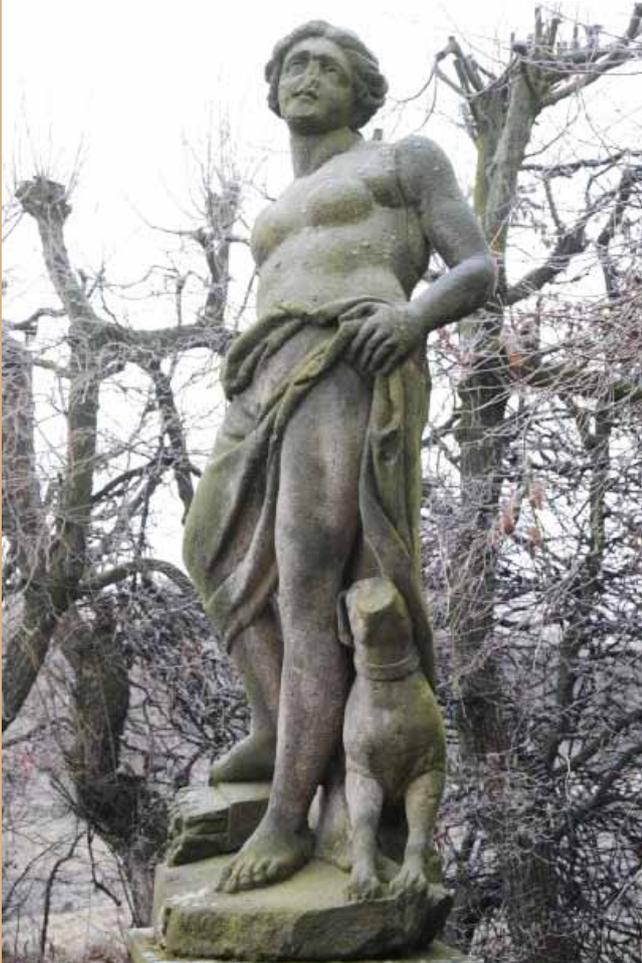
The statue of Diana before restoration
