FLORAL GARDEN IN KROMĚŘÍŽ

KVĚTNÁ ZAHRADA, GEN. SVOBODY 1192,
761 01 KROMĚŘÍŽ

CONTRACTOR: GEMA ART GROUP A.S.

IMPLEMENTATION: DECEMBER 2012–APRIL 2014

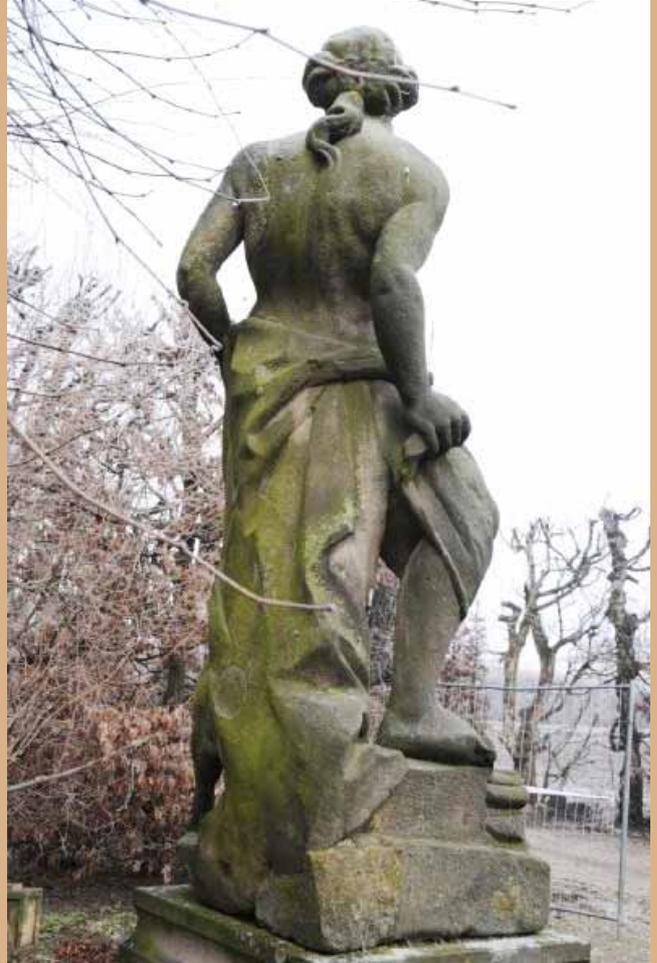
The statue was covered with a thick crust; overall decay of the surface layer was showing especially in fine details. The material suffered from the loss of cohesion and there were a number of cracks in the rear parts of the statue of Diana and also in the head area. The restorers aimed to significantly reduce the effect of the outside environment on the ageing of the statue. The crusts were removed using microjet cleaning with aluminosilicate abrasives. Consolidation of the stone material and restoration works on the missing parts followed. Final hydrophobisation and smoothing out of colours also had to be performed.

The statue of Diana - condition before restoration

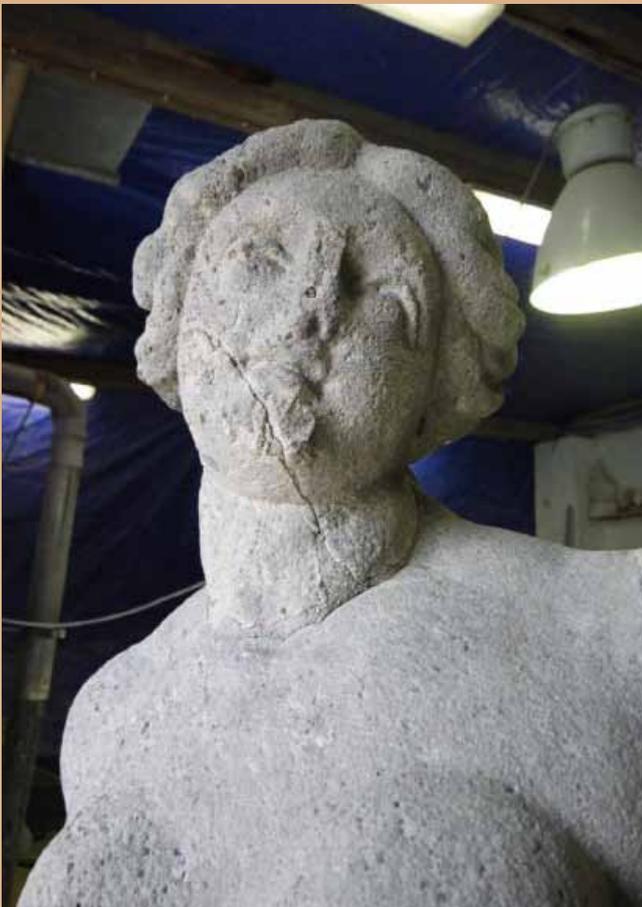
Close-up of a crack on the face of the statue of Diana - the course of the works

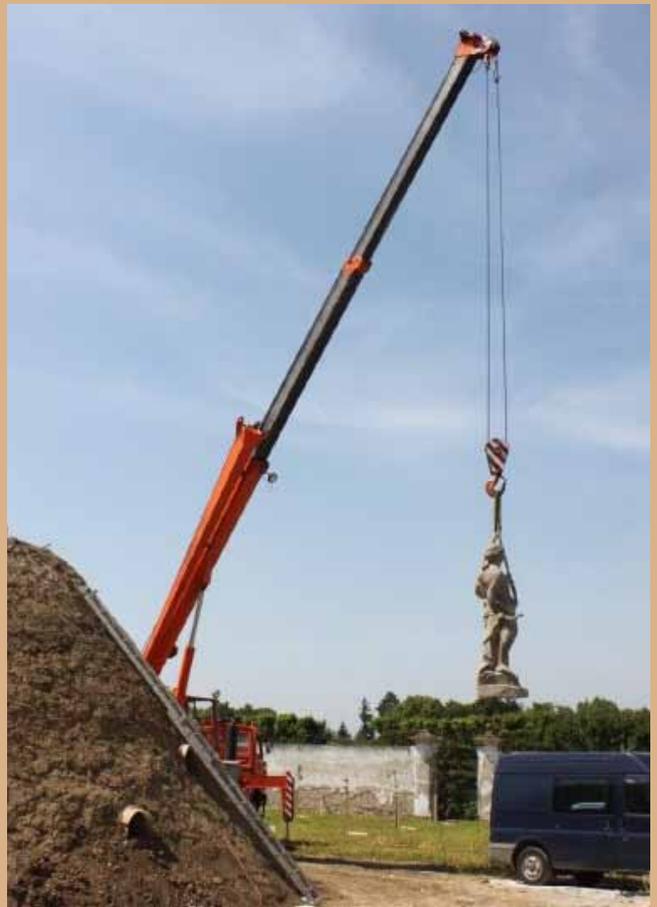
Installation of the sculpture at the Rabbit Hill

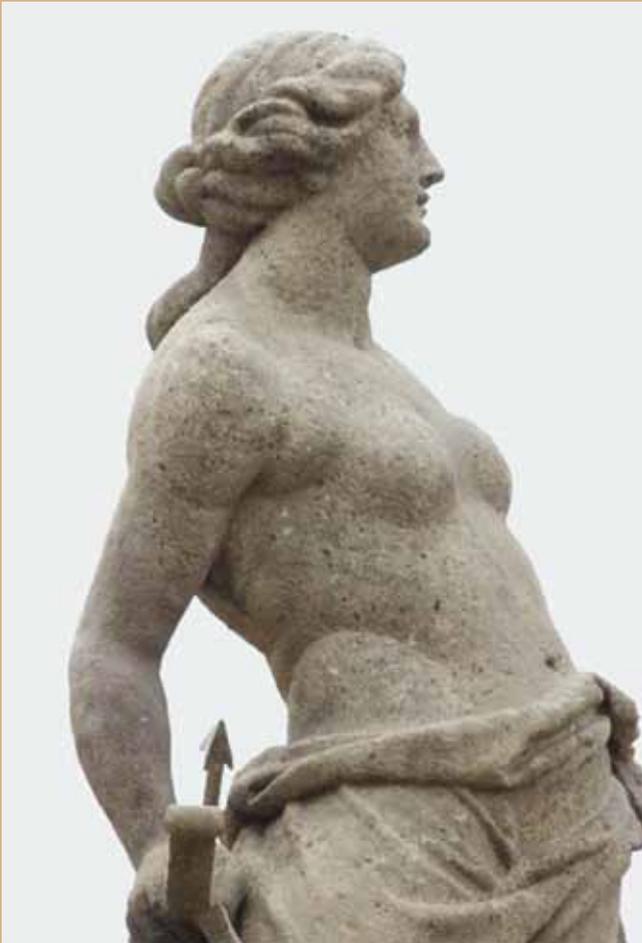
Condition of the sculpture after restoration

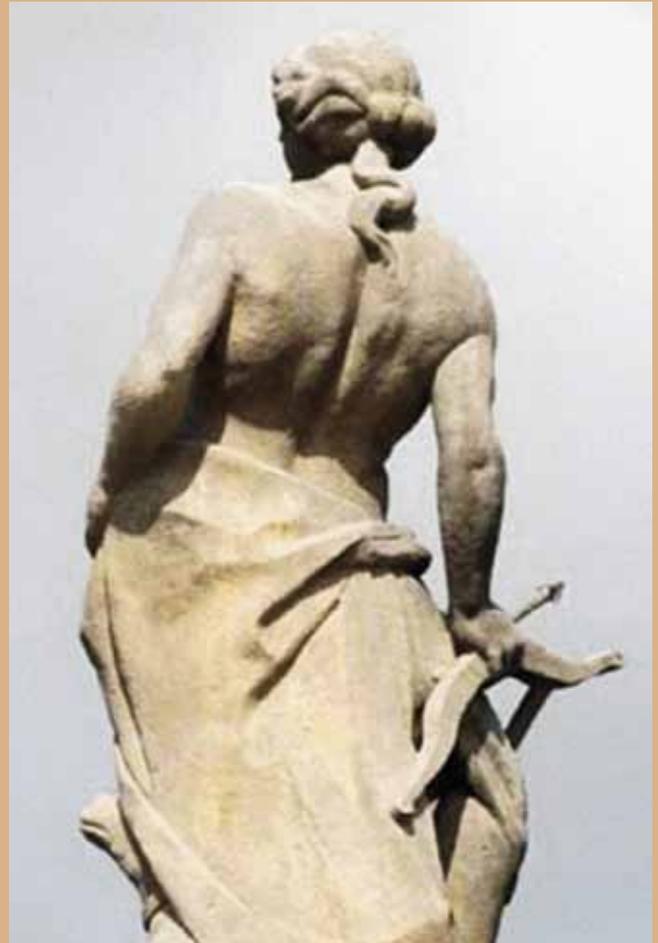
Condition of the sculpture after restoration – rear part

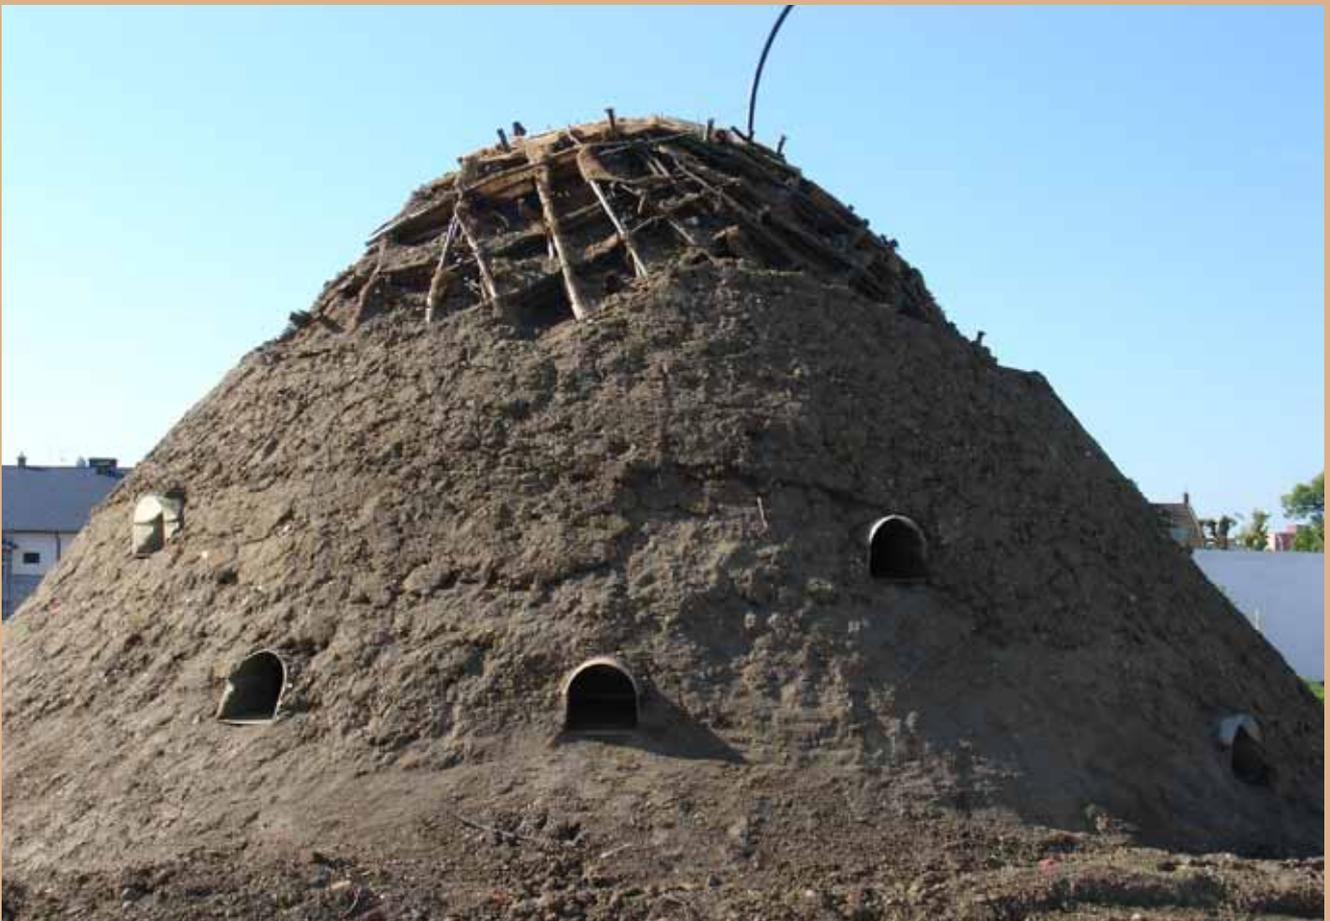
Rabbit Hill – the course of the works

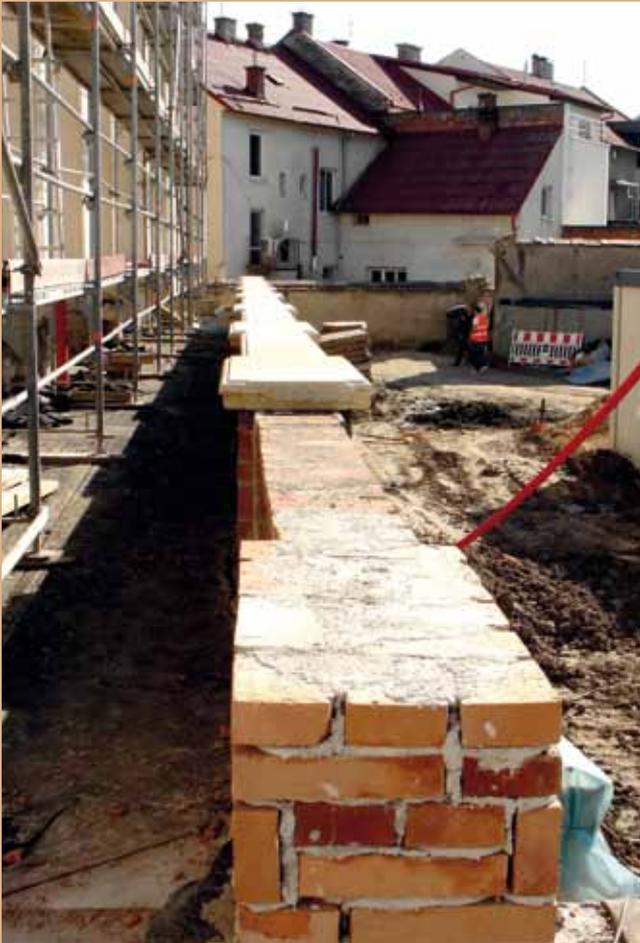
Installation of the stone railing at the greenhouse terrace

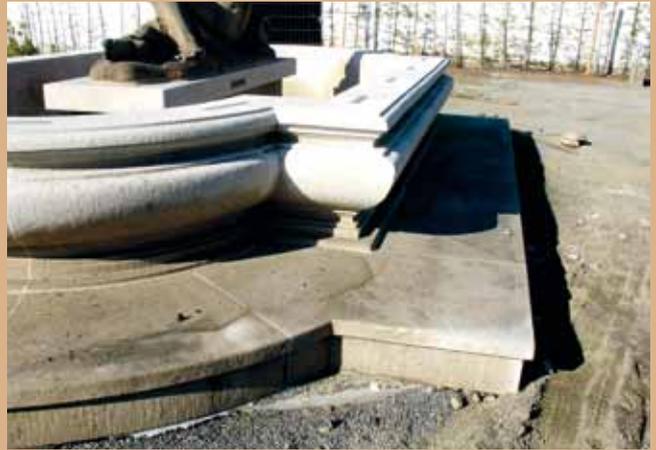
Newly made fountain with a baroque statue of Neptune

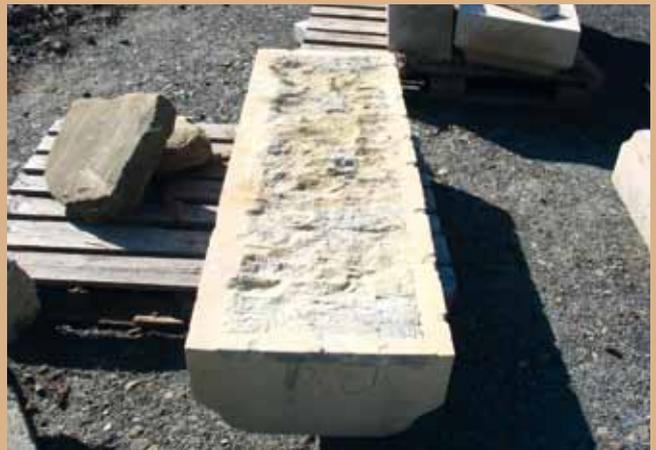
Close-up of a stone element

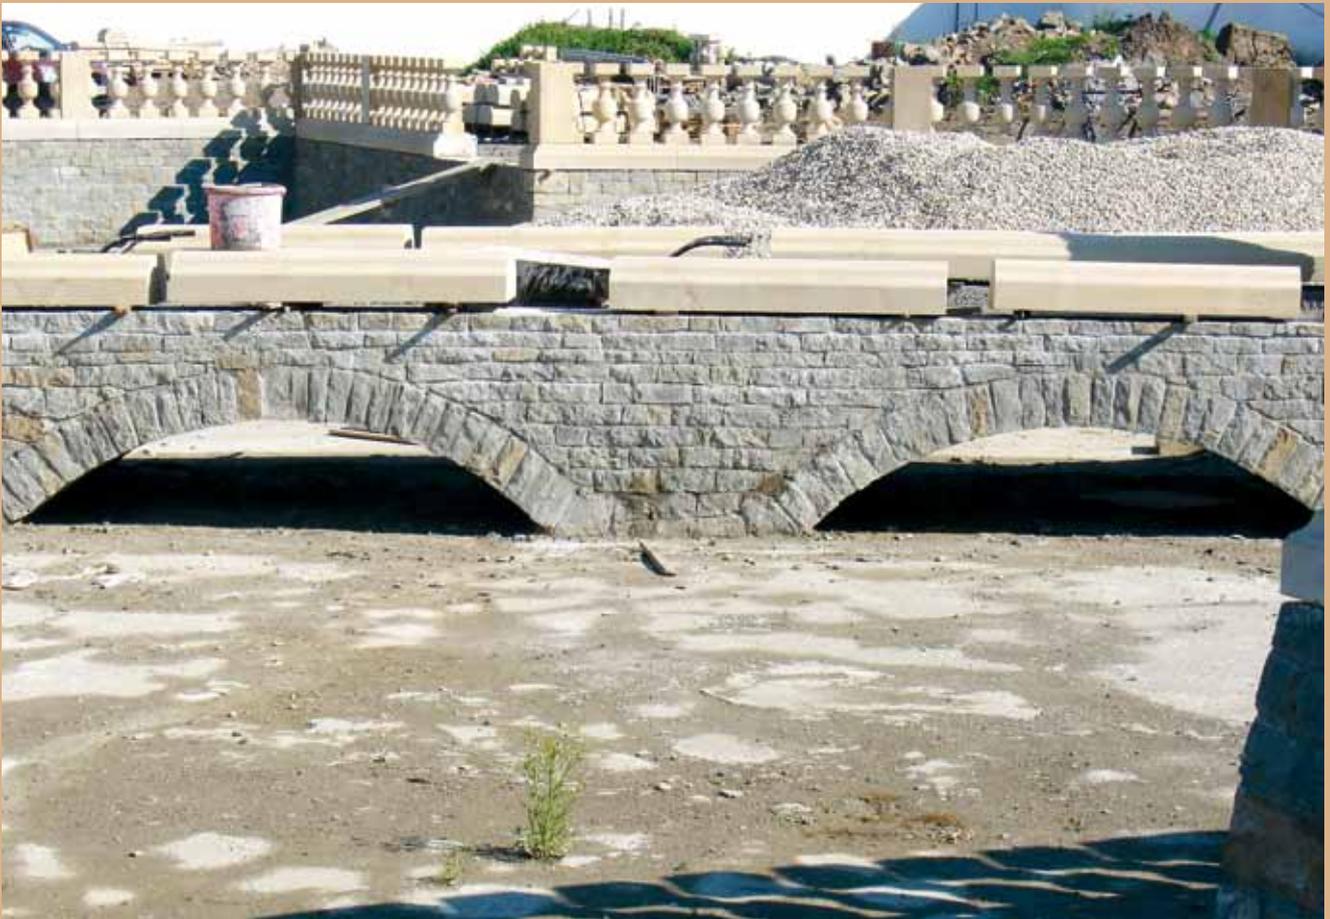
Laying down stone paving on the bridge to the Bird-house

The garden house and the fowler's house underwent a refurbishment of the stone portals, jambs and window sills. The Bird-house received a new stone balustrade, birdbath, stairway, window sills and stone paving on the bridge and in the area around the Bird-house.

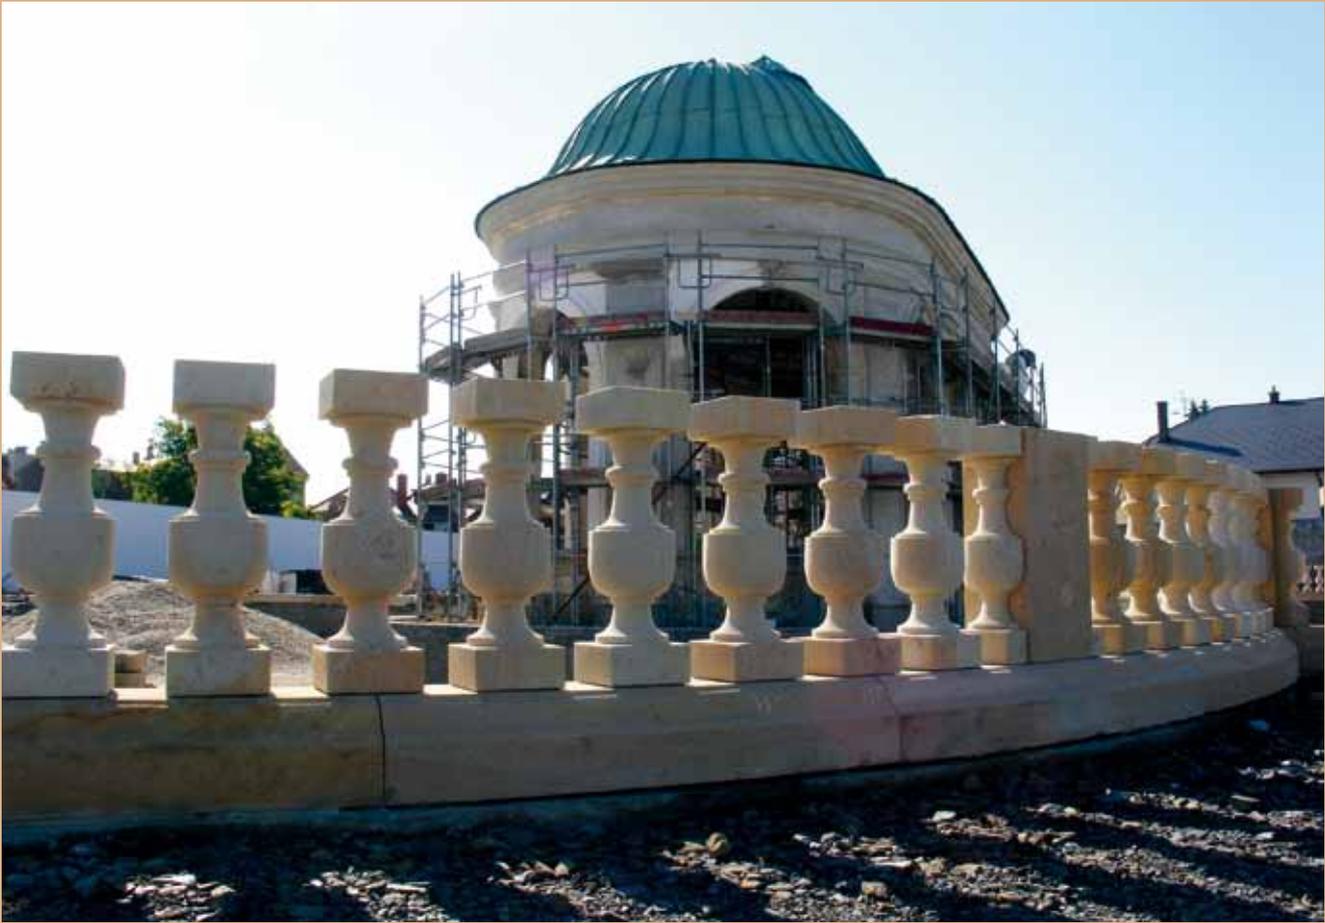
Stone balustrade around the Bird-house

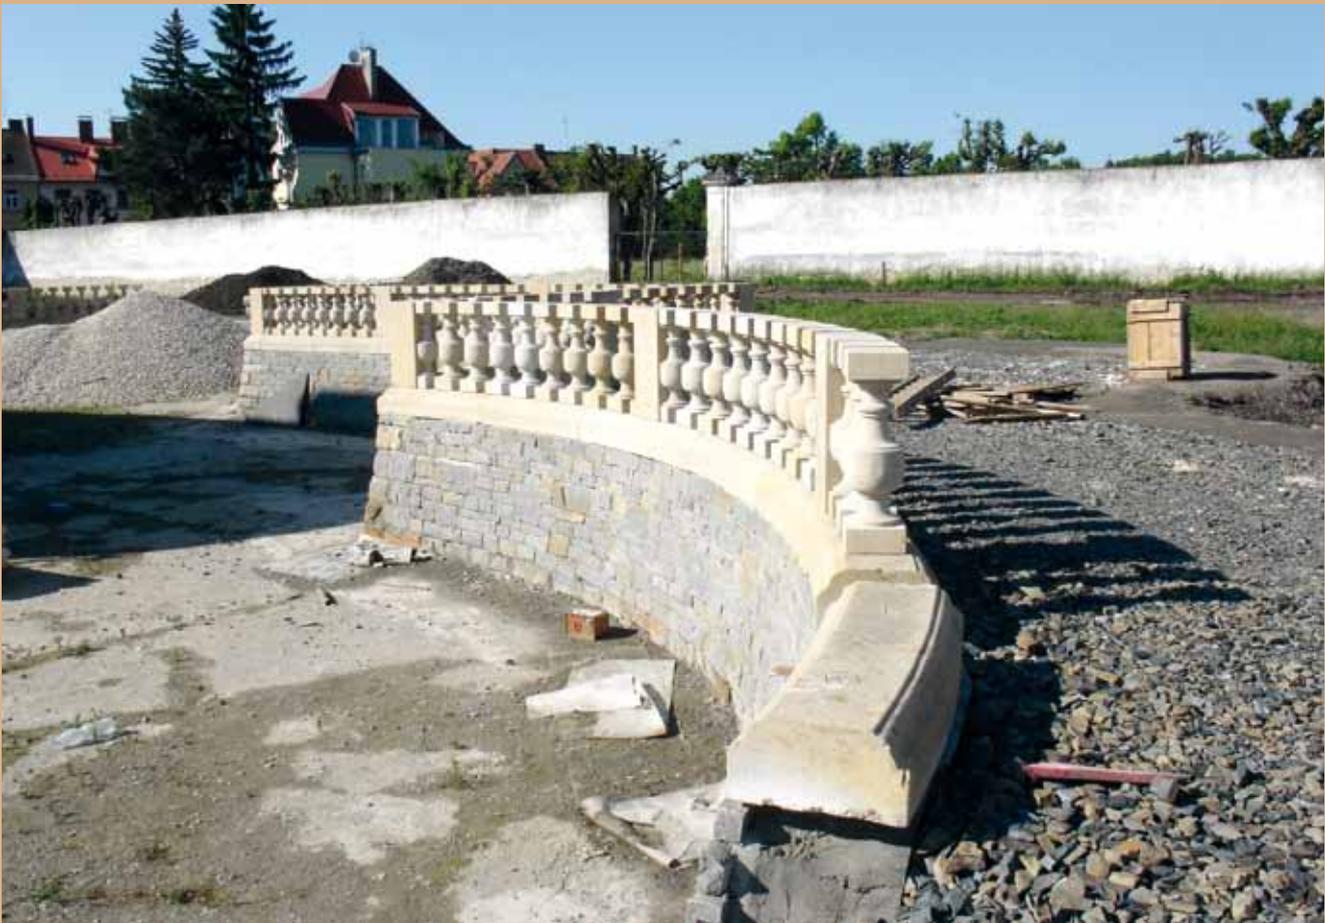
Installation of the stone balustrade around the Bird-house

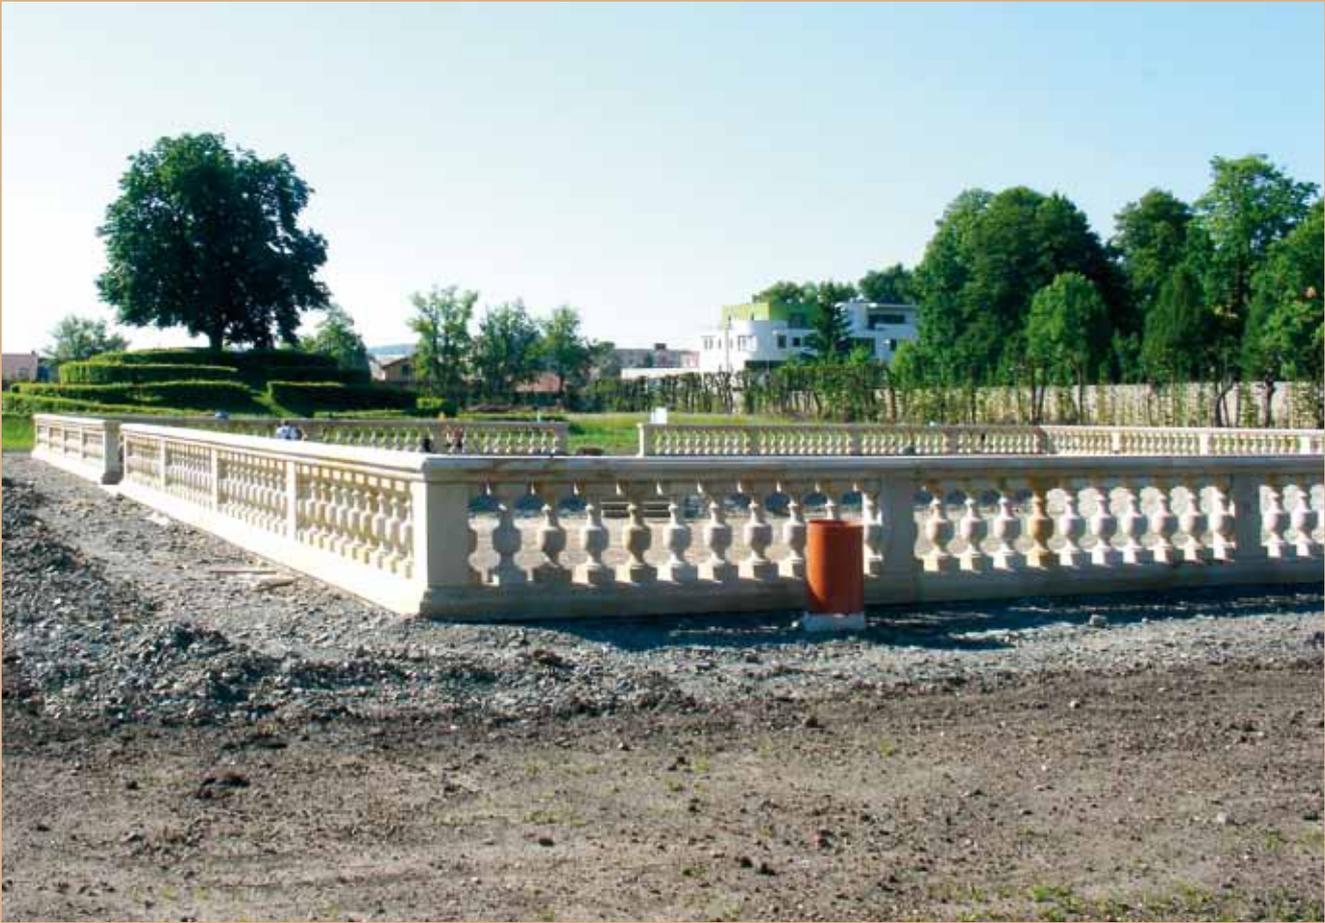
Trout Pond restored to its original appearance

The works carried out by GEMA ART GROUP a.s. consisted in the supply and comprehensive installation of stone elements replicas in the whole complex of the Floral Garden. This included the restoration of the Trout Pond – the construction of the reservoir, installation of a stone stairway and the balustrade railings. The works aimed to restore the garden to its original state as depicted on a surviving 17th century engraving.

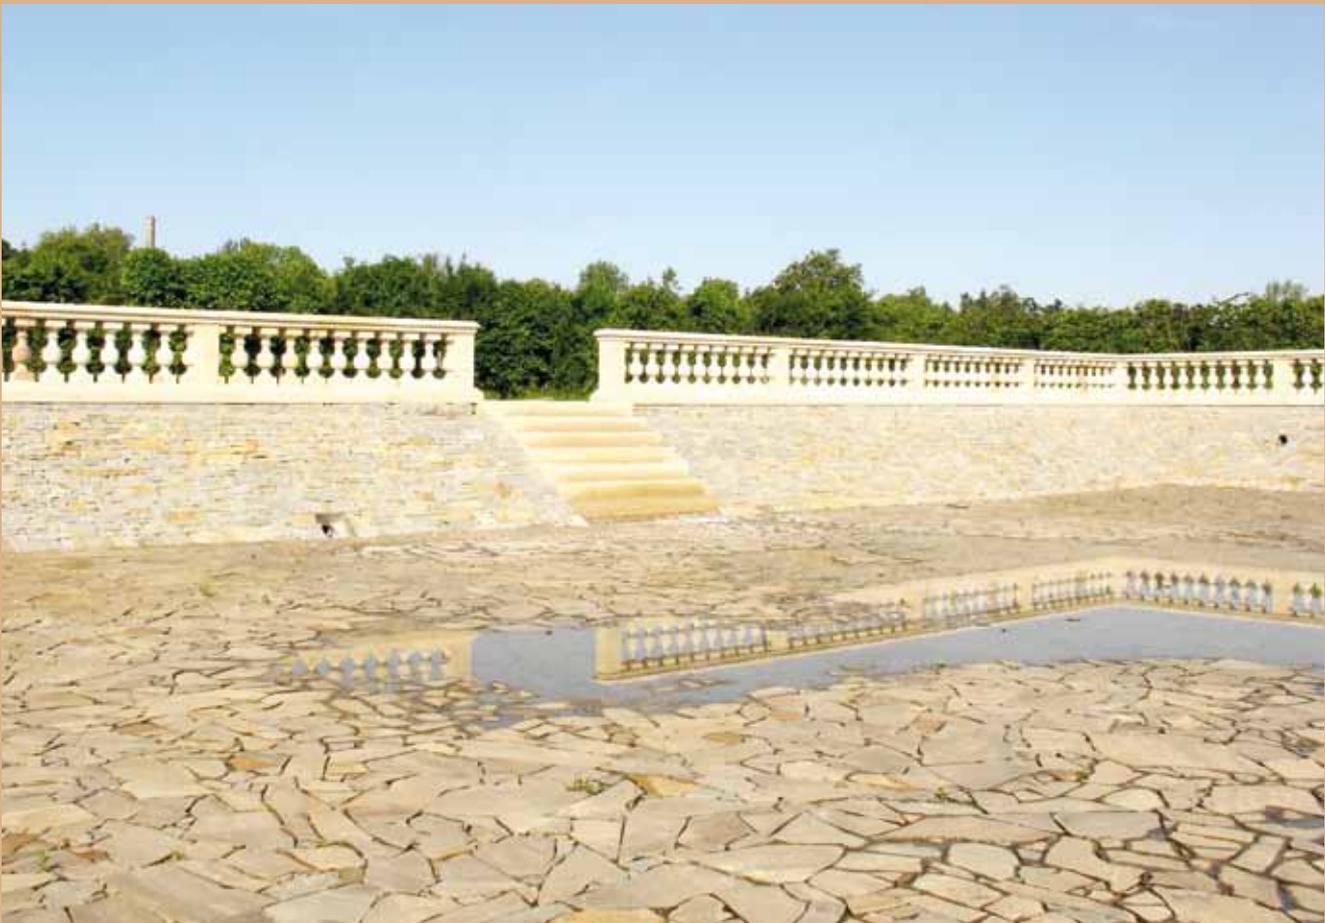
Trout Pond – condition shortly before completion and filling up the reservoir
