WORK ON RENOVATION OF THE KUKS HOSPITAL NATIONAL CULTURAL MONUMENT

NKP KUKS, 544 43 KUKS

INVESTOR: NATIONAL HERITAGE INSTITUTE

CONTRACTOR: THE HOCHTIEF – GEMA ART
GROUP ASSOCIATION

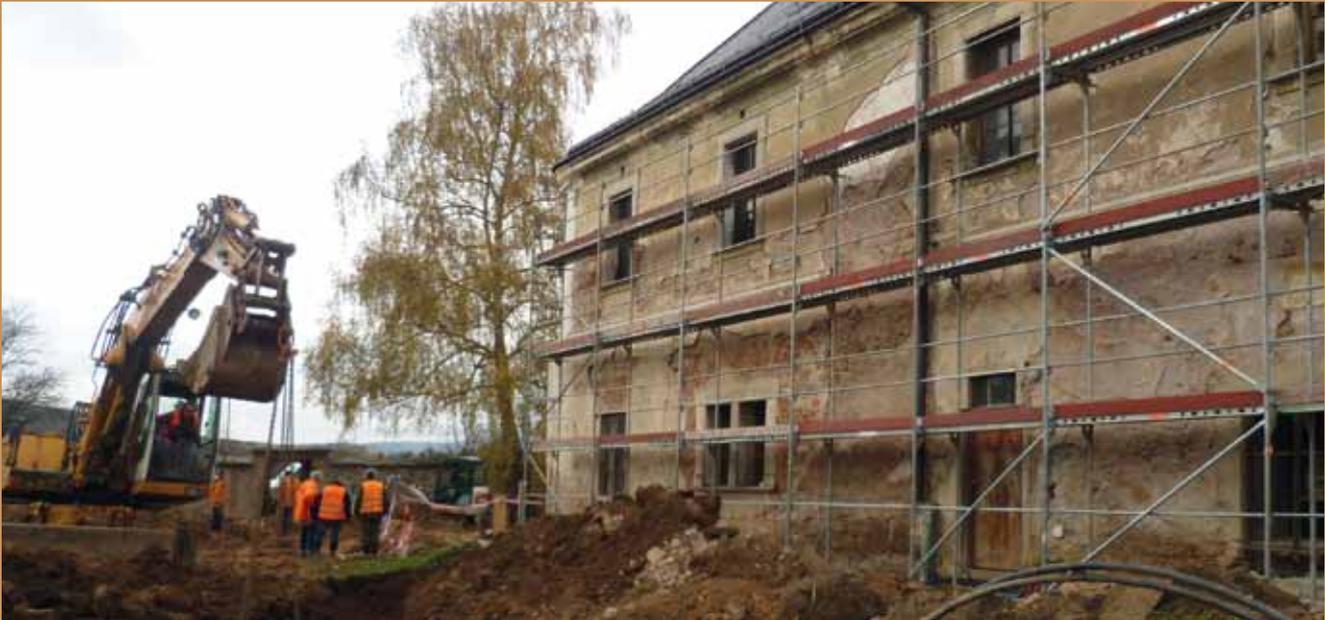
Condition prior to restoration

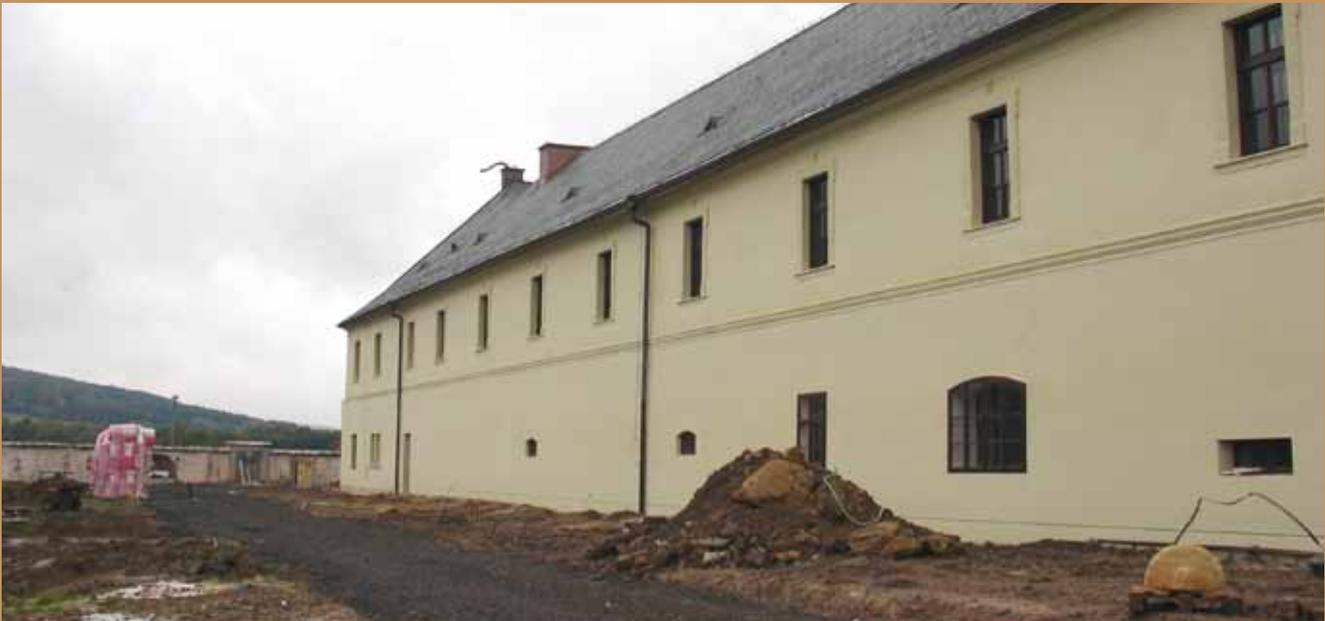
Course of the works

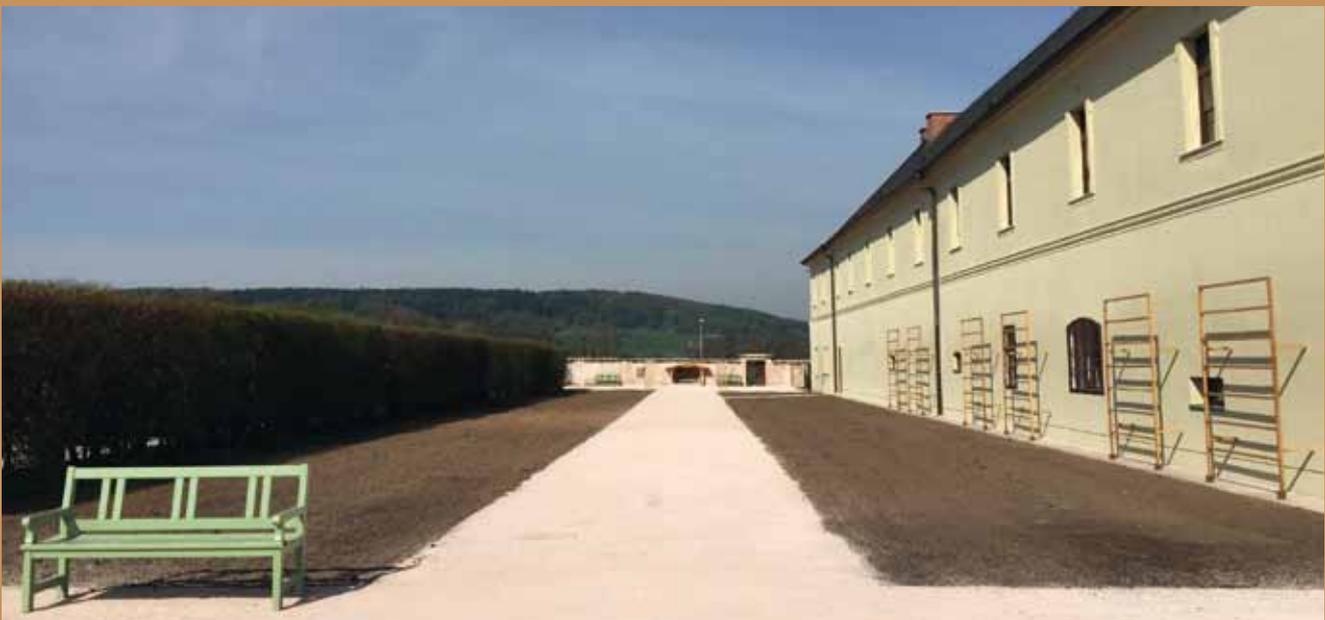
Condition after restoration

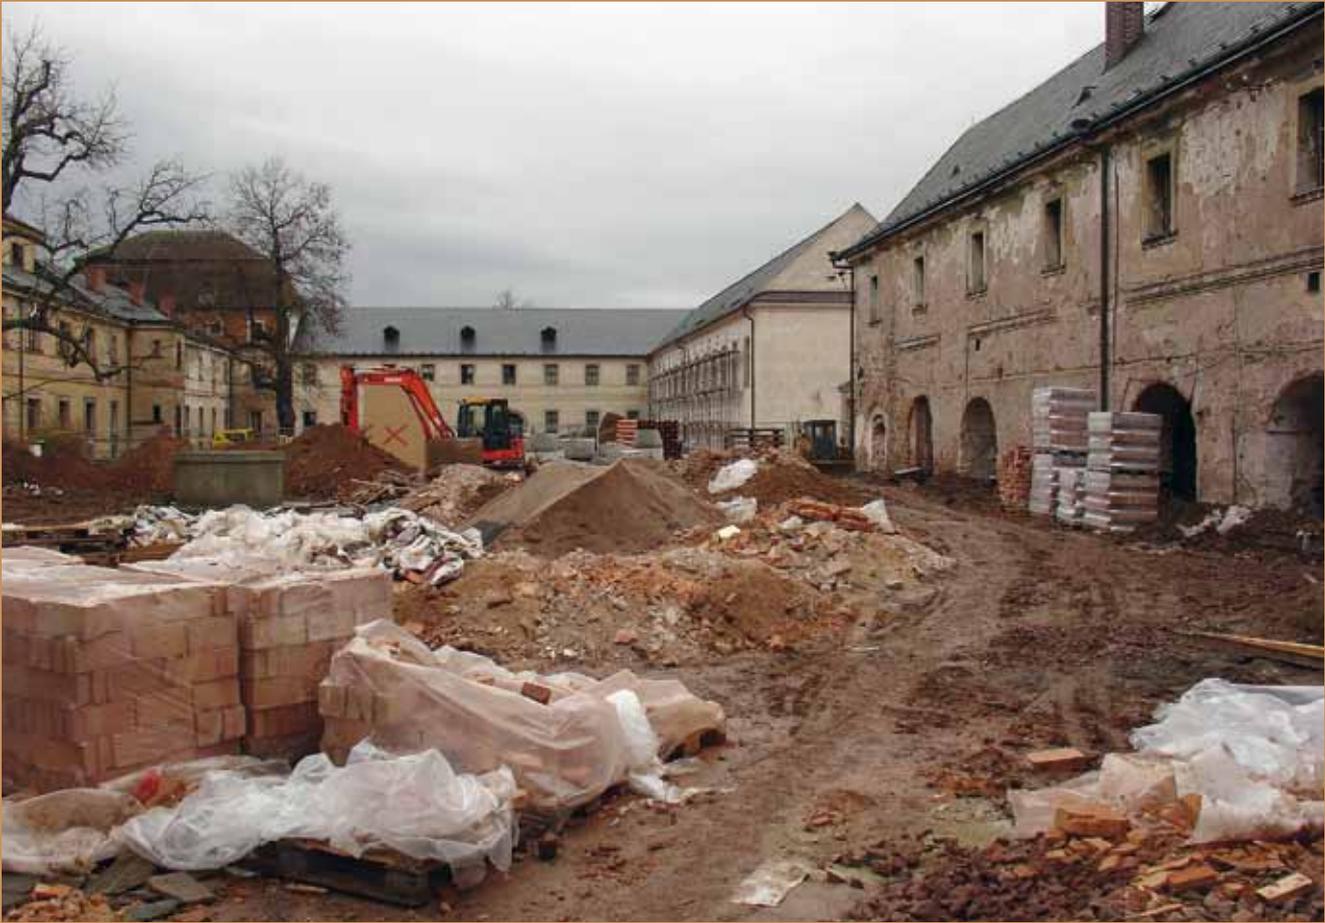
Courtyard – condition prior to restoration

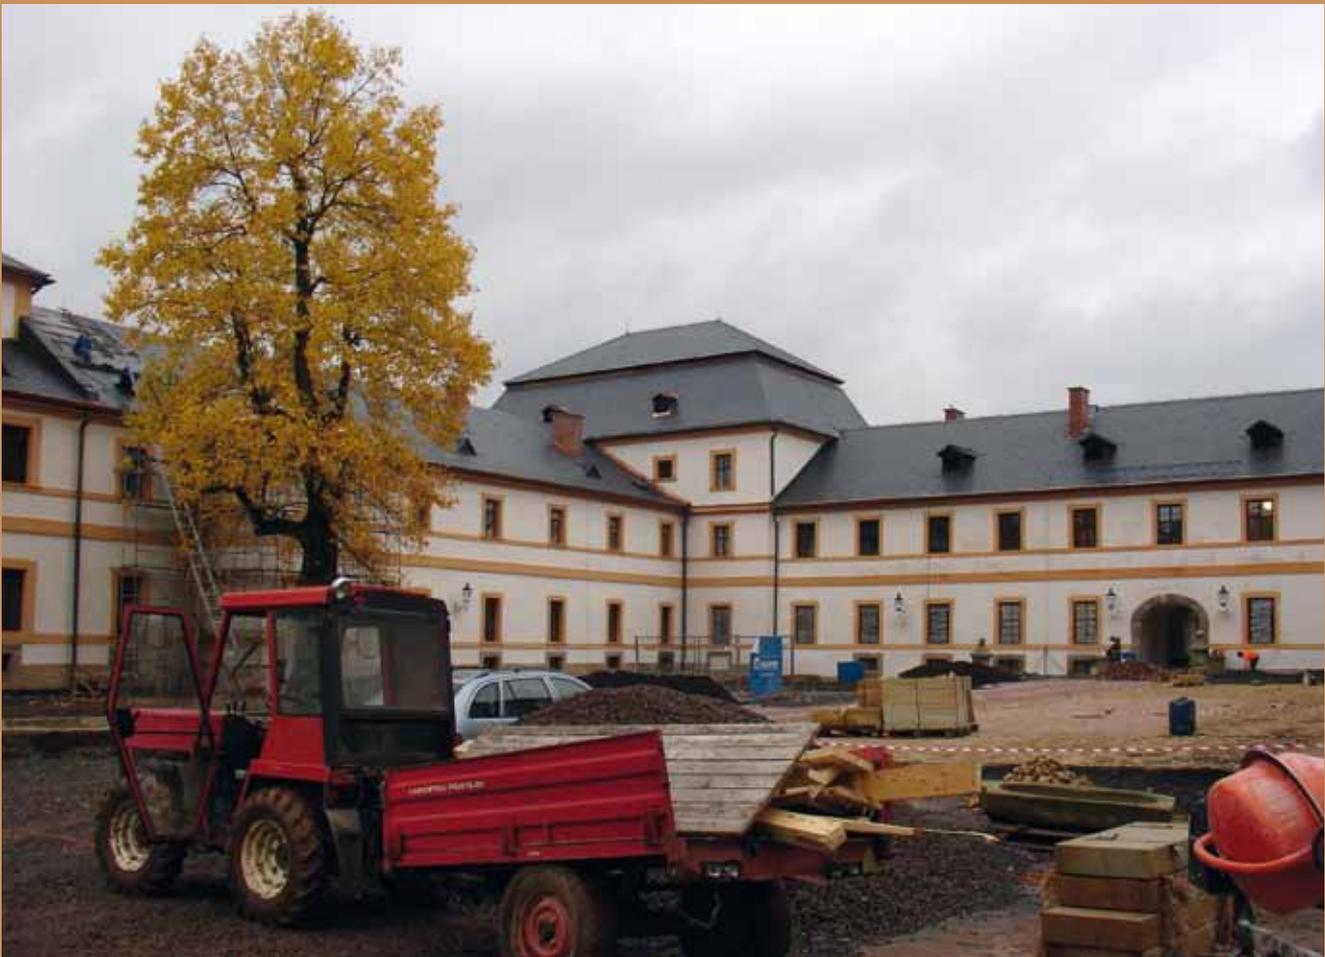
Courtyard – condition shortly before completion of works

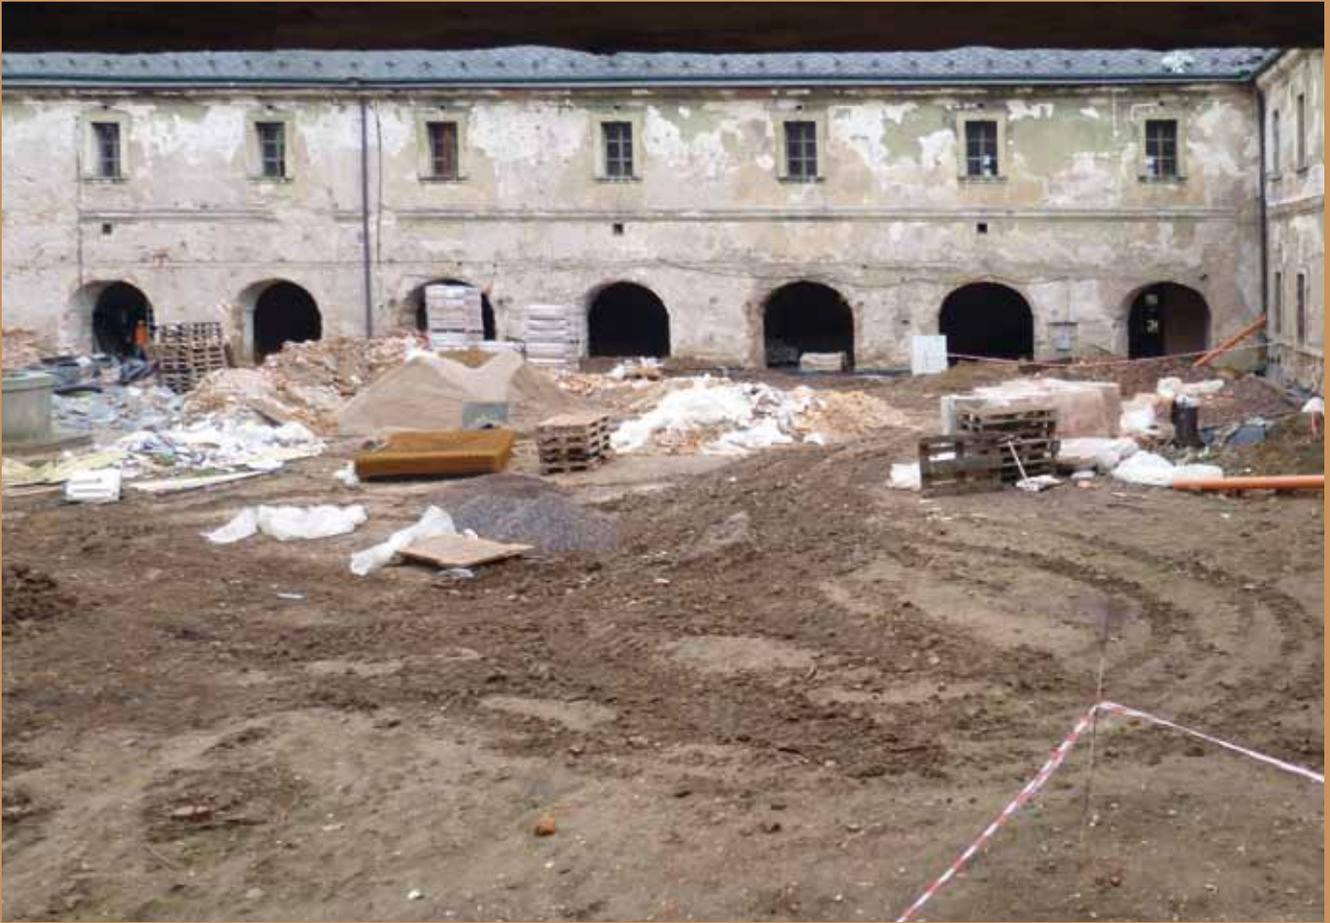
Façade and courtyard prior to restoration

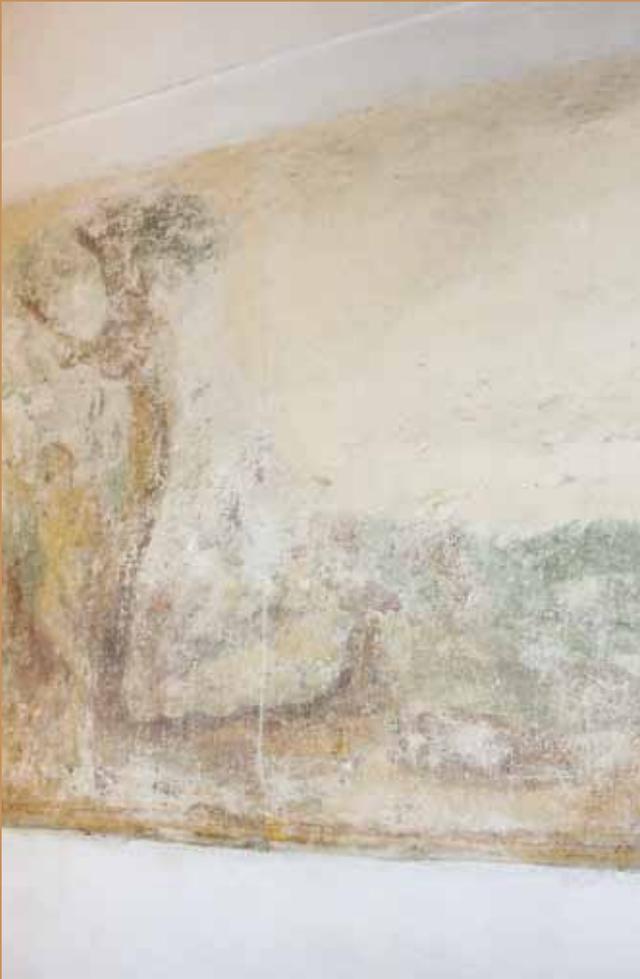
Painting titled The Fall of Adam and Eve – course of the works

The restorers removed the lime plaster layers using scalpels and special restoration mallets. Simultaneously, acrylate dispersion was used for local stabilisation of the uncovered paint. Subsequently, organosilicon compounds were introduced to achieve overall strengthening of the painting. The surface was treated with fungicides. The cracks were filled and stuccoed over to correspond to the structure of the surrounding areas. Hairline cracks were grouted with marble dust and lime. The retouch itself was carried out very conservatively so as not to increase the saturation of the colours. The drawing itself was not restored with the exception of some of the most damaged scenes where the shapes were outlined to improve the clarity of the picture.

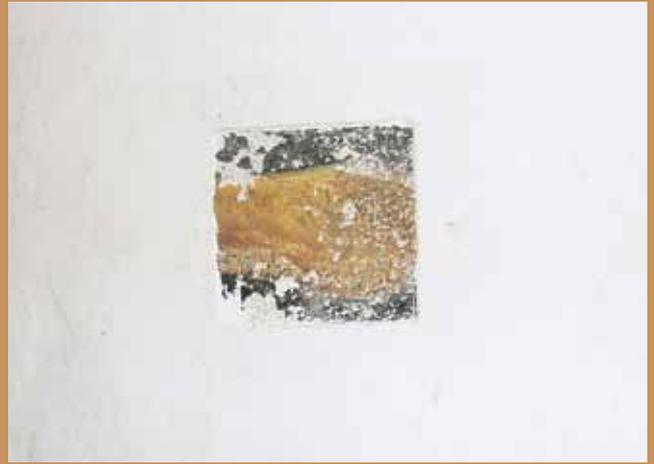
Survey probes prior to the uncovering of the painting

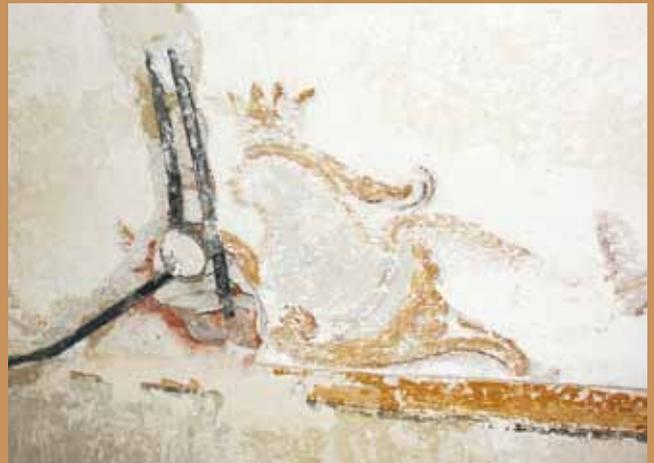
The cycle of paintings was damaged in several places by later construction modifications (a newly built partition damaged The Merchant and The King paintings) and the installation of electrical fittings in places showing the accompanying painted verses. Prior to their covering with lime plaster, the surface of some of the paintings was partially scraped off. The most significant damage was made to the paintings of The Countess, The Sailors and The Blind Man.

Damage to the painting resulting from installation of electrical fittings

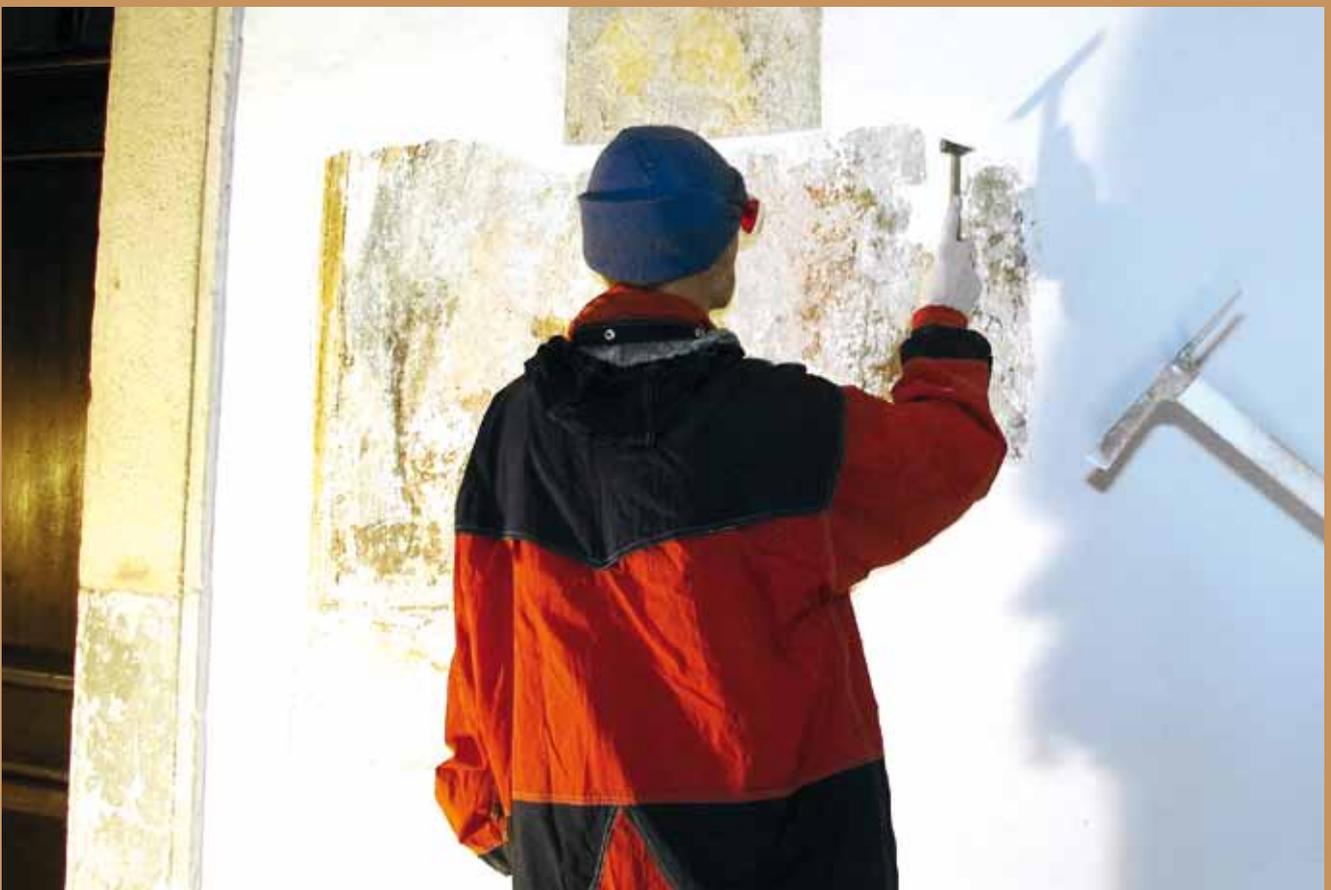
Restorers uncovering historical paintings

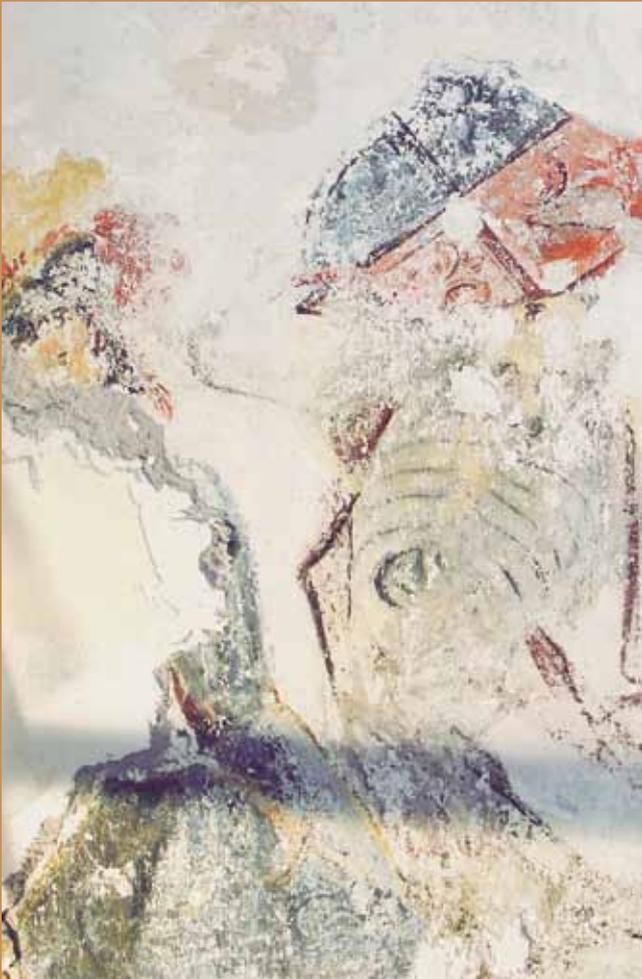
The Count painting – course of the restoration

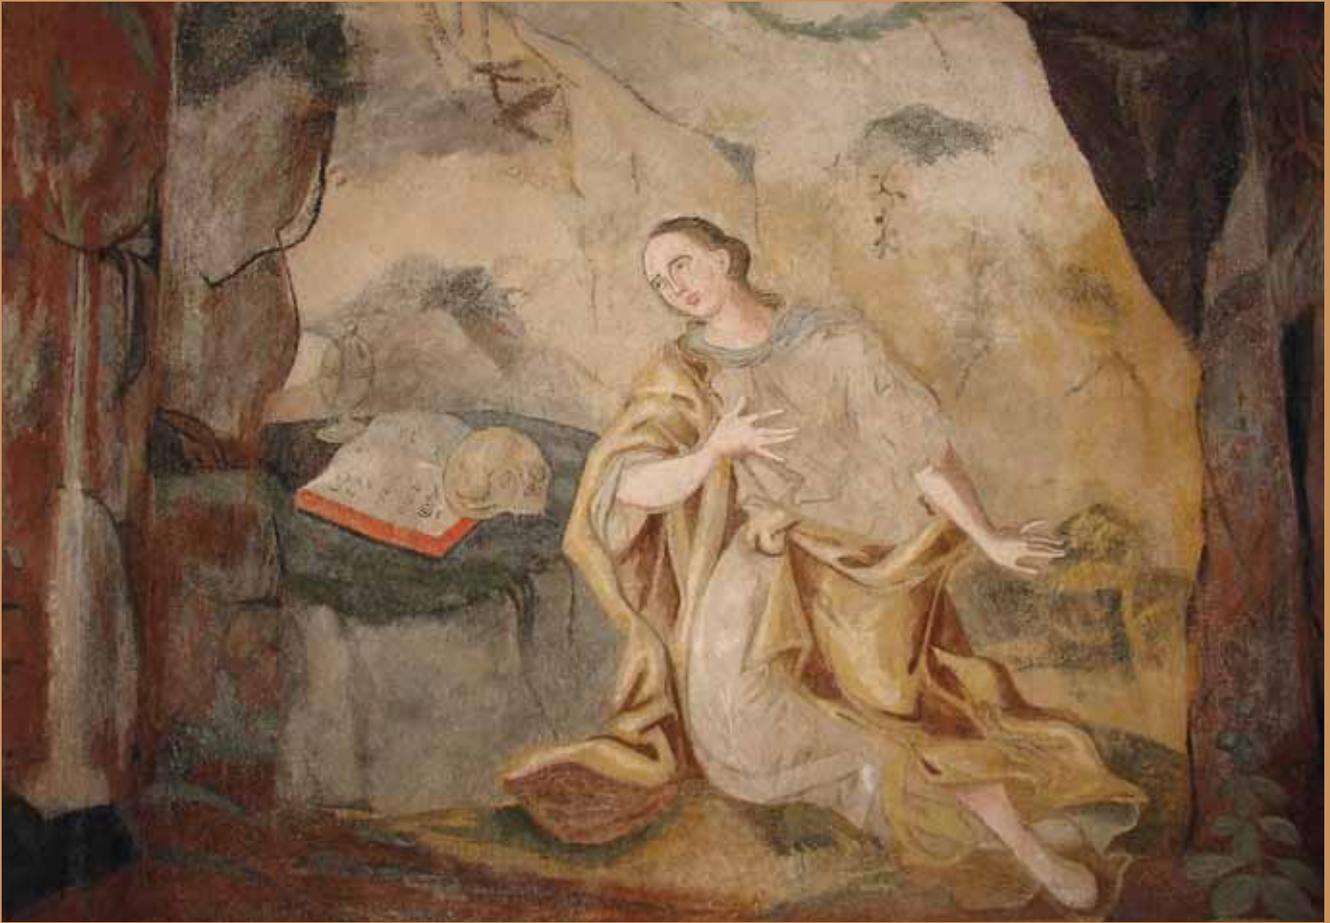
The chapel includes paintings from the second half of the 18th century depicting individual biblical scenes defined by illusive frames. The central scene depicts Jerusalem and its surroundings. The painting was painted-over multiple times in the past and cleaning and elimination of unsuitable layers was thus necessary. The plasters had to be continuously strengthened with organosilicon compounds and the defects grouted with lime stucco. Retouching was made with aquarelle colours.

Northern wall of the chapel – condition after restoration of the painting

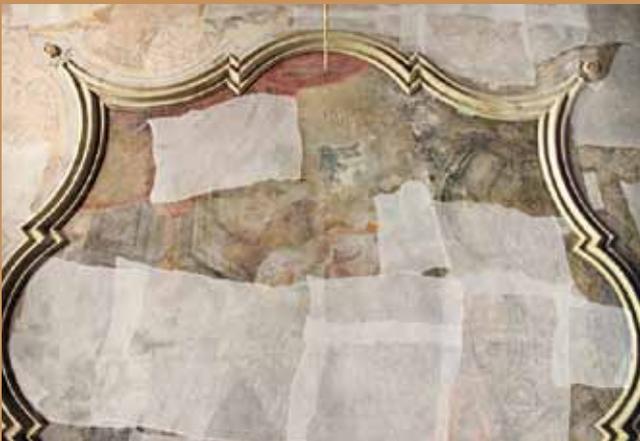
The historical apothecary of the Order of the Merciful Brothers contains an unusual depiction of Jesus Christ as an apothecary. The painting suffered damage during a number of paint-overs and due to the use of unsuitable grouts – in some places, the top layer was completely disintegrated. Unsuitable layers of paint from the 20th century were removed with mallets and scalpels. Organosilicon agents needed to be injected extensively along the whole layer of painting; subsequently, the little holes resulting from the injection were grouted over. Larger defects were grouted with lime stucco. Only one larger crack needed to be sealed with acrylic binders. The restoration of the valuable painting was concluded with an optical consolidation.

Ceiling painting in the At the Pomegranate apothecary – course of the works

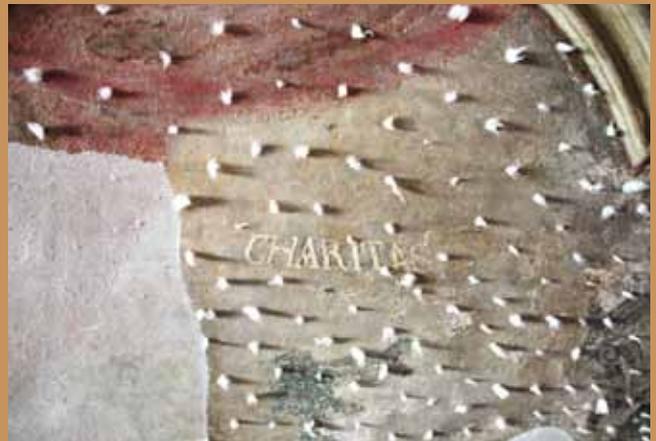
Ceiling painting in the apothecary – condition after injection

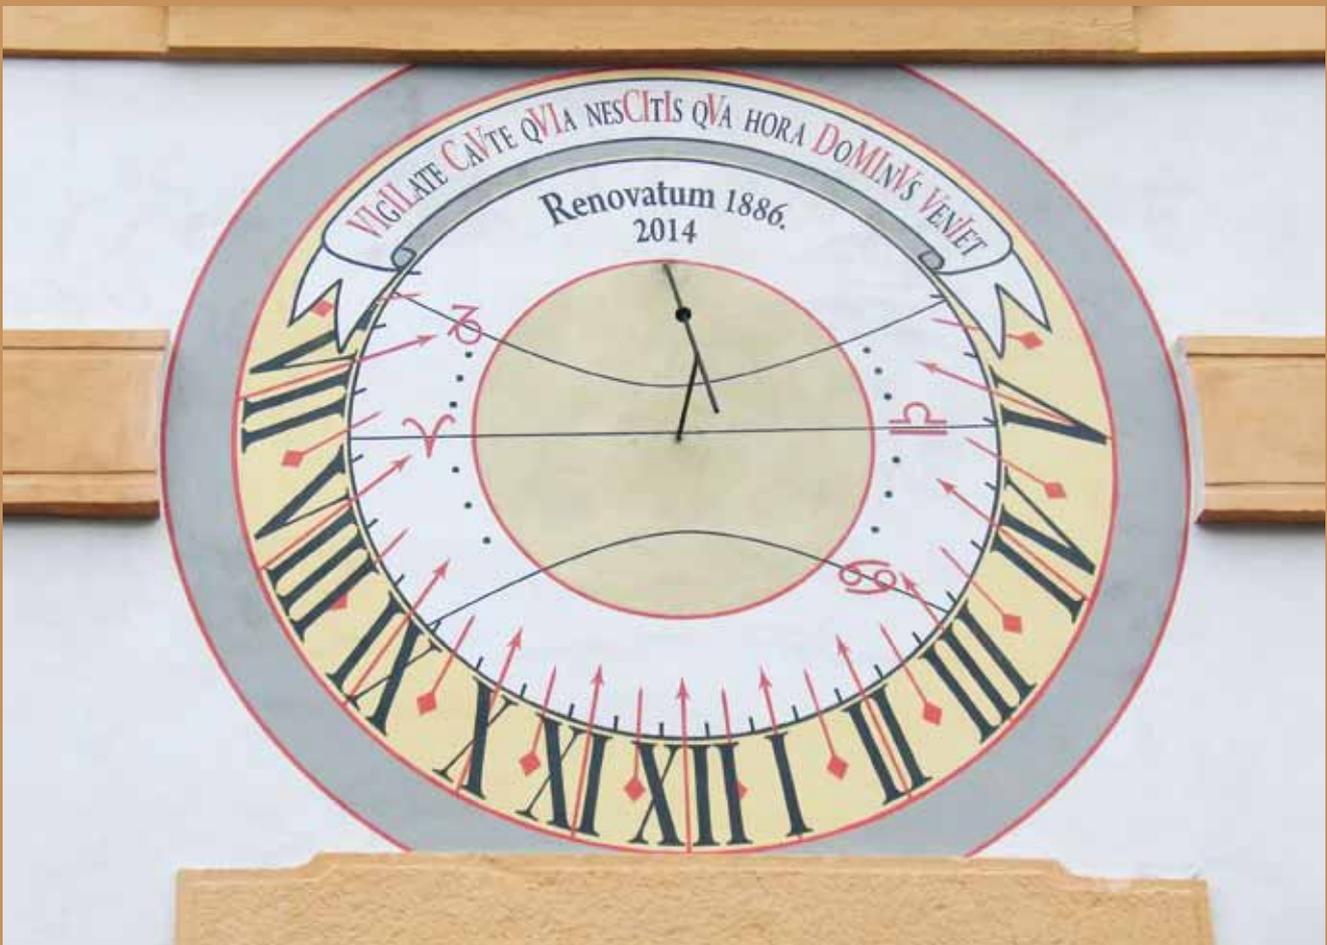
The sundial was originally located on the southern side of the exterior facade. The first restoration works were performed already in 1886 and then again in 1957; these, however, were not done properly and did not take account of astronomical calculations. This meant the sundial lost its original functionality.

Close-up of the newly restored sundial

Restoration and new renovation within the Kuks – Pomegranate project was performed by an Academy painter working together with a sundial expert.

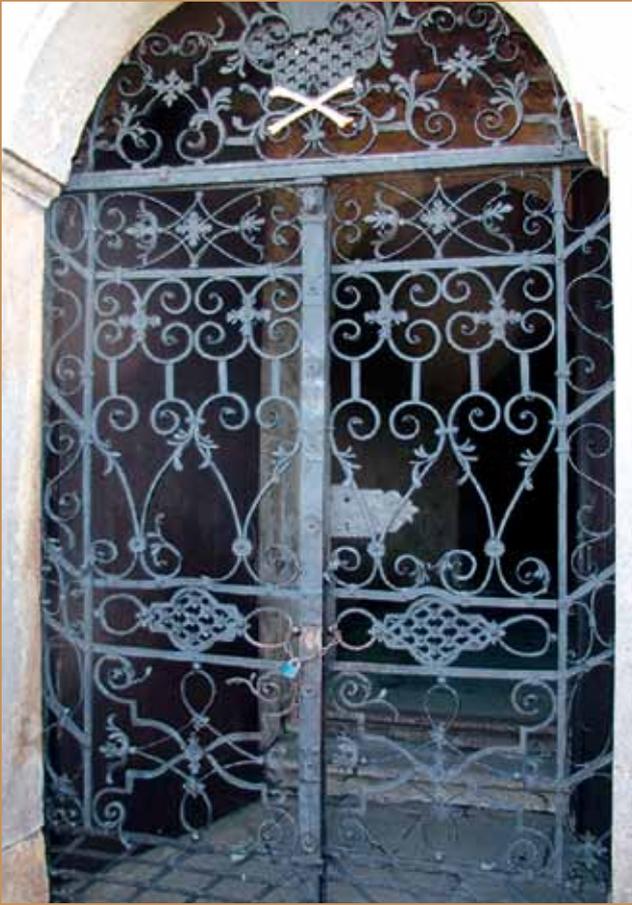
The works involved restoration of baroque window bars and the metal gate in the crypt. The historical ironwork experienced a number of modifications over time – modern welds and makeovers were noticeable, but not seriously damaging.

Ironwork gate – condition after restoration

The bars were cleaned of discontinuous coating, the damaged areas were repaired and the missing parts replaced. The surface was coated with a black zinc-phosphate coating so that in the end the surface attained a graphite-black colour. The original tinning on the gate lock was not restored due to its high porousness and corrosion. The final look of the bars and the metal gate was determined on the basis of the results of the survey of the original colouring.

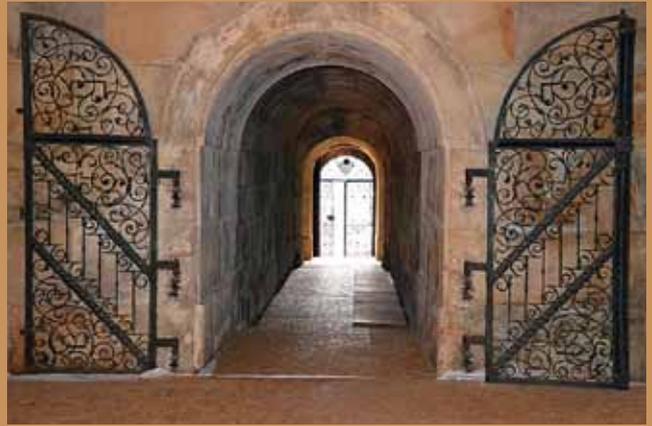
Ironwork gate at the entry to the crypt – condition after restoration

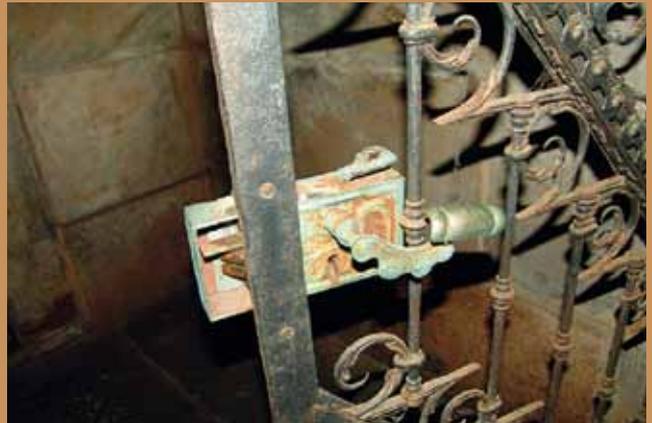
Close-up of the chateâu – condition before renovation

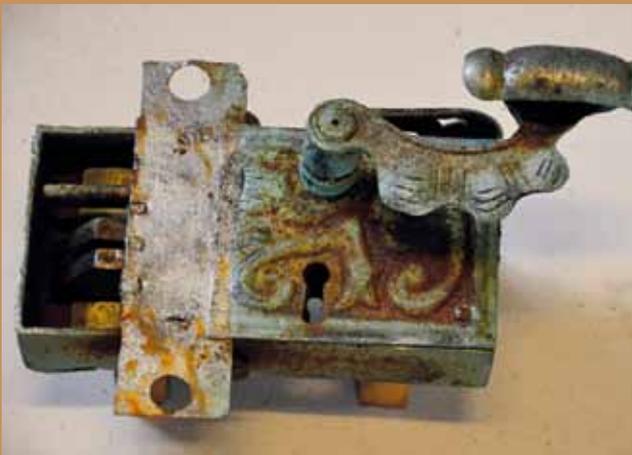
Locking mechanism – after dismantling

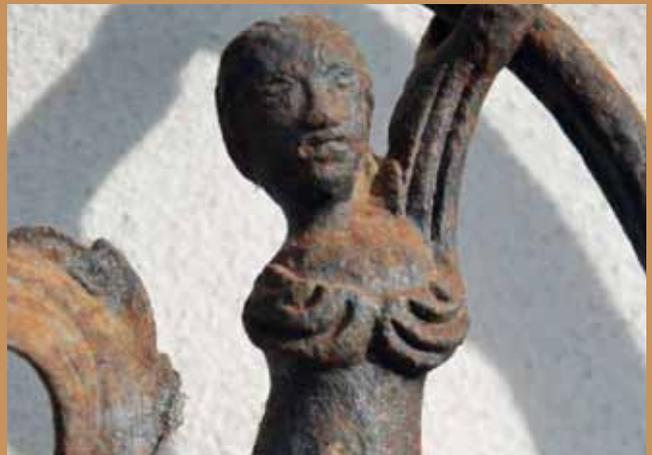
Close-up of the decorative ironwork – condition before restoration

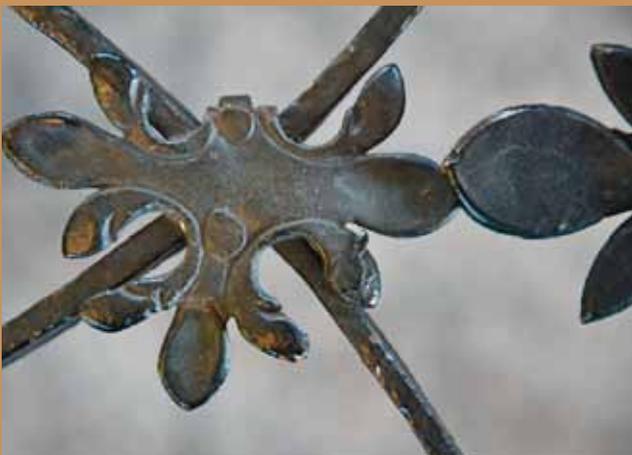
Close-up of the decorative ironwork – condition after restoration

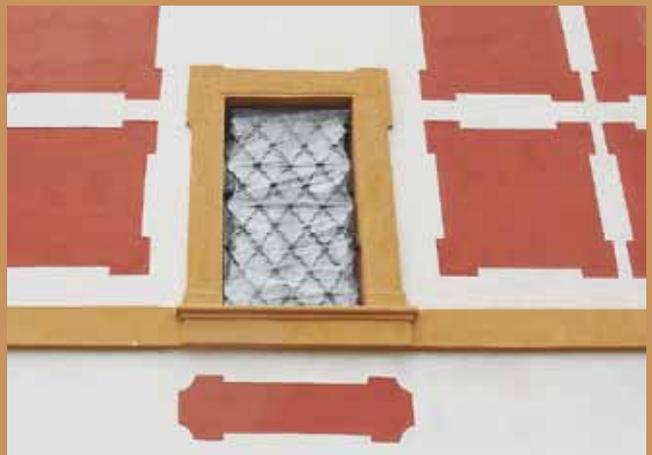
Newly restored metal bars – mounting

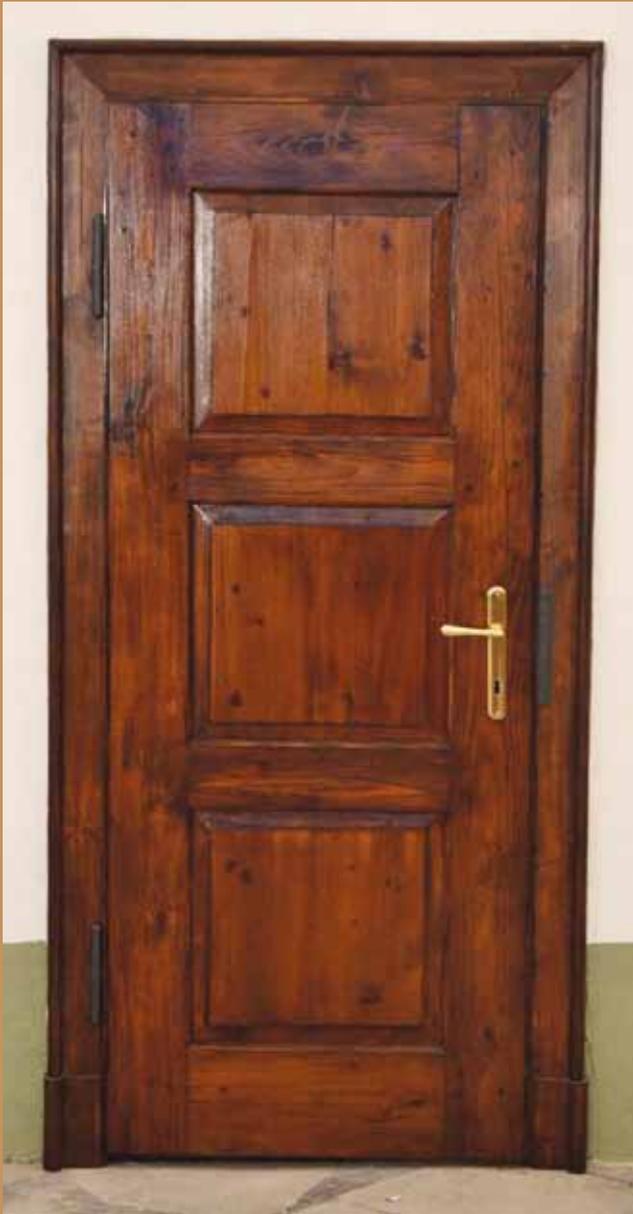
The door was made of soft wood and oak. The wooden elements were dismantled and restored in a workshop. The door was showing mechanical damage, especially along the casing. The surface was covered with layers of varnish and dried oils. Old and unsuitable surface treatments were removed, the damaged parts were repaired, the wood was re-stained, varnished and a shellac layer was put on. Based on the results of colour stratigraphy, the surface received a new top layer in the original 18th/19th-century colouring.

Historical door – condition after restoration

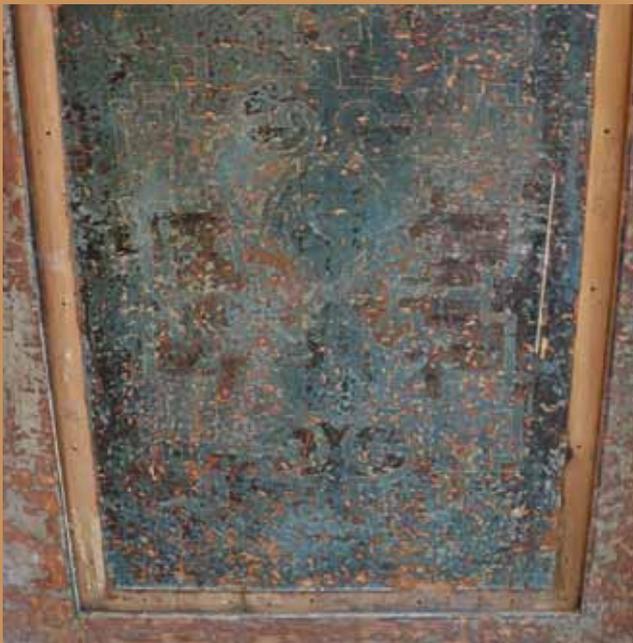
Close-up of the decorative elements – condition before restoration

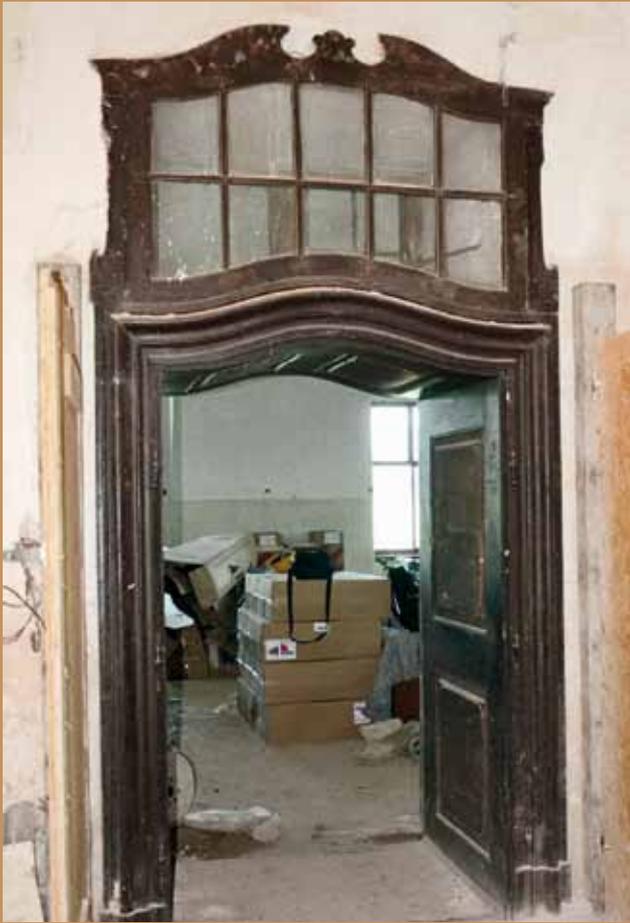
Condition before restoration

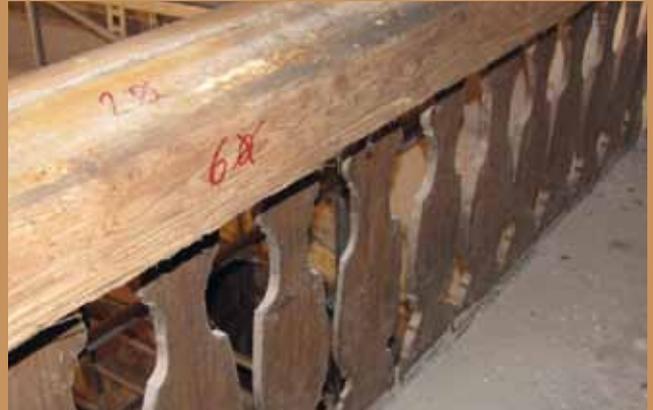
Polychrome railing in the chapel – course of the works

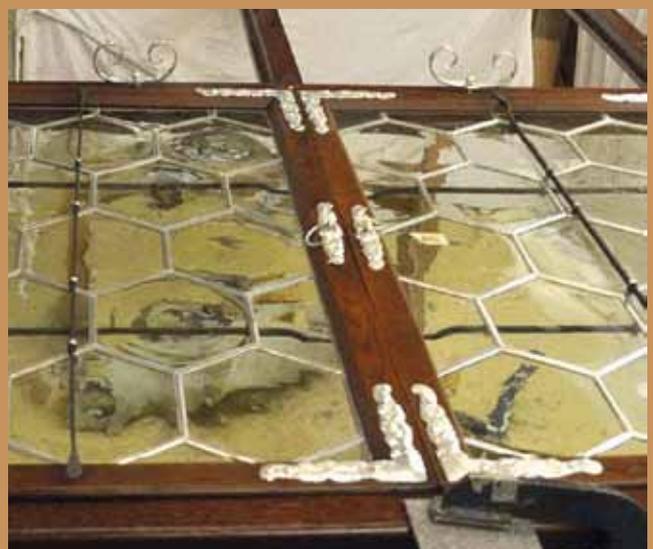
Close-up of the historical windows after restoration

The oak window frames were damaged by years of use; some casements were broken or completely missing. Unsuitable surface coating was removed. Afterwards, the missing parts were replaced and sealants and surface treatment were administered. The wood was pre-emptively treated against wood-attacking fungi and insects. The restoration works concluded with a complete retouch.
