RESTORATION OF THE PLASY MONASTERY FARMYARD

PLZEŇSKÁ 2, 331 01 PLASY

INVESTOR: THE NATIONAL TECHNICAL MUSEUM

CONTRACTOR: ASSOCIATION OF
HOCHTIEF A. S. –
GEMA ART GROUP A.S.

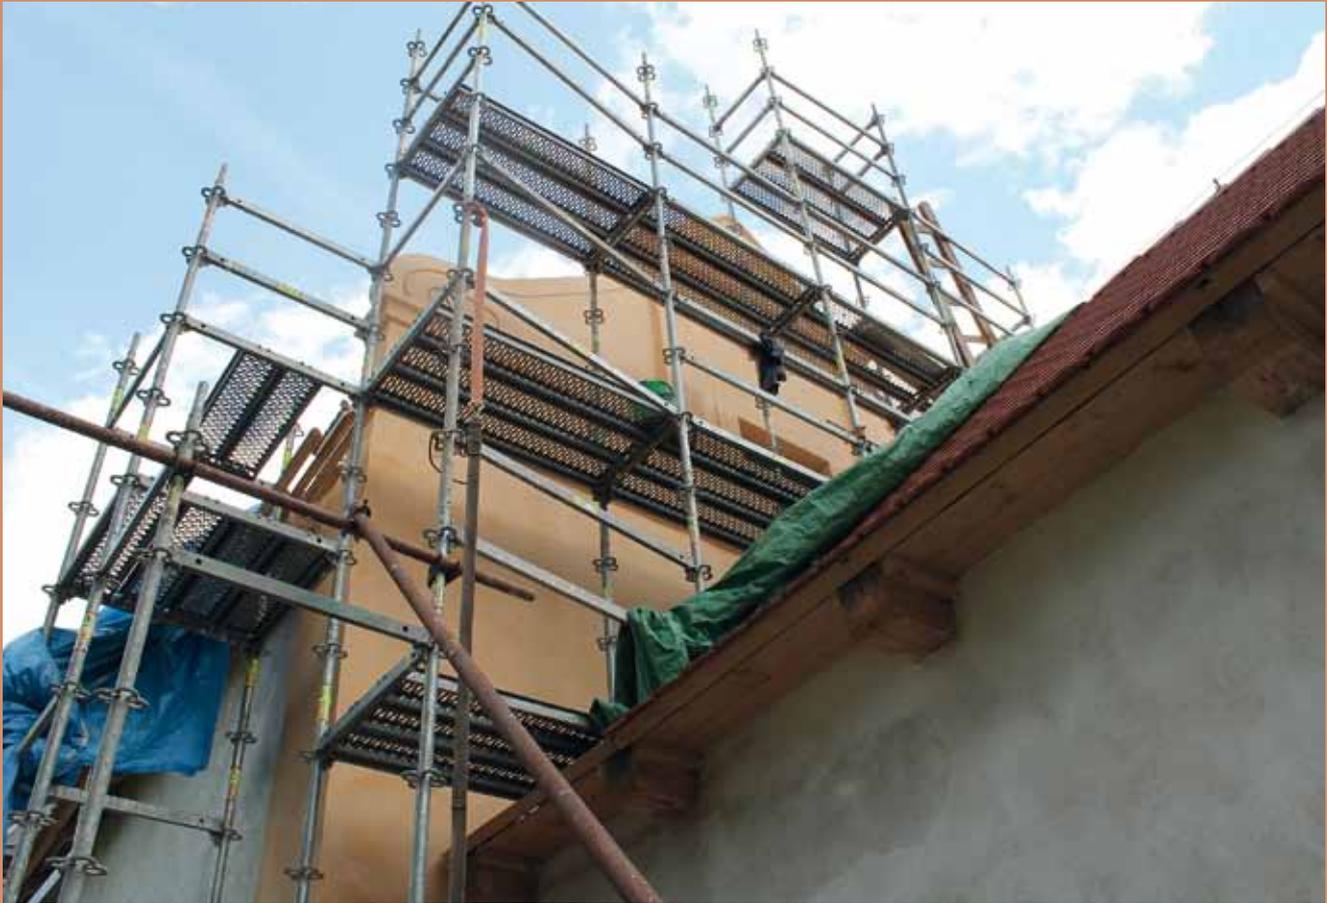
Restoration of the gable

The 18th century gable wall of the south-east facing side of the grange required closer attention of the restorers. A large part of the original architectural elements was not preserved in the façade and the tympanum as well as the cornice were in a state of severe disrepair. The restoration aimed to reconstruct the original Baroque profile (cornices, pilasters, capitals, gable) and restore the façade in its original colour profile. The missing architectural elements were replaced on the basis of templates made according to the preserved originals. The original profiles had to be strengthened, in three to five consecutive cycles. The whole surface of the façade was covered with a white lime base on which lazure paint was applied using the stippling technique.

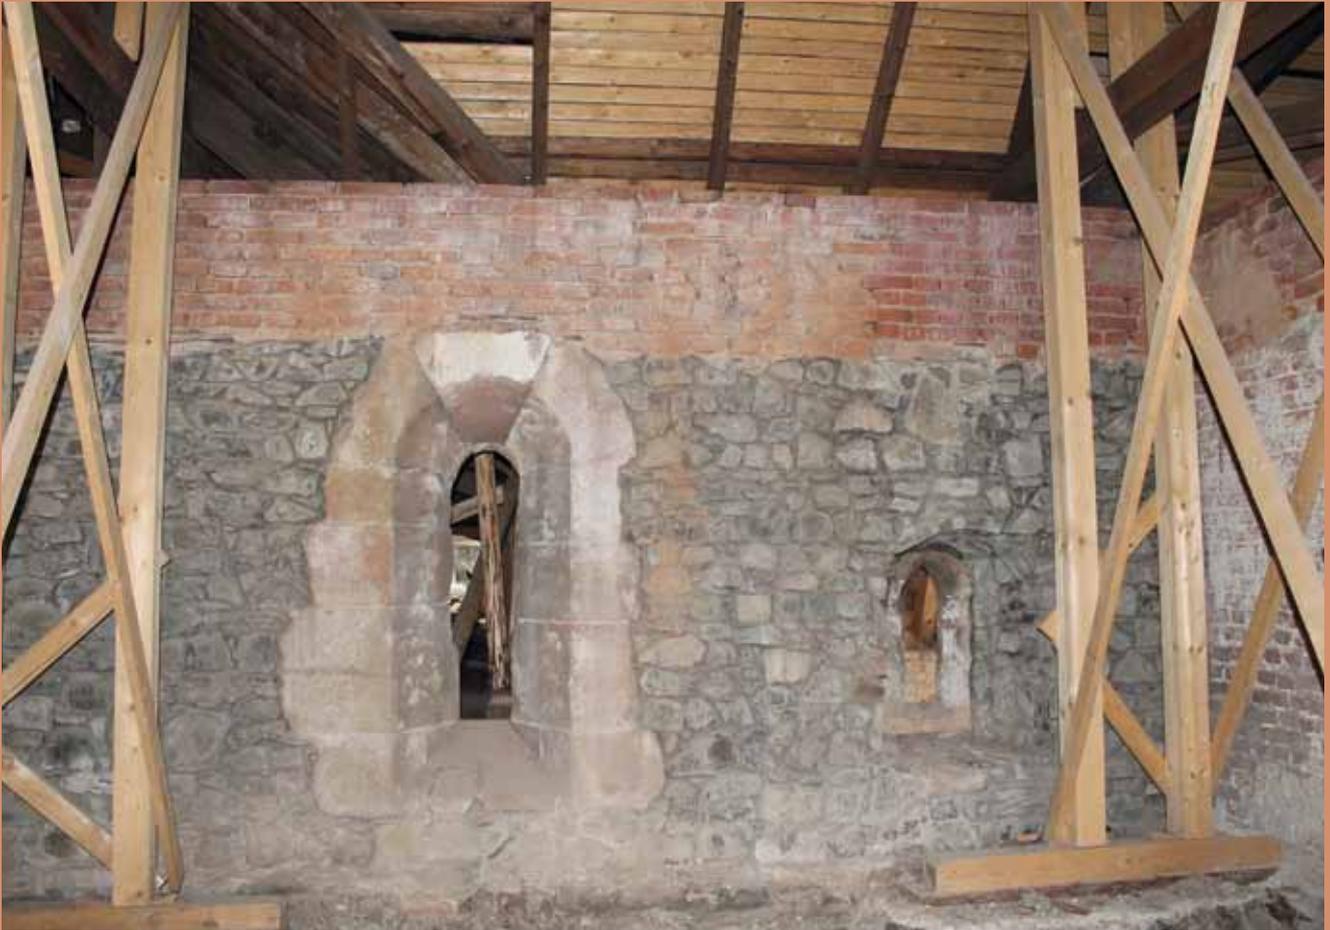
Original Romanesque windows – before restoration

The torsos of the original Romanesque and Gothic windows are now, after reconstructions, located inside the grange and are now a part of the Center for Building Heritage exhibition. The windows are presented in their most original appearance, which is why a gallery-style restoration approach was chosen, meaning minimum reconstruction. Cleaning was done using soft brushes; the critical parts of the Romanesque windows had to be repeatedly penetrated with a solidifying solution. Winder cracks were injected with mineral grouts. Replacement of the missing parts was reduced to using solely consolidating grouts. Finally, optical unification was performed.

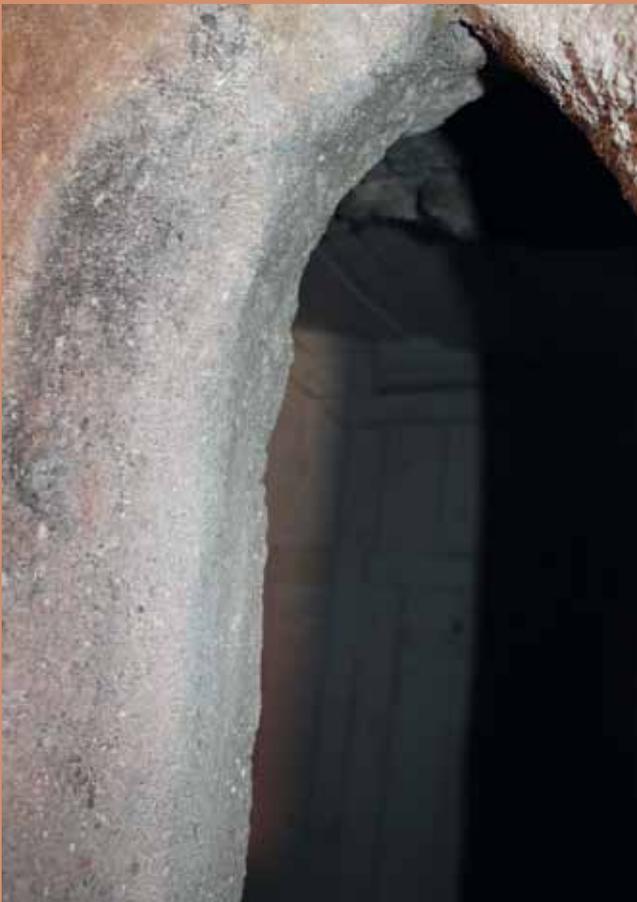
Romanesque window, detail of the jambs

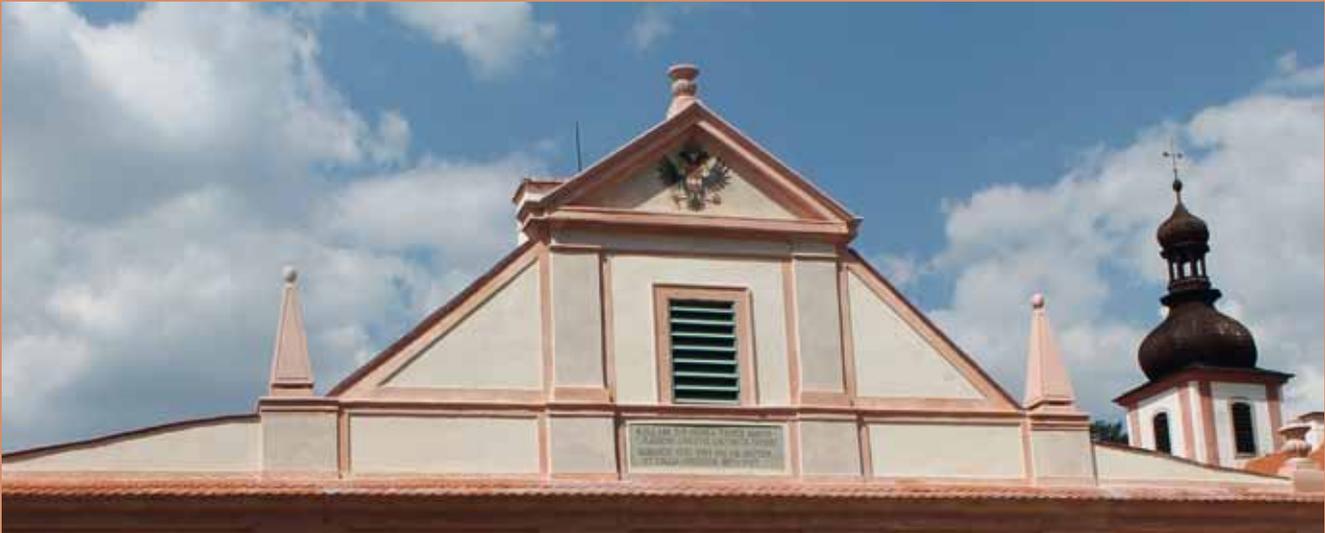
Decorative stone elements on the gable – after restoration

The gable of the cart shed is decorated with 18th century stone obelisk and stone vases. The surface of the stone was showing weathering effects – the basic material was washed out, as well as the joints. The stone was further damaged by dark crusts and attacked by aggressive vegetation. The most damaged parts had to be first treated with a mineral-based artificial stone mixture. Subsequently, a local consolidation and optical unification was carried out.

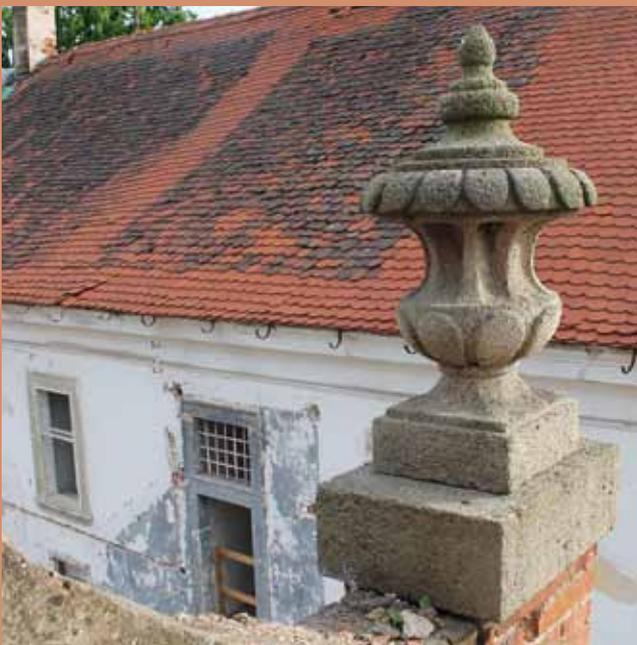
Stone vase detail – before restoration

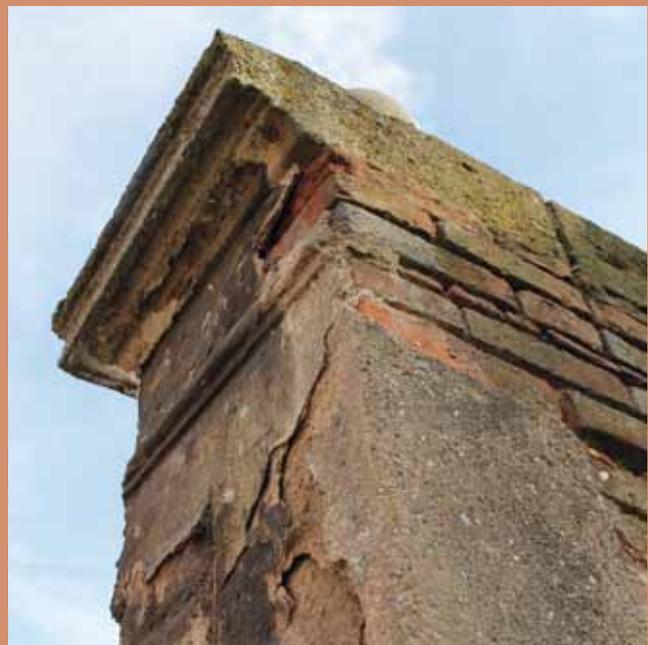
Detail of the stone cornice on the gable – before restoration

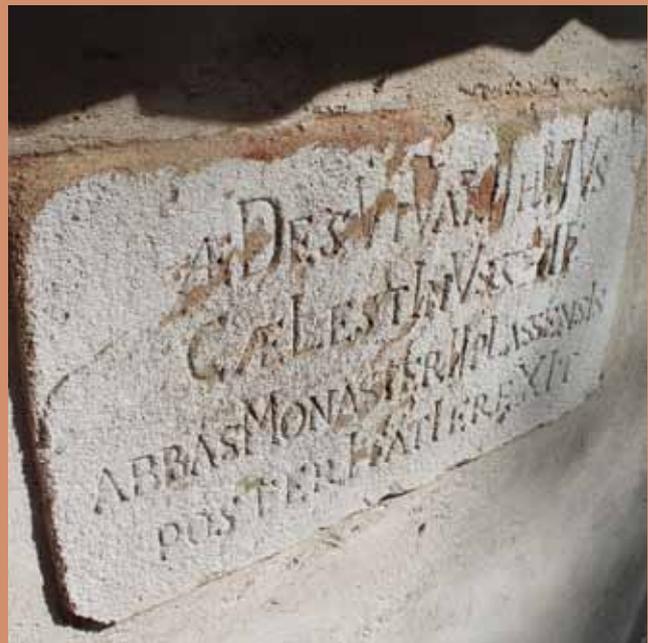
The stone inscription tablet set in the farmyard's façade was also subject to restoration. The Latin inscription with a chronogram was made in the 18th century. Due to weathering effects, the surface is eroded and shows mechanical defects. Before restoration proper, a pre-consolidation of the cracks using organosilicon compounds had to be performed. Brush and microjet cleaning was followed by penetration and replacement of the missing parts. Colour retouch was carried out using mineral pigments and lime.

Original tablet with a chronogram – before restoration

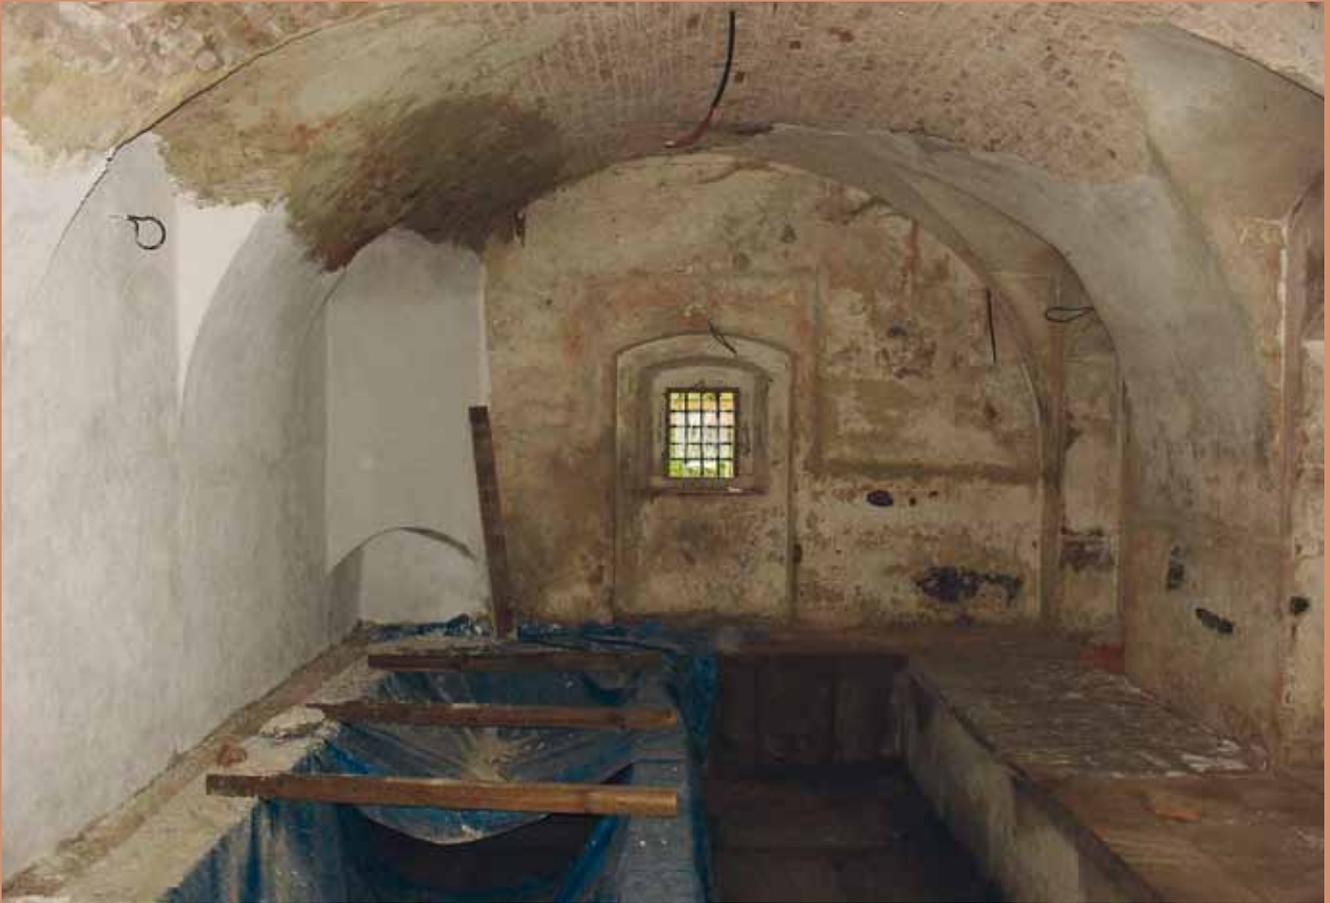
Stone fish tanks - the course of the works

The fish hatchery from the 17th century is located below the grange's ground floor level. These two water tanks were for a number of years filled with rubble, which helped to preserve them in good condition. Stone decay was present only in some places. After cleaning, the tanks were structurally secured and artificial stone was added. The hatchery will not serve its original purpose now as it will become a part of the exhibition.

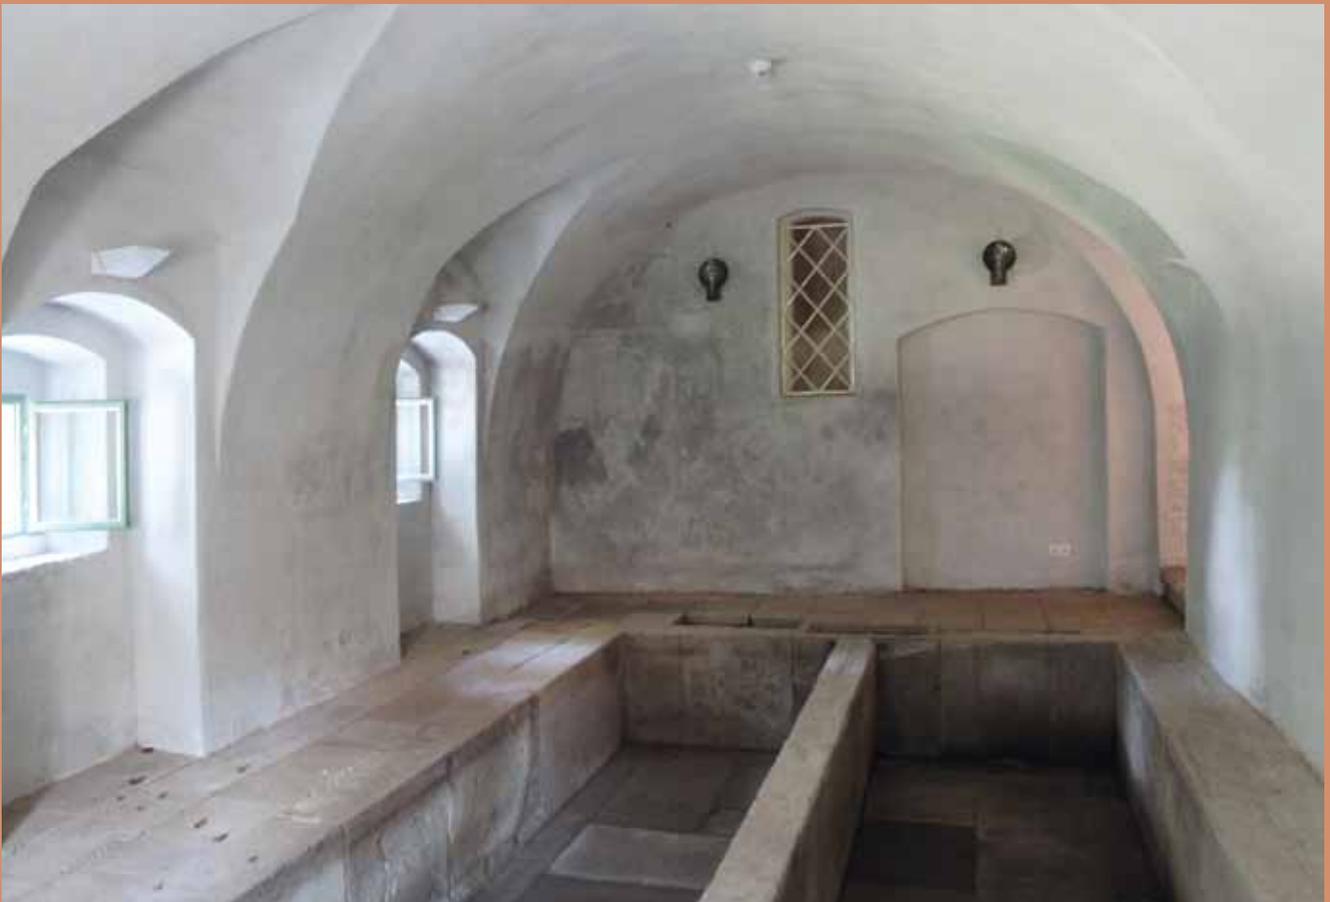
Stone fish tanks - after restoration

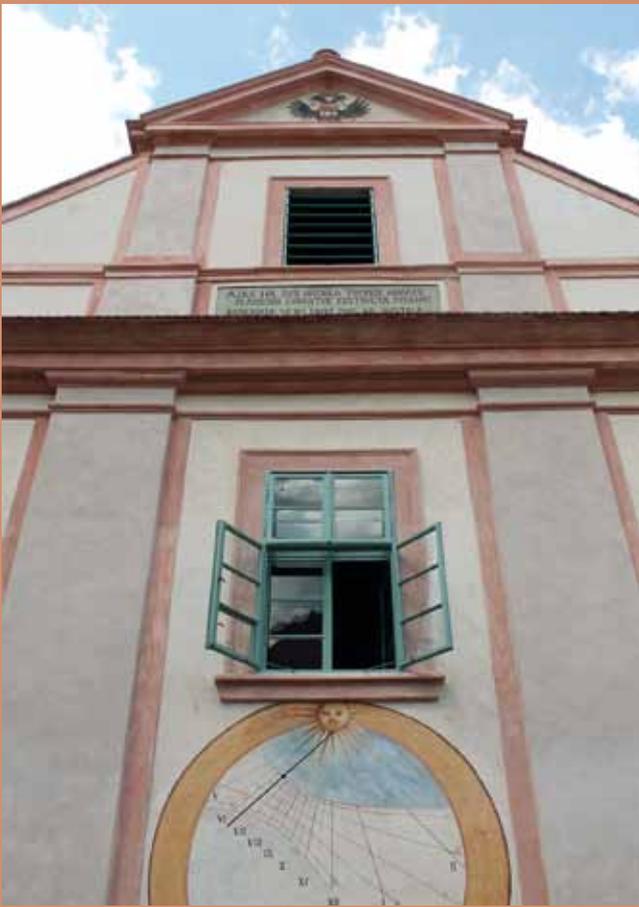
Front face of the building with the wall painting - after restoration

A wall painting – the Austrian eagle – was discovered under layers of newer coatings in the middle of the tympanum during restoration surveys. The painting lacked cohesion and it had to be fixated already during the surveys and cleaning using scalpels.

Defects were carefully grouted and the missing parts were retouched. The wall painting was then finalised and conserved.

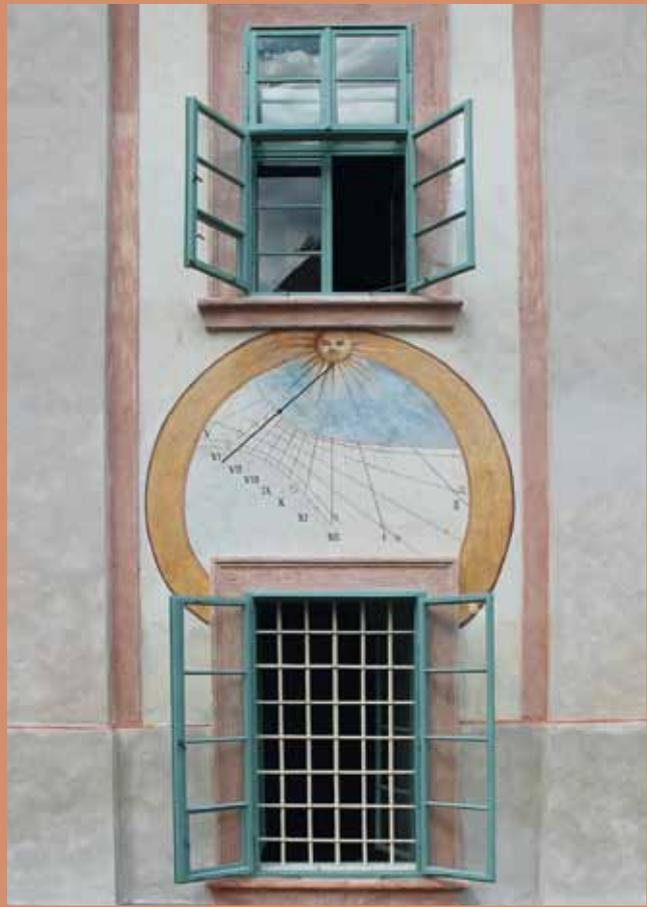
Detail of the sun dial

An artistic sundial was also discovered on the south-east face of the building. The painting was fragmented and severely damaged. After uncovering the entire sundial, the original colour tones of the painting were identified; there were blue-pink and ochre colours. An expert in sundials was called in to the restoration works to assess technical drawings in order to ensure full functionality. The painting was restored and retouched into its present appearance.

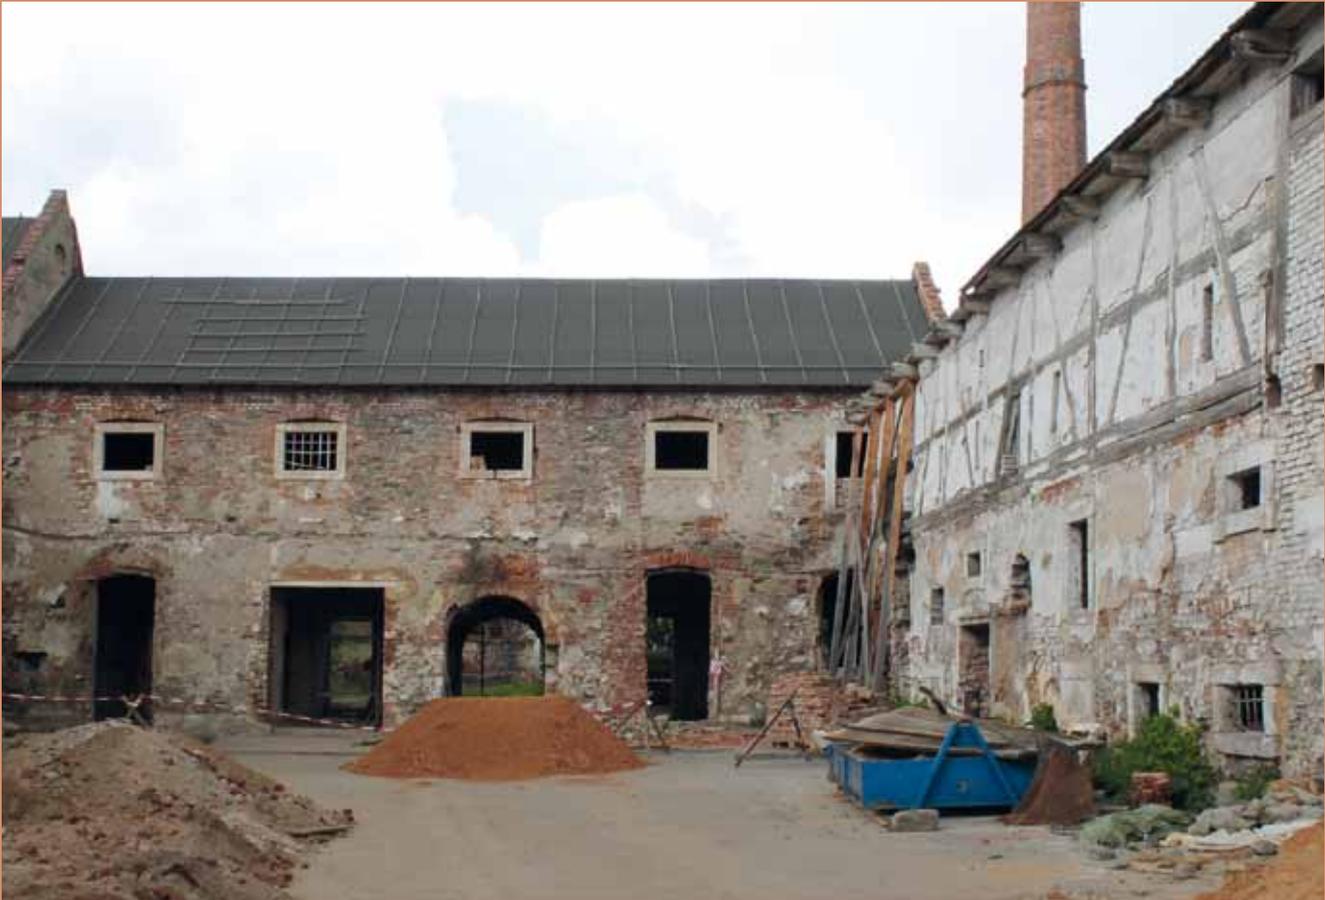
Condition before reconstruction

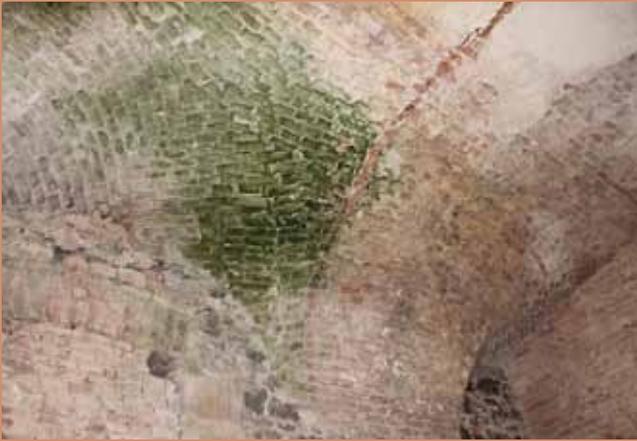
The interiors of the farmyard required extensive restoration and conservation of the plasters and the soot in the original scullery. The condition of the interiors was catastrophic. Due to structural damage, the cracks were sometimes even a meter wide. The omnipresent dampness resulted in strong salting on the plasters and the surfaces were also attacked by green algae and fungi. Some walls were also vandalised with graffiti.

Interiors attacked by green algae

The work began with removal of the degraded and newer coatings. Subsequently, salt build-ups were eliminated and the plasters were mechanically cleaned using scalpels and fibreglass. Localised consolidation spraying was applied to some walls due to their lack of cohesion. Cavities were injected with lime and consolidation mixtures. The missing masonry and brickwork were replaced with stone and old bricks. The fragment of the original oven in the scullery was left without major interventions. The restorers only consolidated the oven, cleaned it and added mortar in some places.

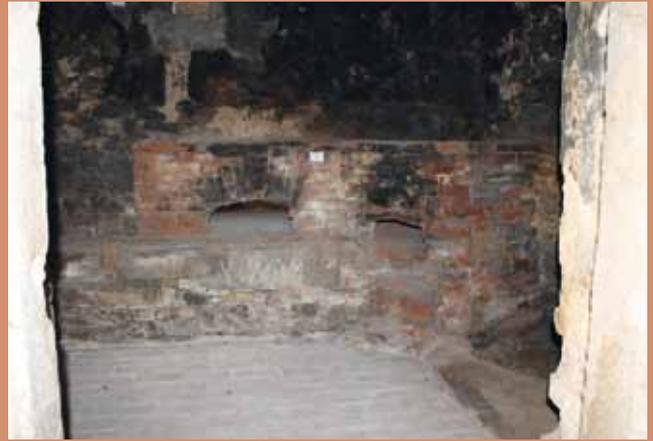
Scullery - restoration survey

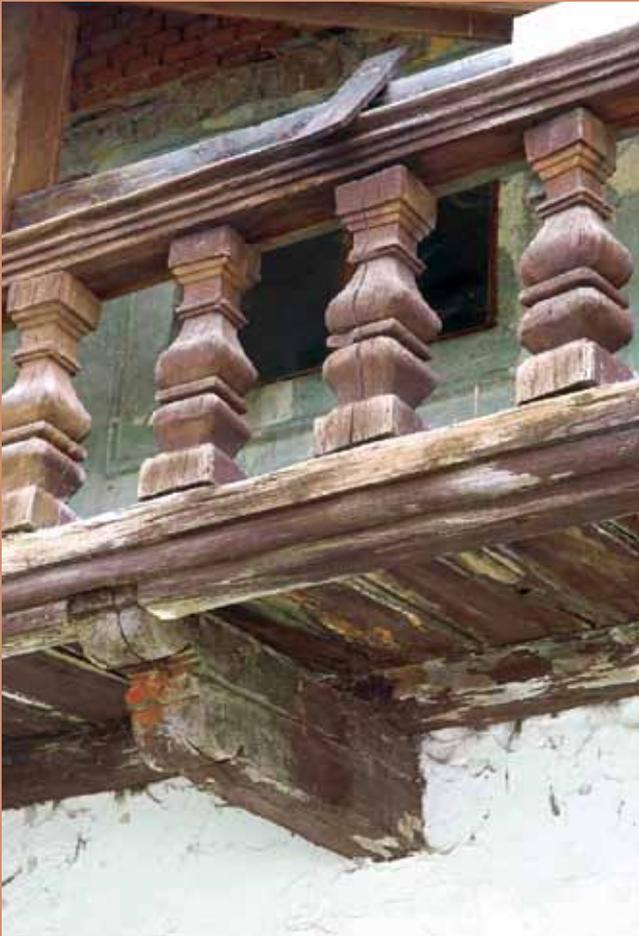
The wooden balustrade railing was made during the construction of the farmyard, i.e. in the mid-17th century. It is located on the second above-ground floor of the grange. The railing originally comprised fifteen balusters, but only nine survived to the present day. The load-bearing beam in the gallery also showed a high degree of degradation; the cantilevers were relatively stable.

Original wooden balustrade before restoration

The individual balusters had to be disassembled and restored in the studio. Replicas were made according to the originals. Weathered parts of the original elements had to be infused with consolidating agents, fungicides and insecticides. In the most damaged parts, the restorers carried out local petrification. It was also necessary to repair the structural elements. Finally, they were treated with boiled oil and oil-based paint.

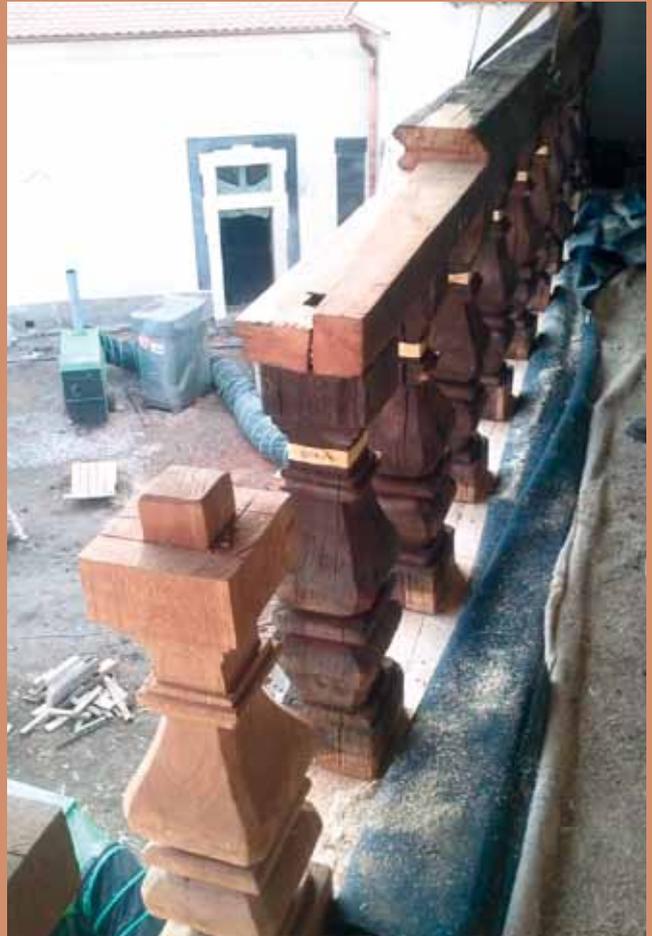
Wooden balustrade - course of the works

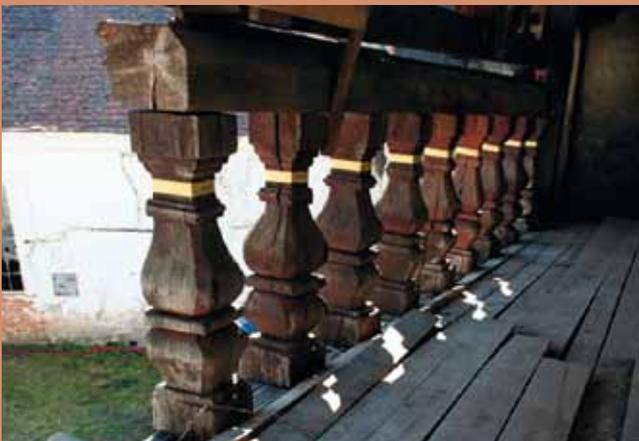
Wooden balustrade before restoration

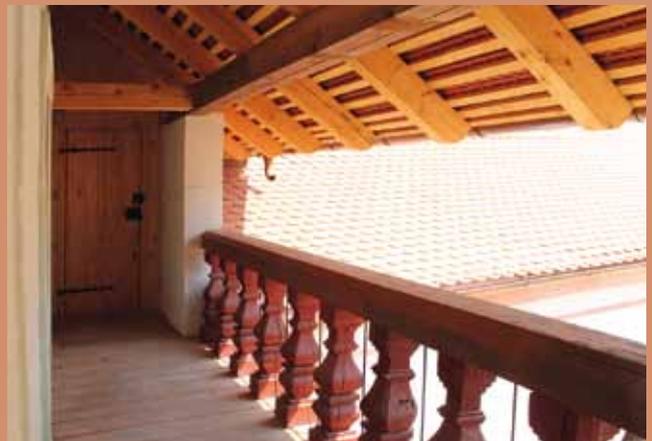
Condition of the historical balustrade after restoration

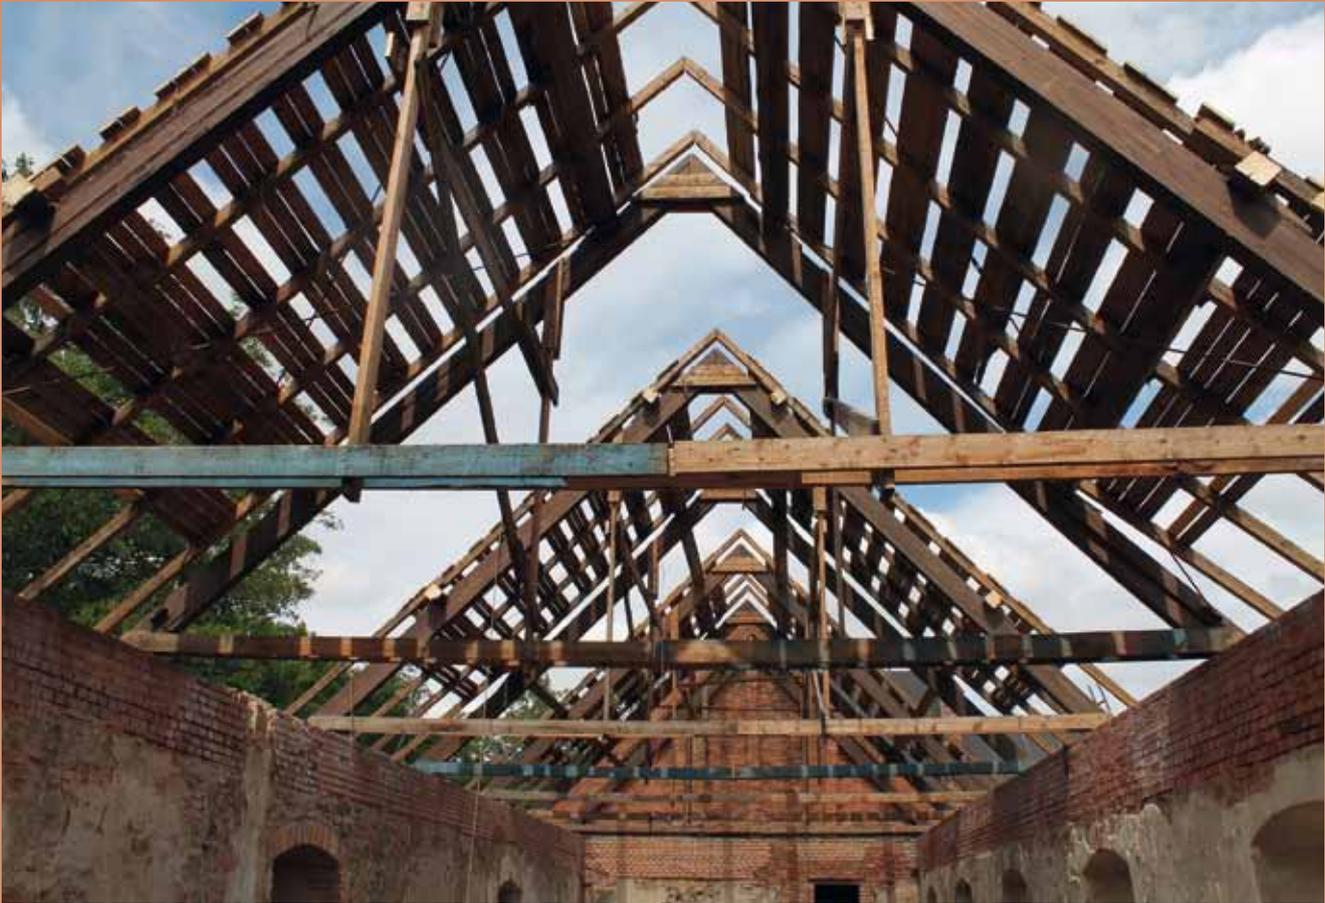
Condition of one of the rafters before reconstruction

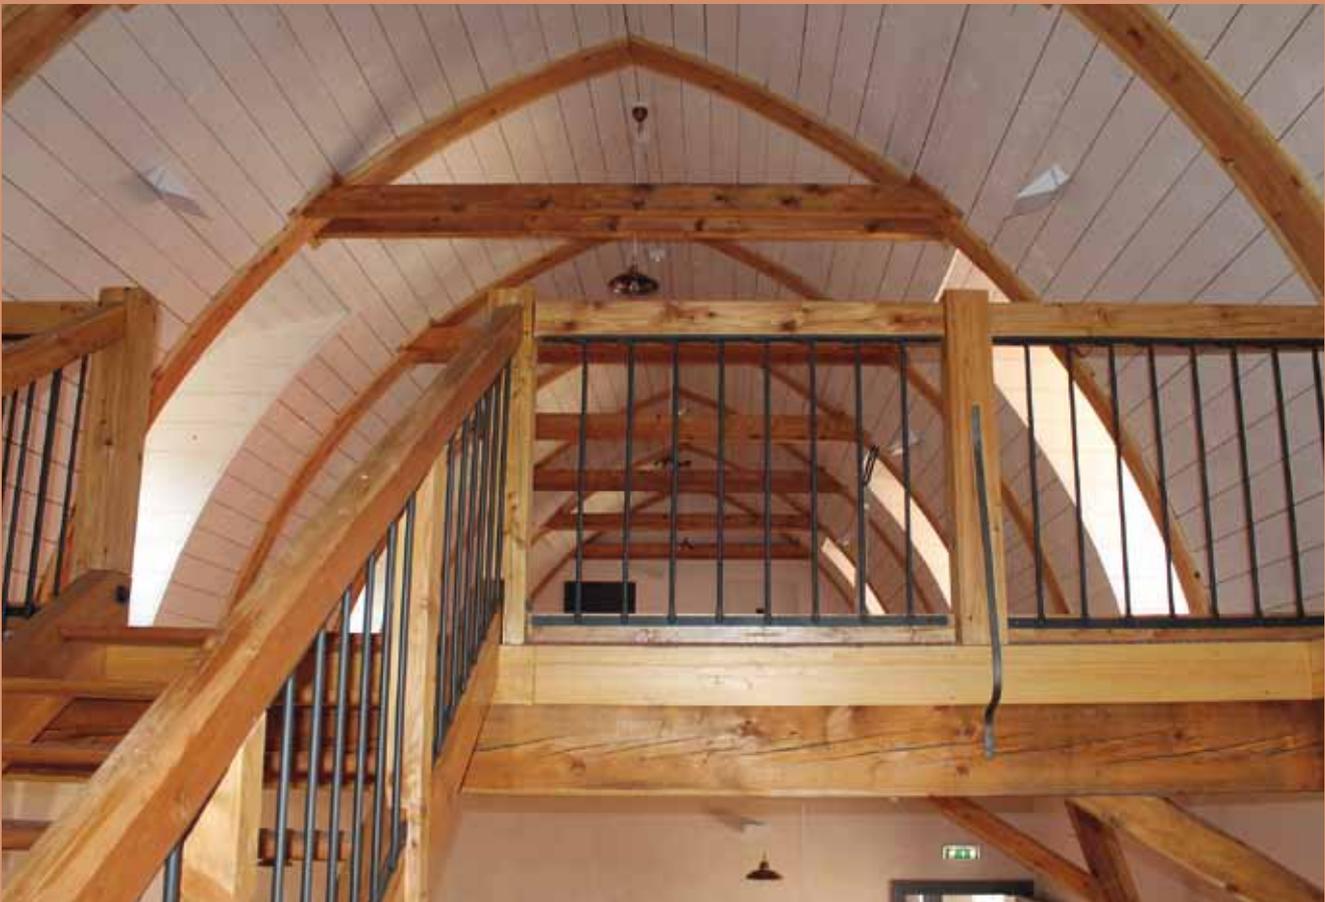
Condition of one of the rafters after reconstruction

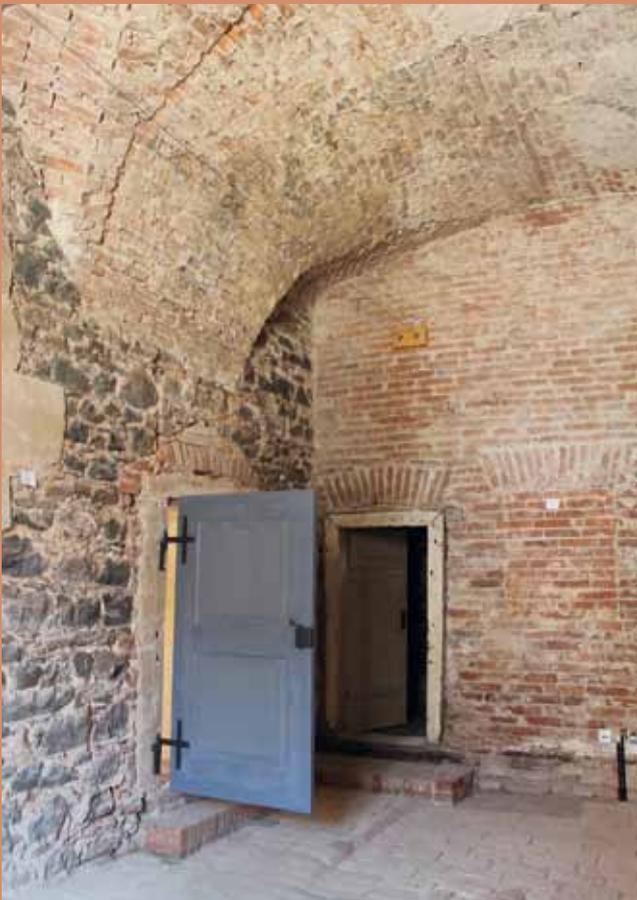
Door after restoration

Restoration works involved chiefly historical doors and balustrade railings. The double-leaf entrance door was made of spruce in the second half of the 19th century. The artistic Neo-Baroque coffered surface was severely damaged especially in the lower part; the profile mouldings were also degraded. The restorers thus dismantled the door and took it into their studio, where the non-original coatings were removed and the wood was infused with fungicides and insecticides. Local petrification and conservation with boiled oil was also necessary. The surface received a new oil-based paint coating.
