MACHOŇ ARCADE IN PARDUBICE

MACHOŇOVA PASÁŽ, TŘÍDA MÍRU NO. 60,
530 06 PARDUBICE

INVESTOR: METROSTAV A.S.

CONTRACTOR: GEMA ART GROUP A.S.

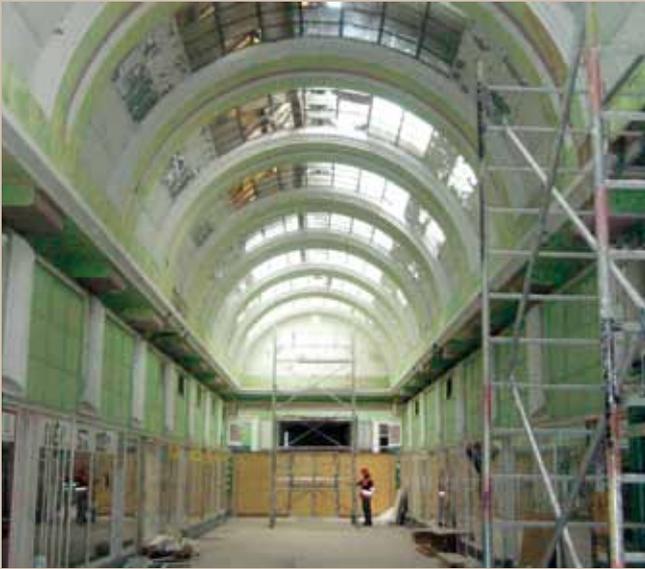
Overall view of the interior of the arcade – condition before renovation

A complete renovation of the building was launched in January 2011. The renovation plans were prepared by the architect Miroslav Petrů. GEMA ART GROUP a.s. participated in the project as the main supplier of restoration work.

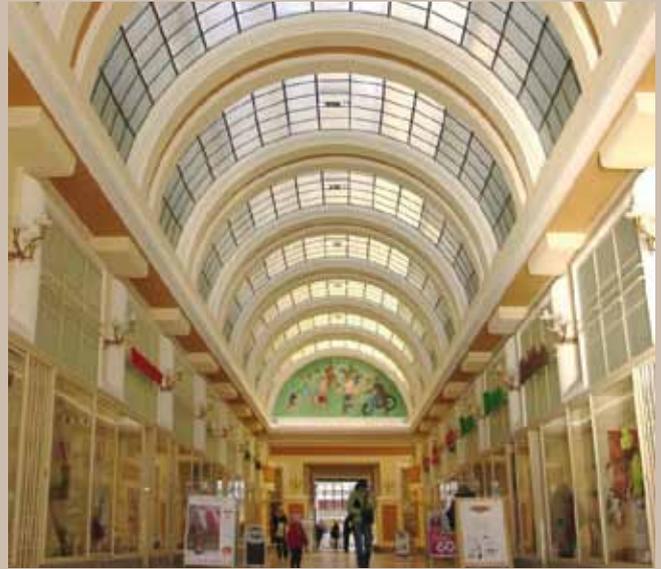
Overall view of the interior of the arcade – condition after renovation

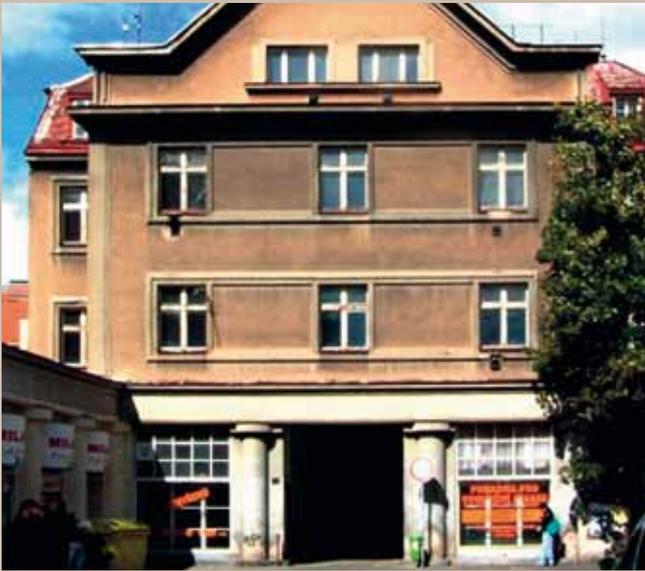
Rear parts of the arcade – condition before renovation

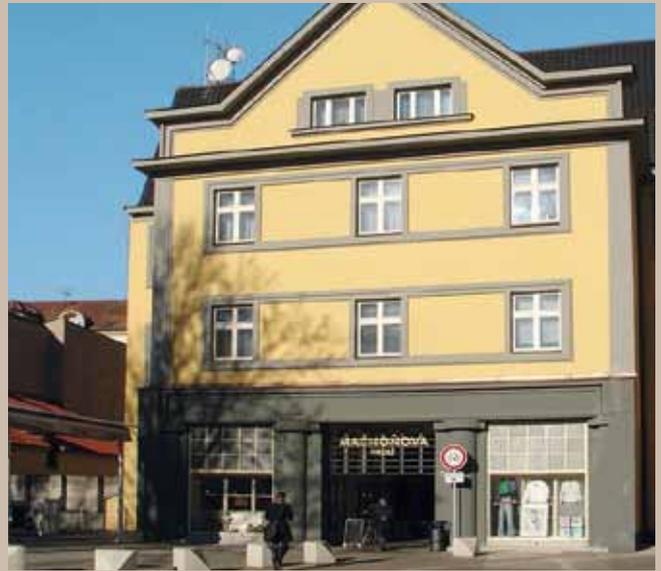
Rear parts of the arcade – condition after renovation

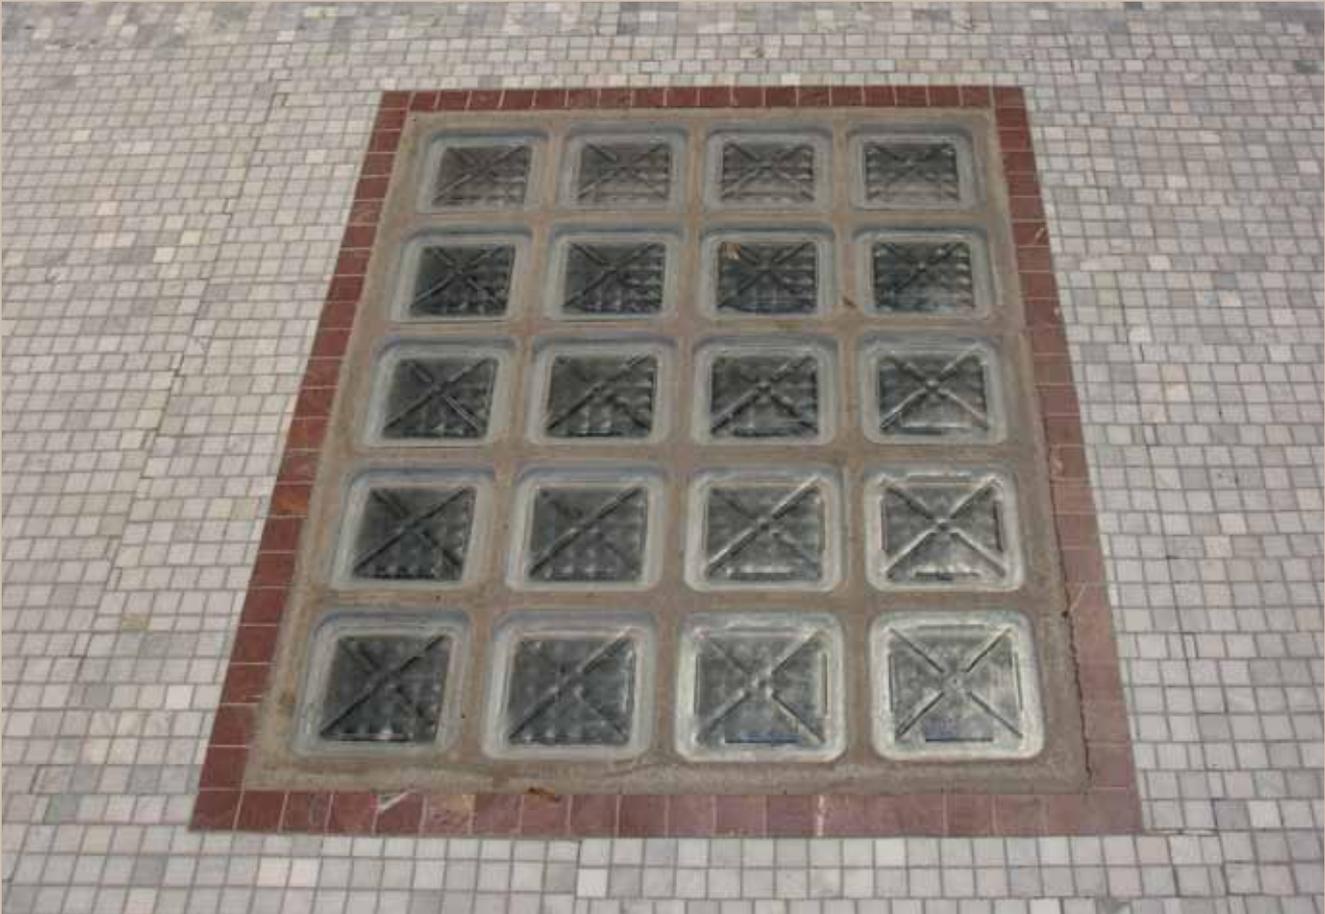
The mosaic floor had suffered considerable damage and was repaired several times in the past, often with unsuitable materials: ceramic tiles, concrete and even pieces of bricks. Considering the degree of damage to the mosaic, it had to be completely replaced.

Mosaic floor – condition after restoration

The restoration of the original mosaic floor was carried out with attention to the smallest details and on the basis of accurate measurements of the original shapes and patterns.

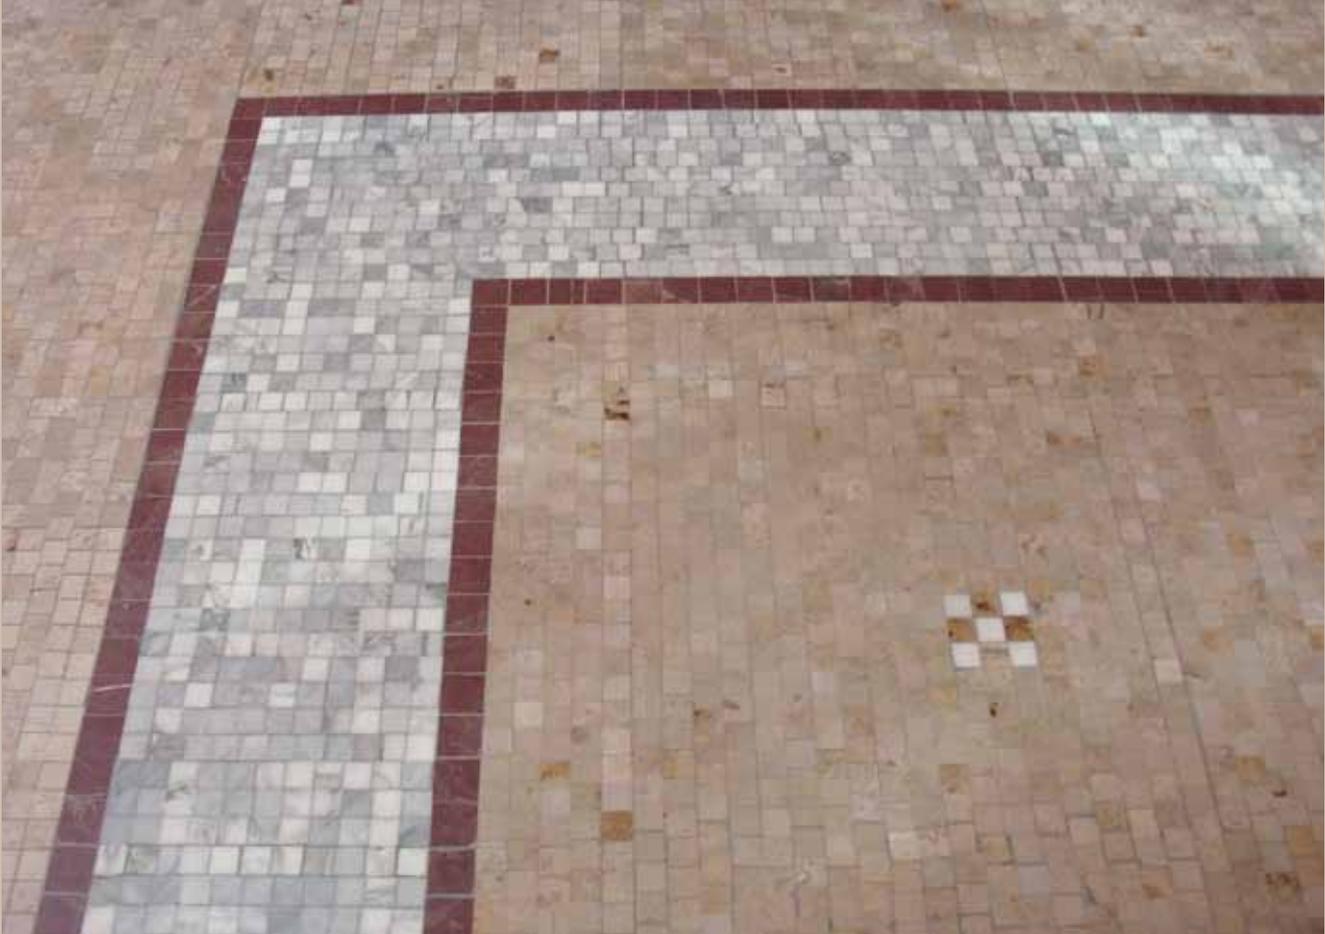
Mosaic floor – condition after restoration

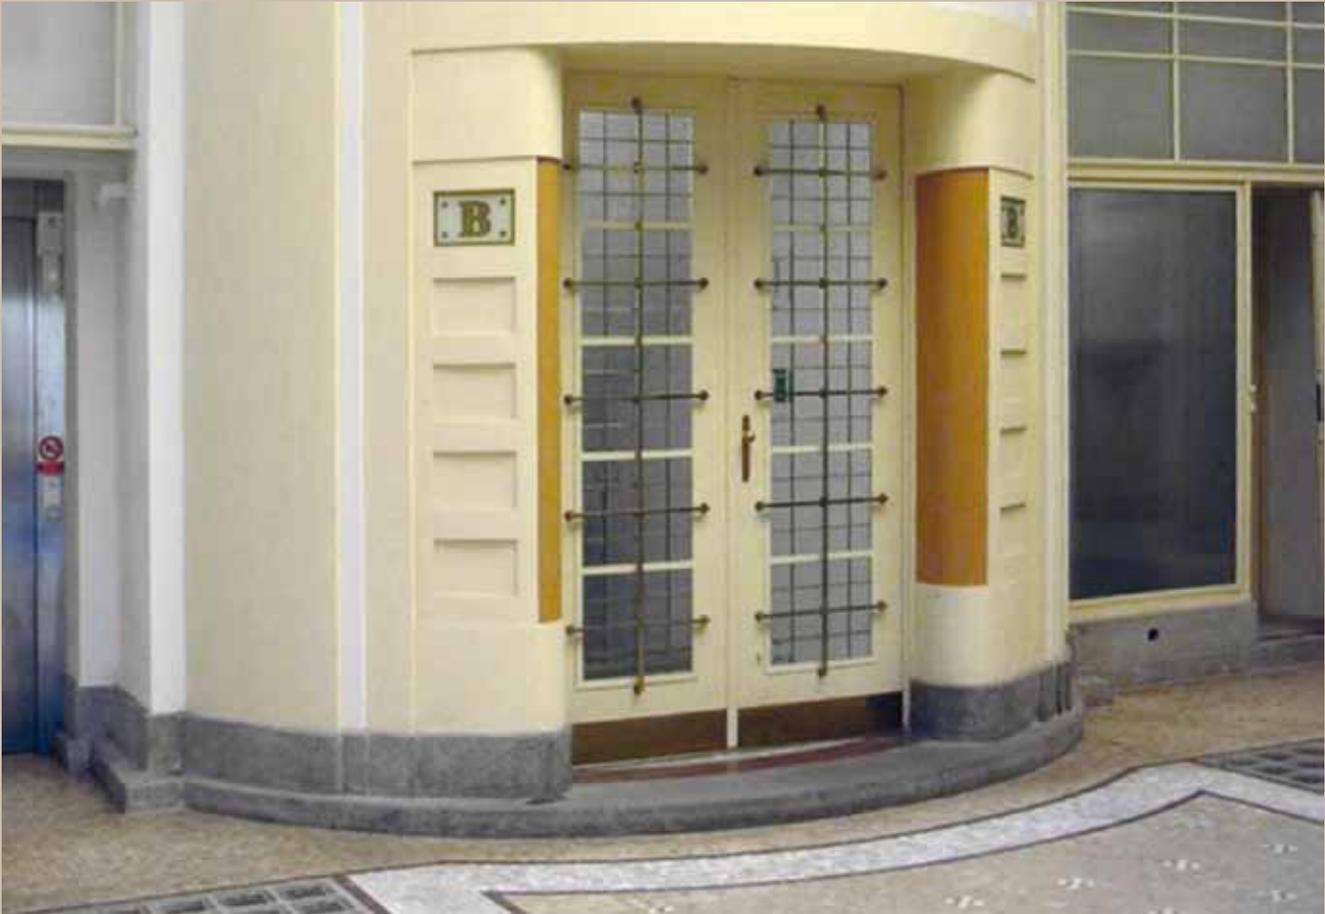
Restoration of the granite socles lining the mosaic floor of the arcade was also a part of the project. At the entrances to the individual shops, the socle forms thresholds made of artificial stone. Artificial stone was showing the largest degree of degradation in the form of cracks and heavy pollution.

Granite socles – condition after restoration

The surface was first steam-cleaned; in the most polluted areas, mechanical and chemical cleaning was used. Sealants were injected in the cracks and the missing parts were re-moulded. The re-moulded parts further needed to be patinated. The experts replaced the missing granite parts of the socle with suitable replicas visually adjusted to fit with the surroundings.

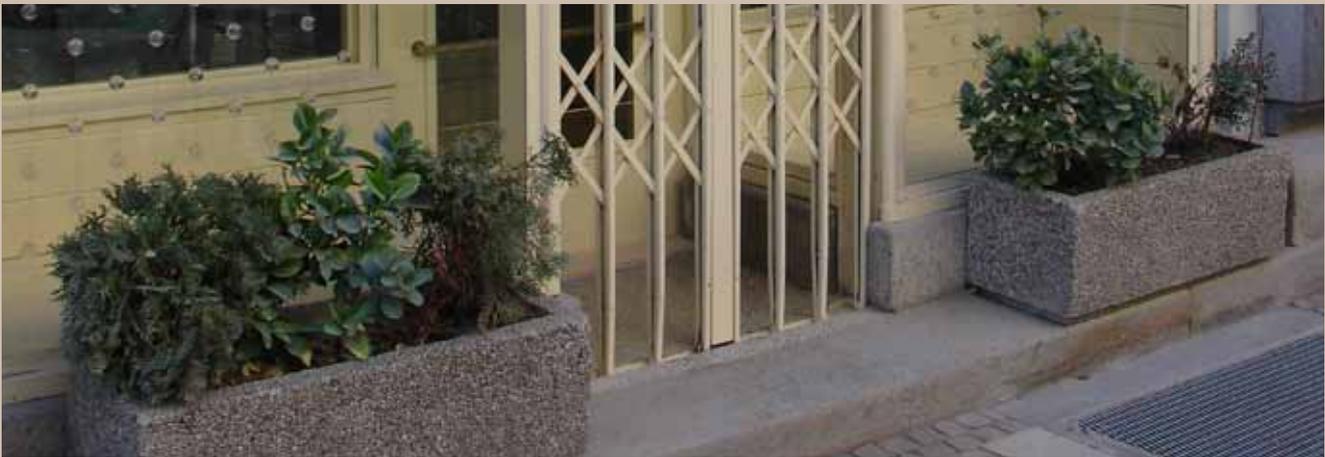
Granite socles – condition after restoration

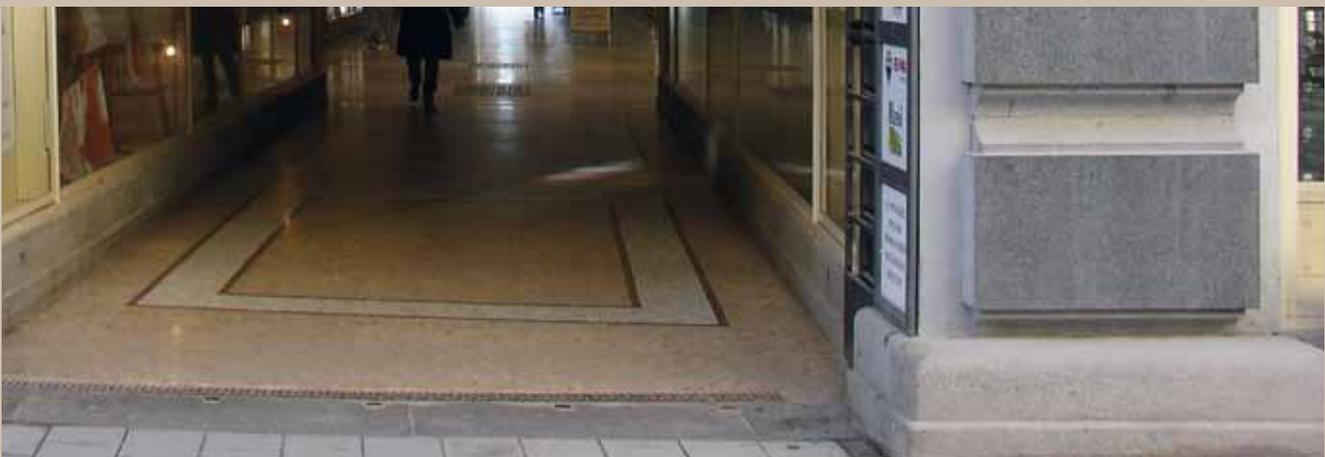
Mosaic floor – condition after restoration

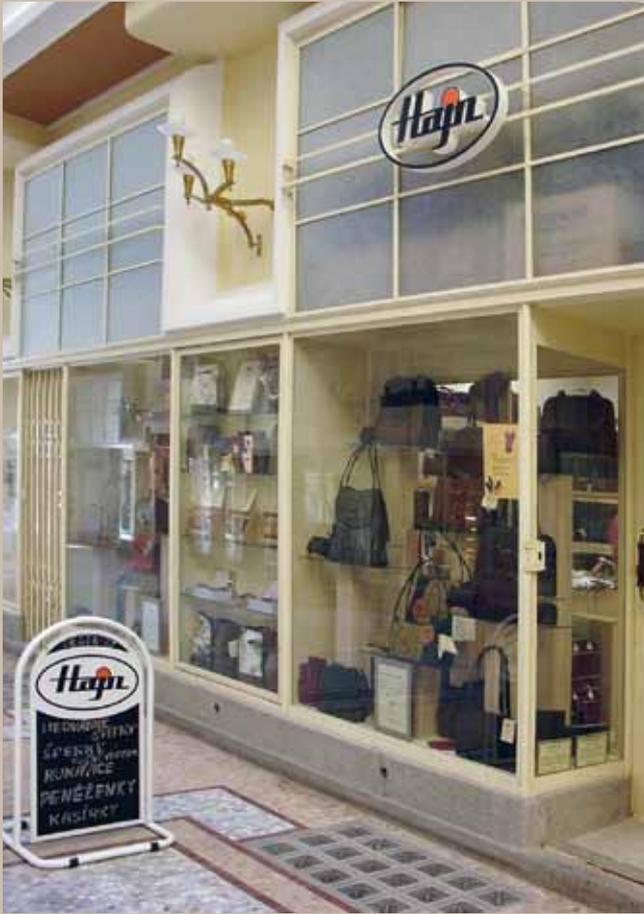
Experts from GEMA ART GROUP a.s. also participated in restoring the original appearance of the wooden elements. The wooden parts of the shop windows underscored the atmosphere of interbellum Czechoslovakia; however, it was destroyed over time and replaced with inappropriate replicas.

Replicas of interbellum Czechoslovak wooden shop window frames

During restoration works, suitable wooden replicas of the original shop window frames were made to match the two preserved originals.

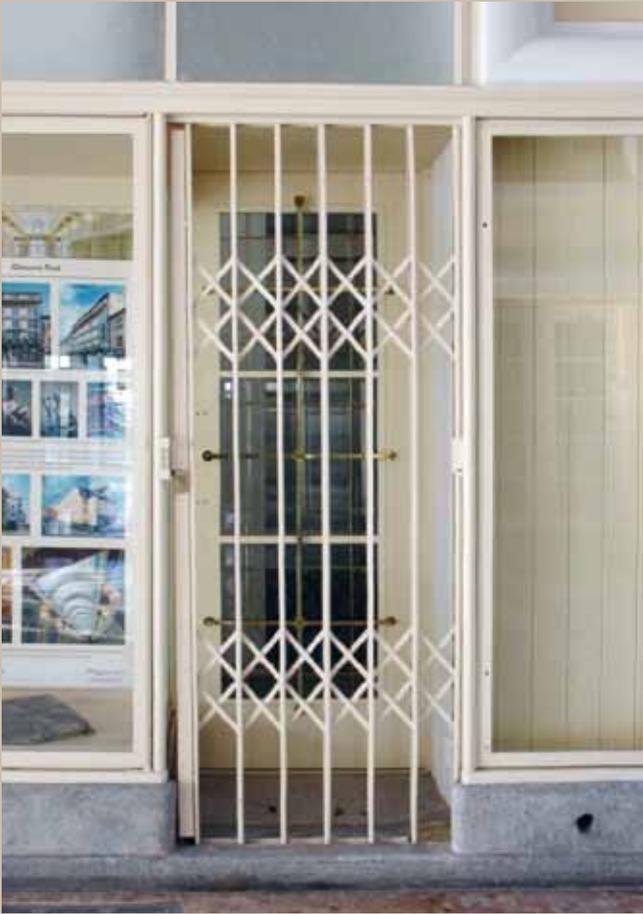
Locksmithing works and restoration of metal elements involved in particular the metal parts of the shop windows including the steel frames of the shop windows, collapsible gates, brass bars of the entrance door, the original display case locks and steel fanlight with vent windows.

Collapsible gates

A number of original steel doors and shop window frames were carefully restored on the basis of the performed restoration survey. After cleaning by sand blasting and the use of sodium hydroxide, the surface had to be degreased with a special anti-oxidation solution prepared according to old recipes. The surface was then passivated and coated. The works involved the installation of stained-glass windows.

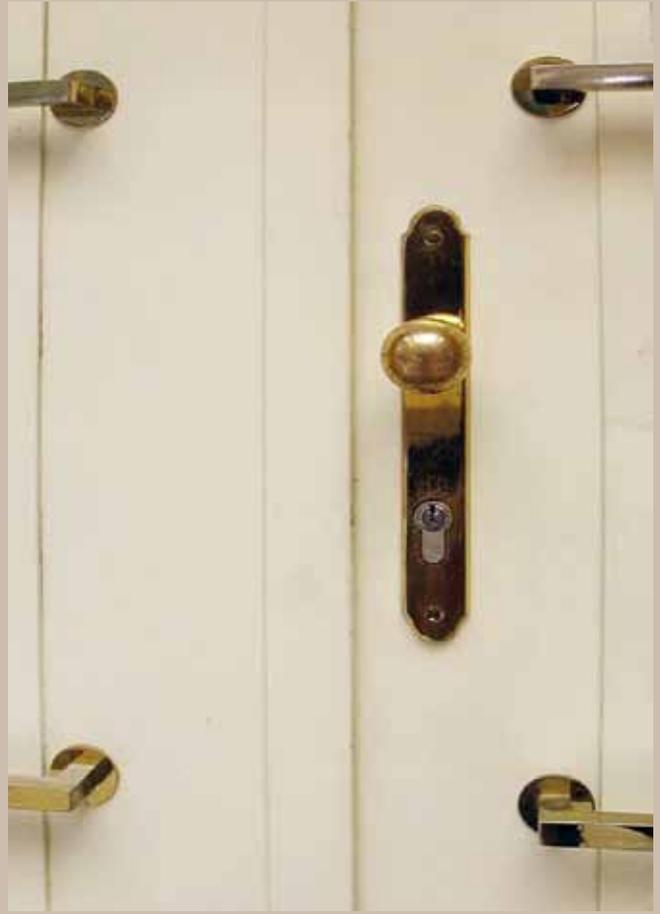
Close-up of a metal handle

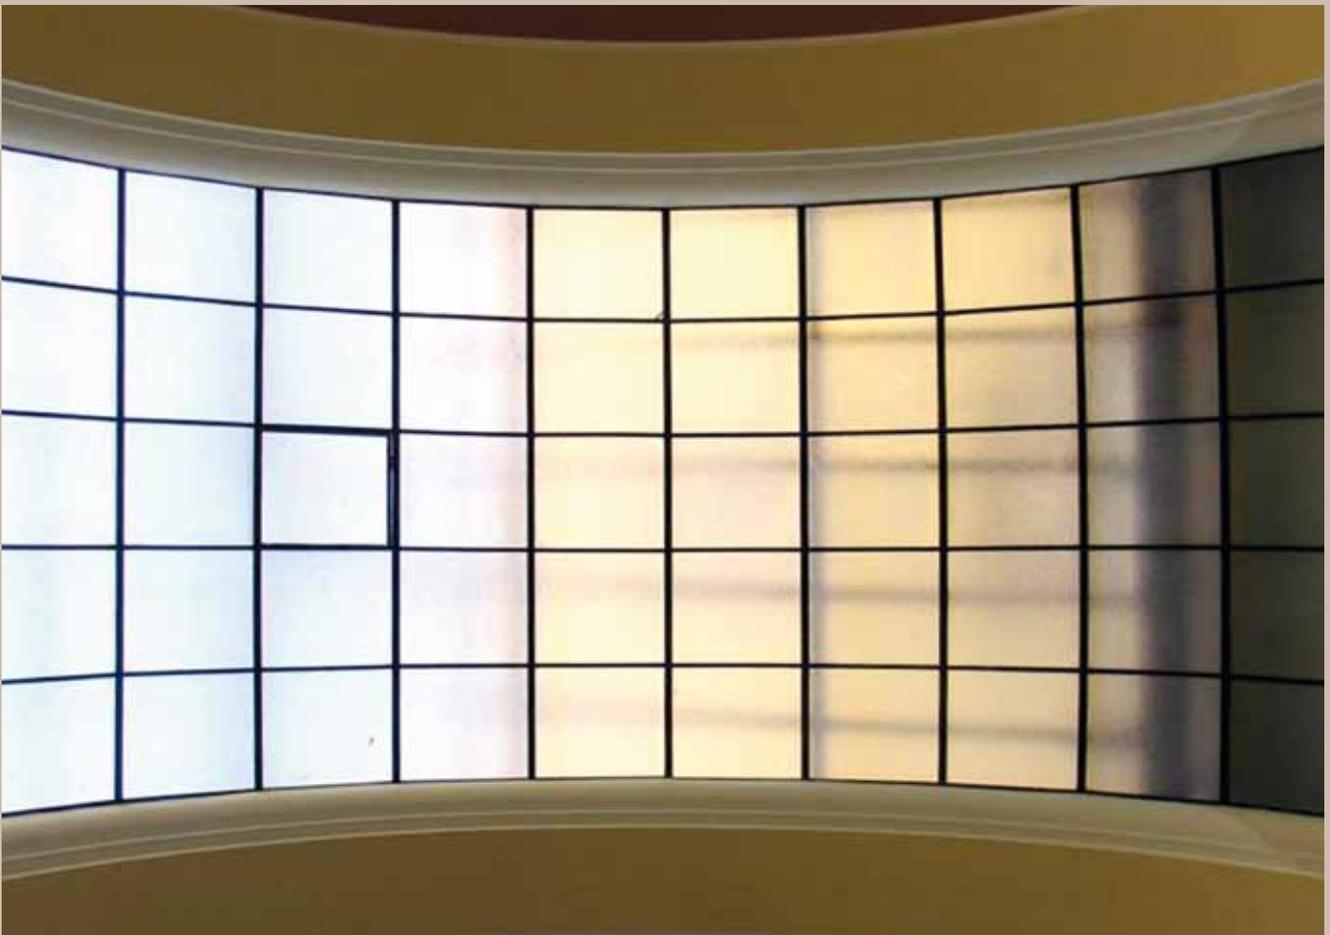
Arcade window with a metal bar – condition after restoration

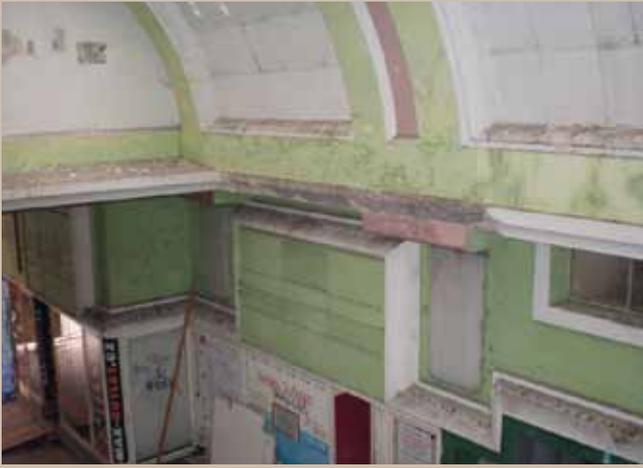
The works encompassed restoration of all stucco decorations and walls inside the Machoň Arcade. Restoration surveys showed that, for years, the original stuccos were preserved under comparatively newer layers of coating. After the removal of these unsuitable coatings, the restoration itself could begin. Broken up parts were stabilised by injecting fortifying substances into the material. Where the damage was too serious, the profiles were replaced with replicas. Scratches and minor damage were expertly retouched. The surface was subsequently sanded to achieve the desired smoothness. The colouring was set to correspond to the original 1920s appearance.

Condition before restoration

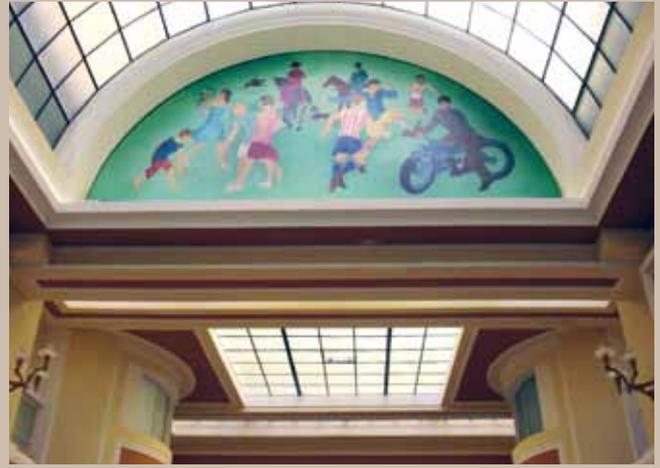
Restored lunette

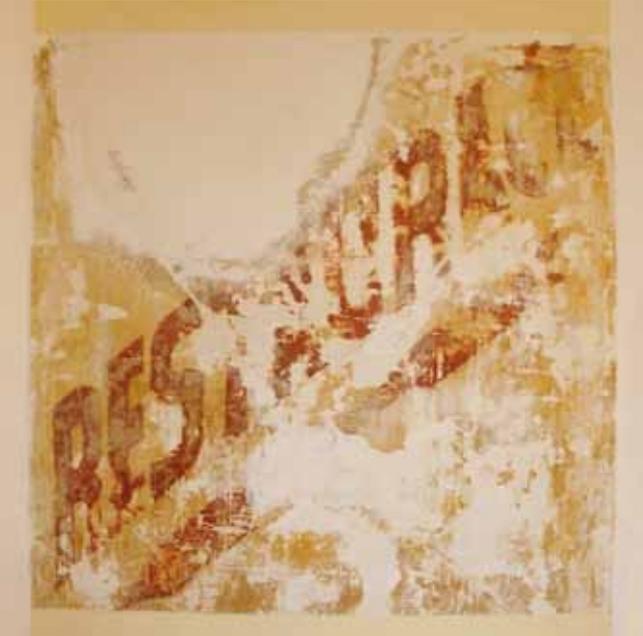
Close-up of the wall - conservation of an original inscription
