EMBASSY OF THE CZECH REPUBLIC IN PARIS
BUILDING RENOVATION

THE PROJECT

Renovation of the Embassy of the Czech Republic in Paris

Location: 15 avenue Charles Floquet, Paris, France

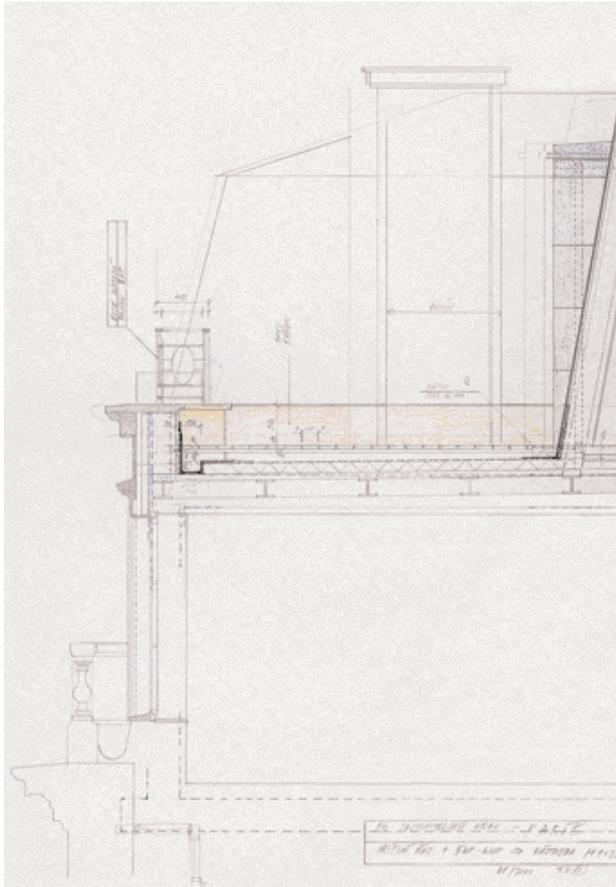
Terrace cross-section

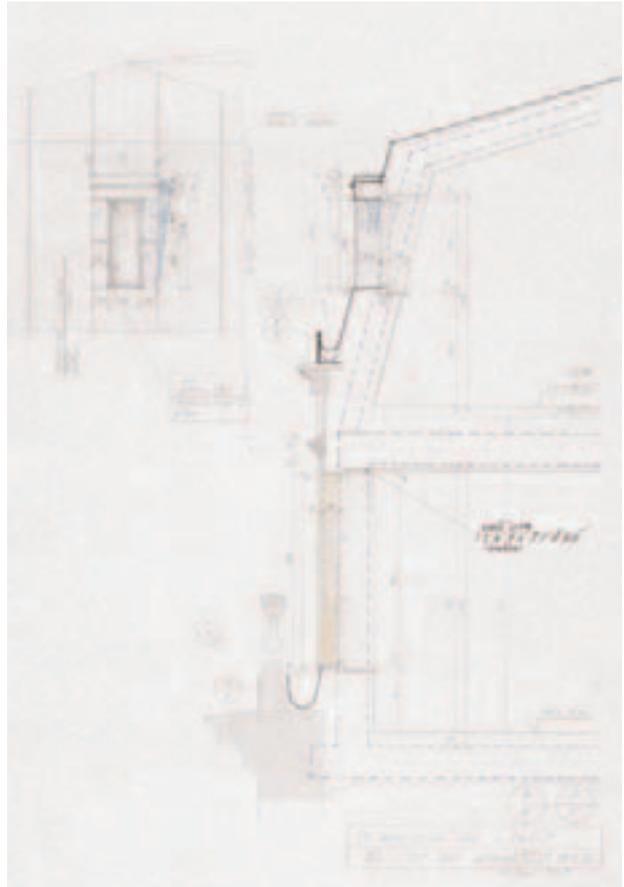
View of dormer and cross-section

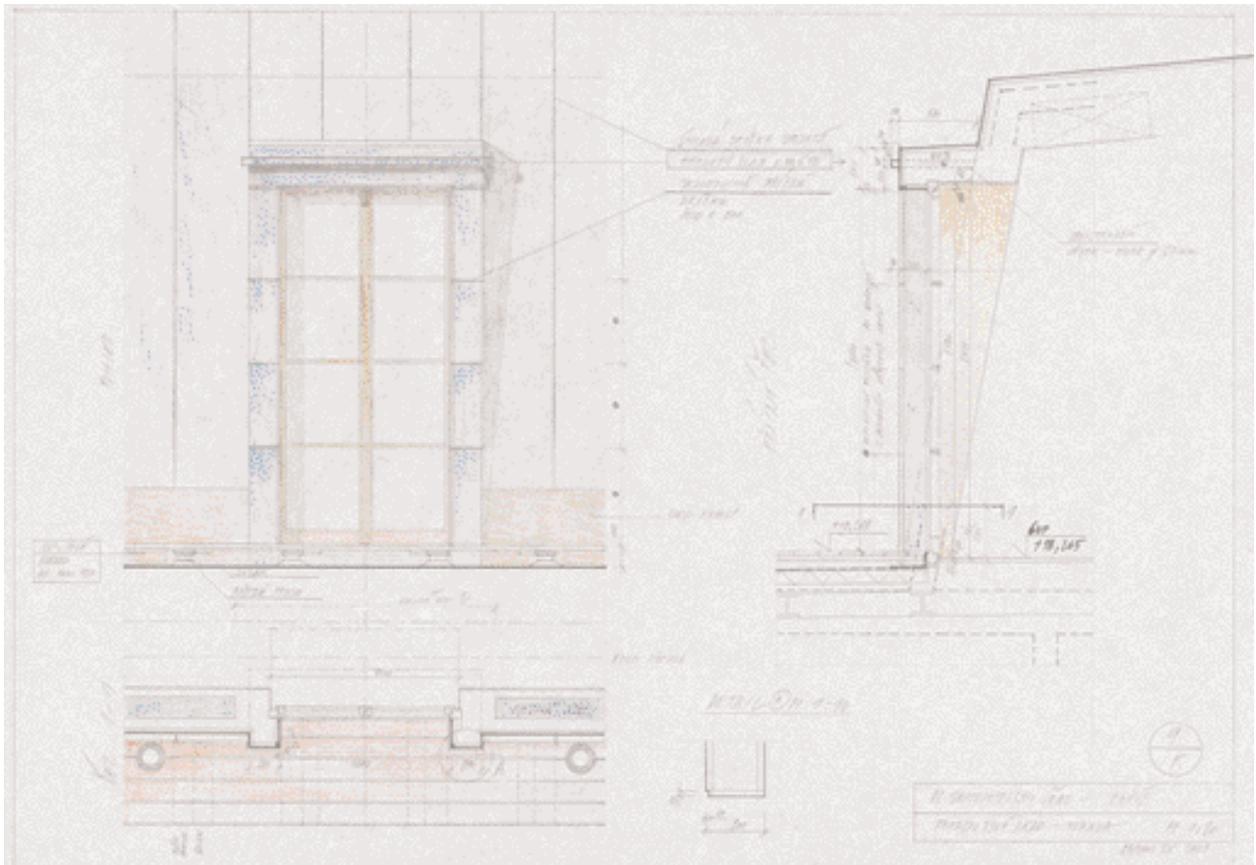
View of French windows on the terrace and cross-section

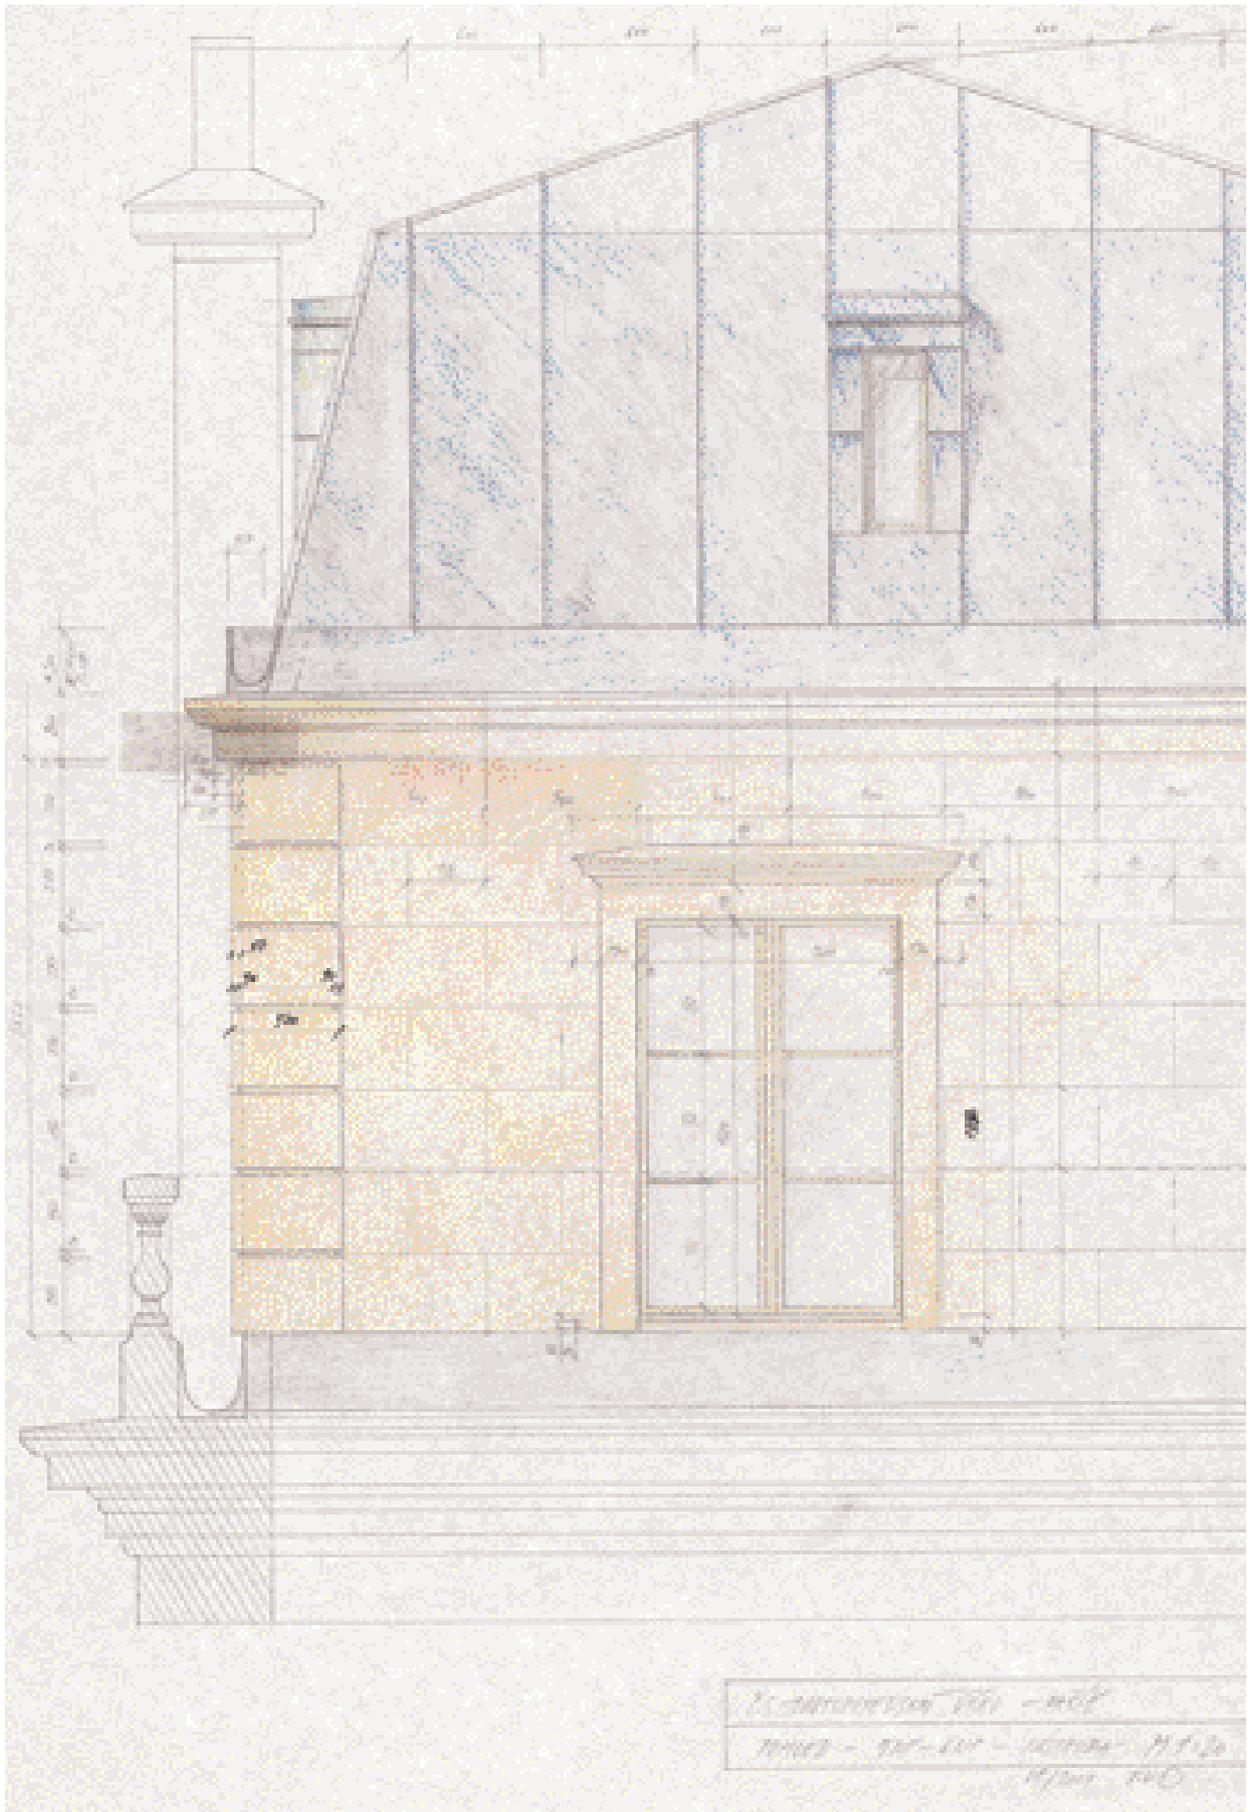
View of detailed design of the mansard extension

The original fifth storey, in which the technical offices were located, was completely demolished and replaced with a two-storey steel extension weighing 140 tonnes, anchored into the new crown cornice. The original intent was to leave the crown cornice and the balustrade without substantial modification and restore it in place, and then to continue the historicist extension of the fourth and fifth storeys. After examining the crown cornice, however, it was decided to reinforce the building with a circumferential ring. After reinforcing the load-bearing structure, the steel extension of the fourth and fifth storeys was built. The fourth historicist storey was overlain with local stone, while the new fifth roof storey has the character of a mansard roof. The surface is made of titanzinc.

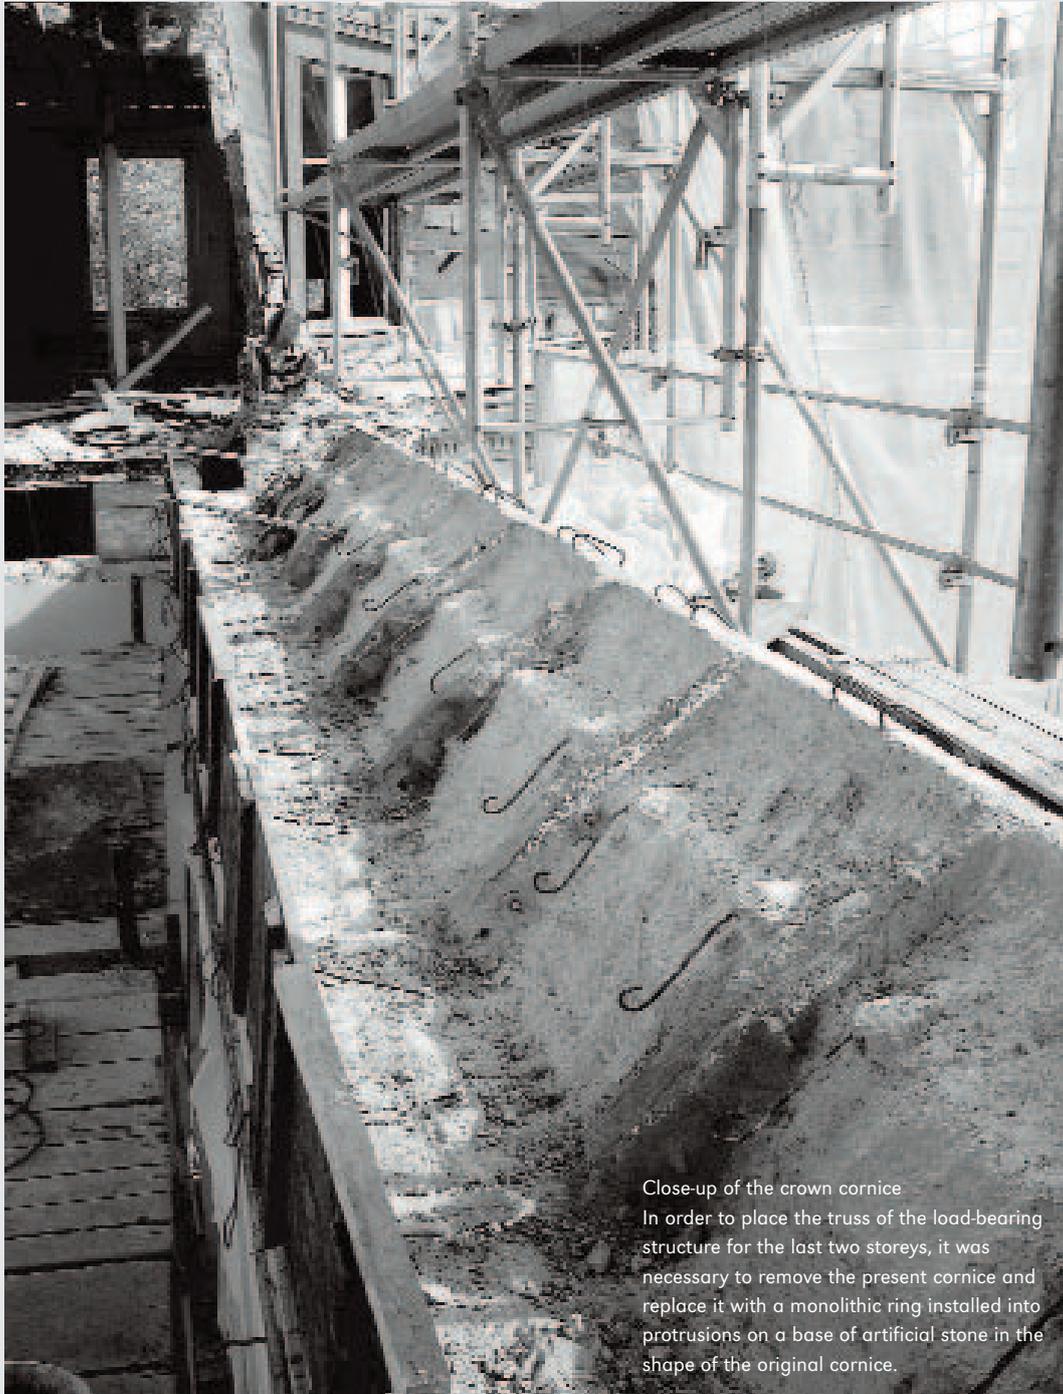
Close-up of the crown cornice

In order to place the truss of the load-bearing structure for the last two storeys, it was necessary to remove the present cornice and replace it with a monolithic ring installed into protrusions on a base of artificial stone in the shape of the original cornice.

In renovating the exterior, the main task was to resolve the structural embedding of the steel edifice into the crown cornice. Upon examination, it was decided that the crown cornice should be removed, as a probe of the full width and height of the cornice had revealed that stone blocks were situated in places only above the crown of the wall and that the remainder had been made out of a heterogeneous material. The moulded surface, including dentils on the exposed side, was completed in place with plaster – technique *a la prima* – in order to perfectly match the limestone already used on the building. Casts were taken of the arches and parts of the cornice and then the cornice was removed. After consultation with a structural engineer, the new cornice was fabricated as a concrete protrusion, which formed the lost casing for the new concrete ring. The exposed parts of the concrete shell were made of artificial mineral-based stone, perfectly matching the stone of the building. The shell was fabricated in approximately 1-metre pieces and was constructed in order to make it possible to connect the individual segments and to insert the armature of the new concrete ring.

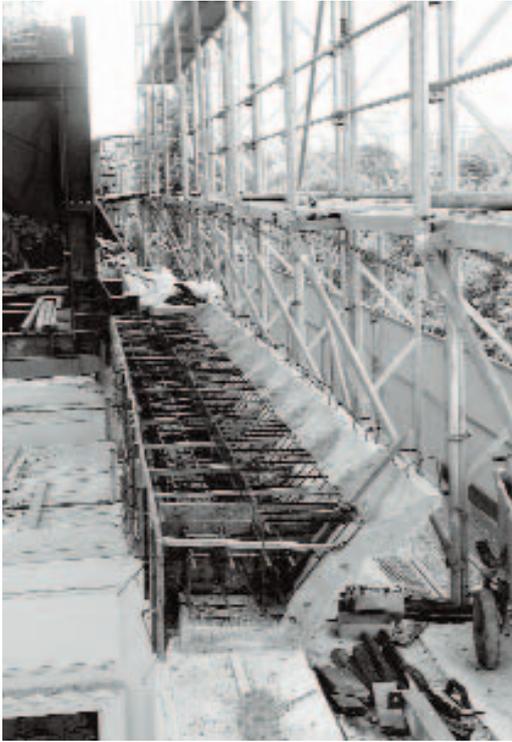
The shell was fabricated in approximately 1-metre pieces and was constructed so that it was possible to connect the individual segments and to insert the armature of the new concrete ring.

The exposed parts of the concrete shell were made of artificial mineral-based stone, perfectly matching the stone of the building.

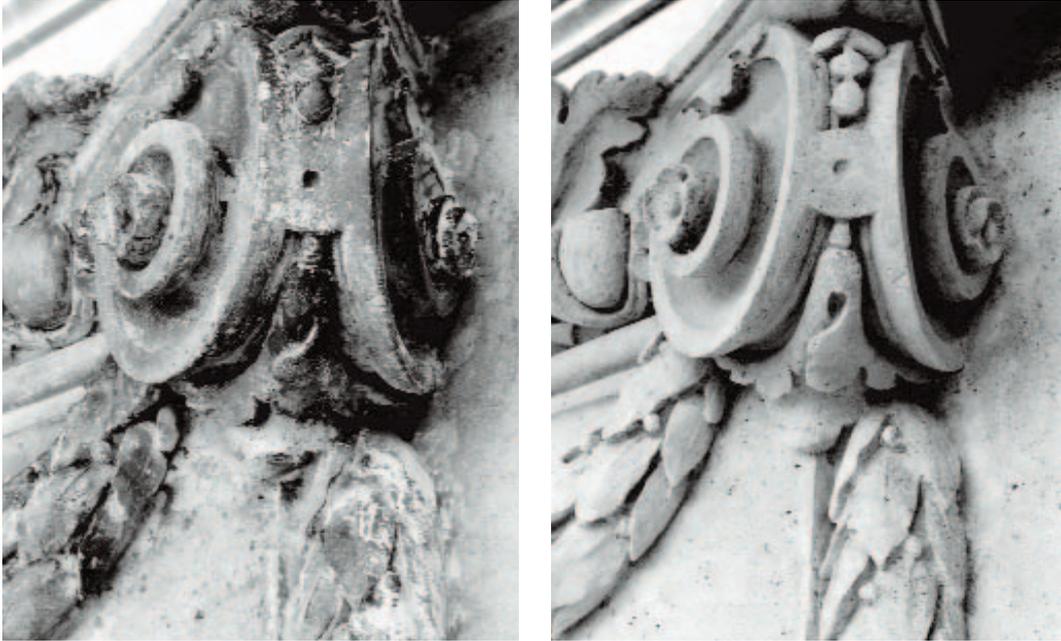
Head of a pilaster, close-up of a volute before and after restoration

Reliefs on the external jacket of the building can be classified into several groups according to plasticity, nature of workmanship and theme: reliefs representing the four seasons of the year, reliefs depicting four types of artistic activity, reliefs with a hunting motif and reliefs with a medallion. The building is ornamented with 20 such reliefs ca. 70cm x 140cm in dimension and 4-10cm in thickness located in alcoves below the windows of the second storey.

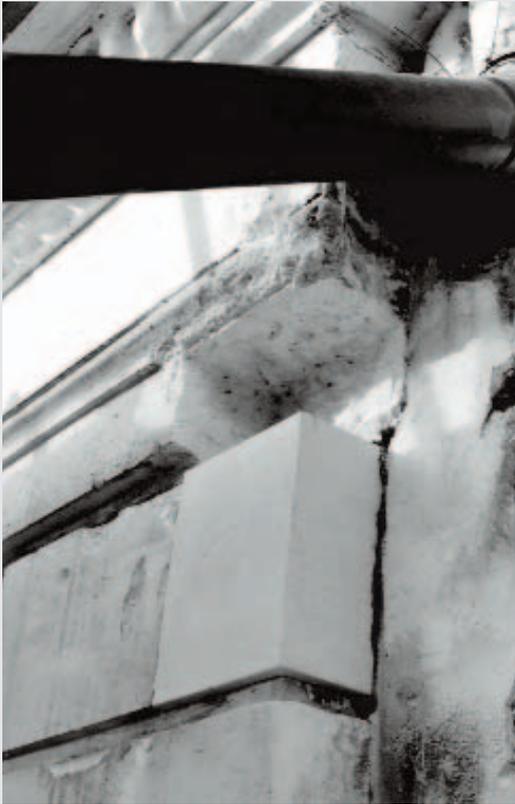
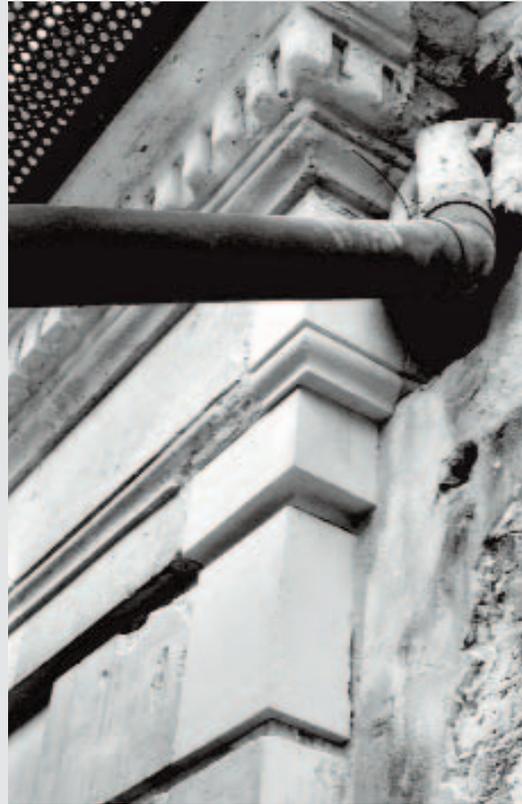
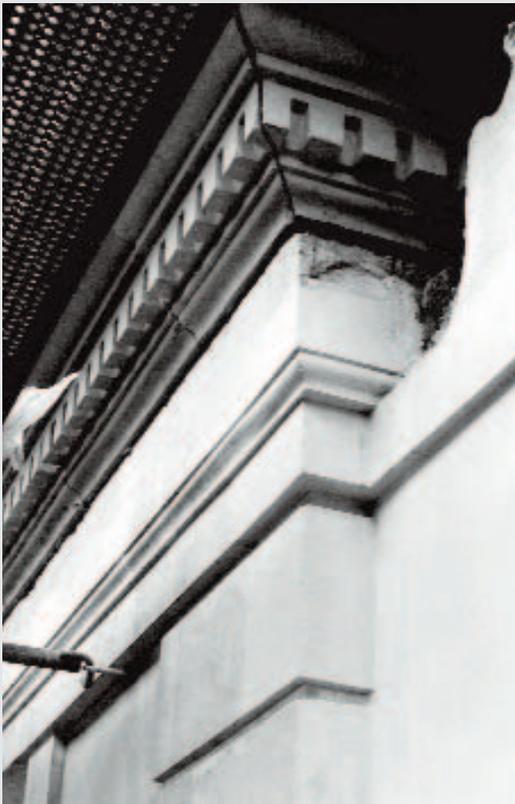
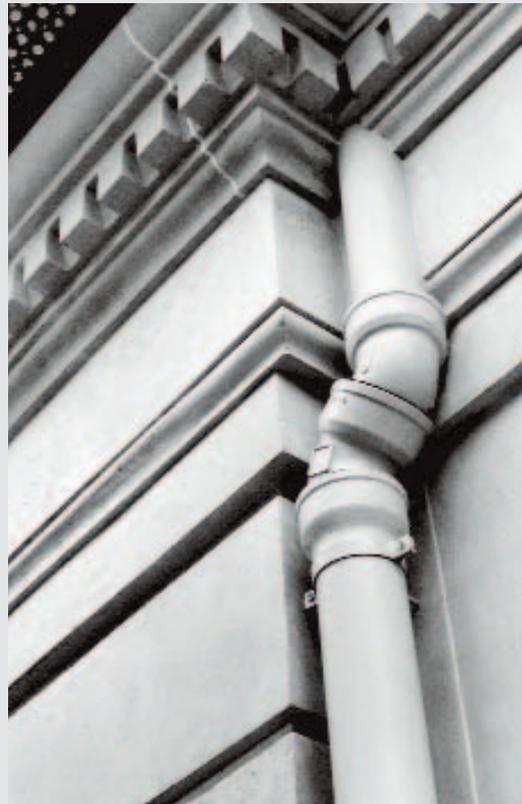
Right corner of the fourth storey – gradual replacement of deteriorated components, after mounting the new blocks, after mounting the new crown cornice and after completion

The band cornice was covered by an already corroded sheet of metal which did not prevent the penetration of rainwater into the limestone, resulting in significant degradation in the material of the cornice and its surroundings. Forty percent of the plaster grouting was degraded, loose or completely missing. The interior sides of the window and door linings, as well as the window cornices (fourth storey) were notably damaged mechanically – grouting crumbling away, damaged edges and damaged and weathered corners of the window cornice.

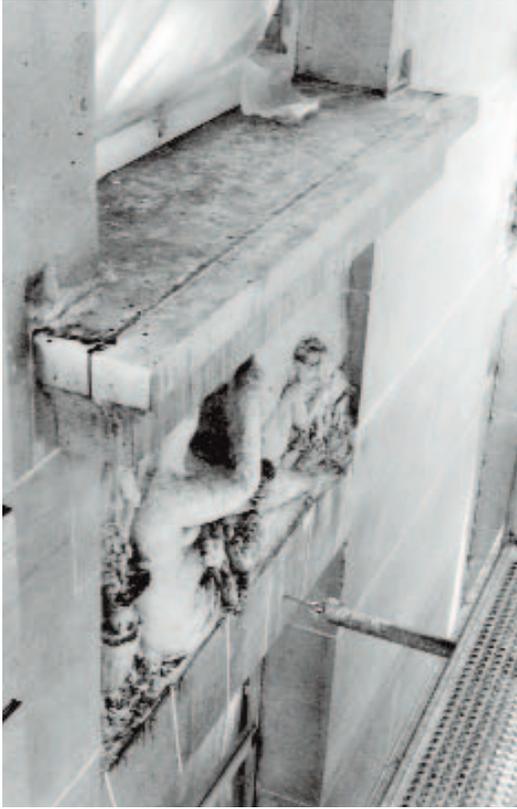
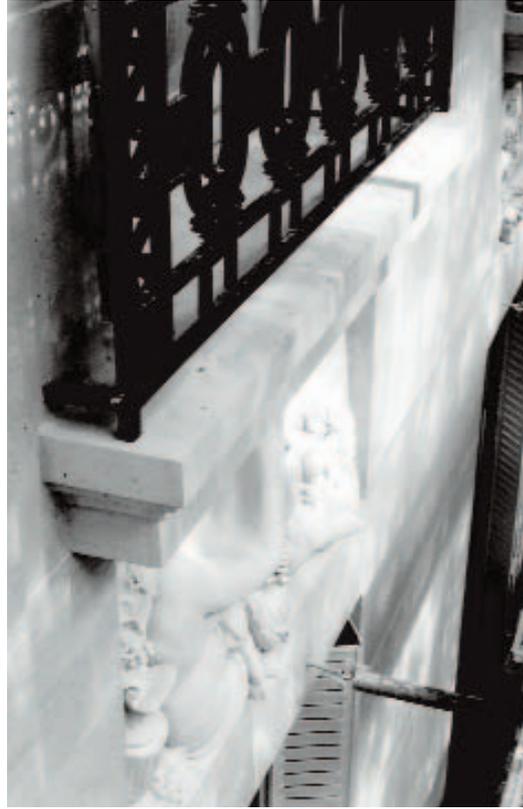
Window cornice in the fourth storey – after first high-pressure wash and after completion

The stone part of the facade with alternating surfaces of local seashell limestone and artificial stone was visibly deteriorated and covered with a thick layer of dust deposits. In the rain shadows the stone surface was covered with a crust, as was the surface of all decorative elements, statues and reliefs. In the past this situation had been remedied by building up oil and limestone coatings, but under the air-tight surface the limestone was severely degraded.

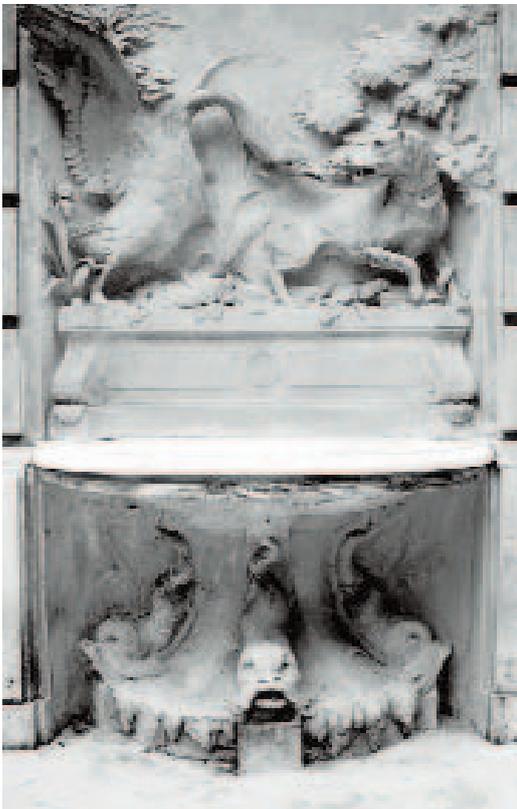
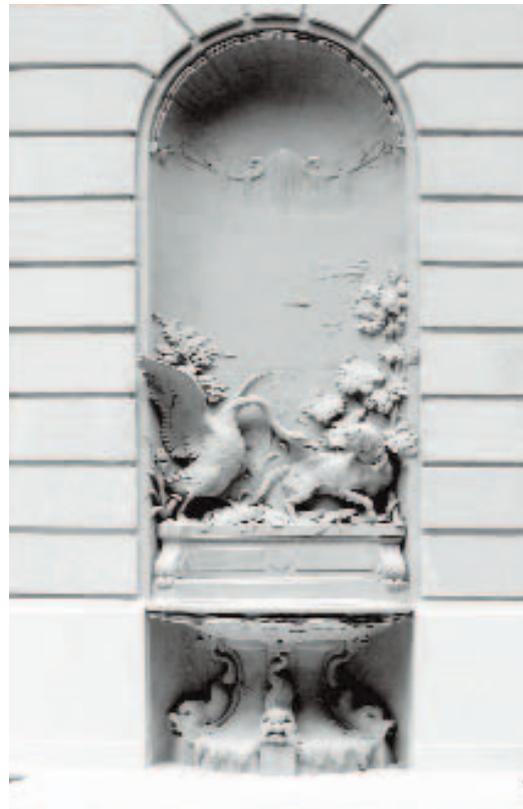
Sculpted relief in a niche near the side door from the east side of the building facade; relief dimensions 4.5 m x 1.5 m

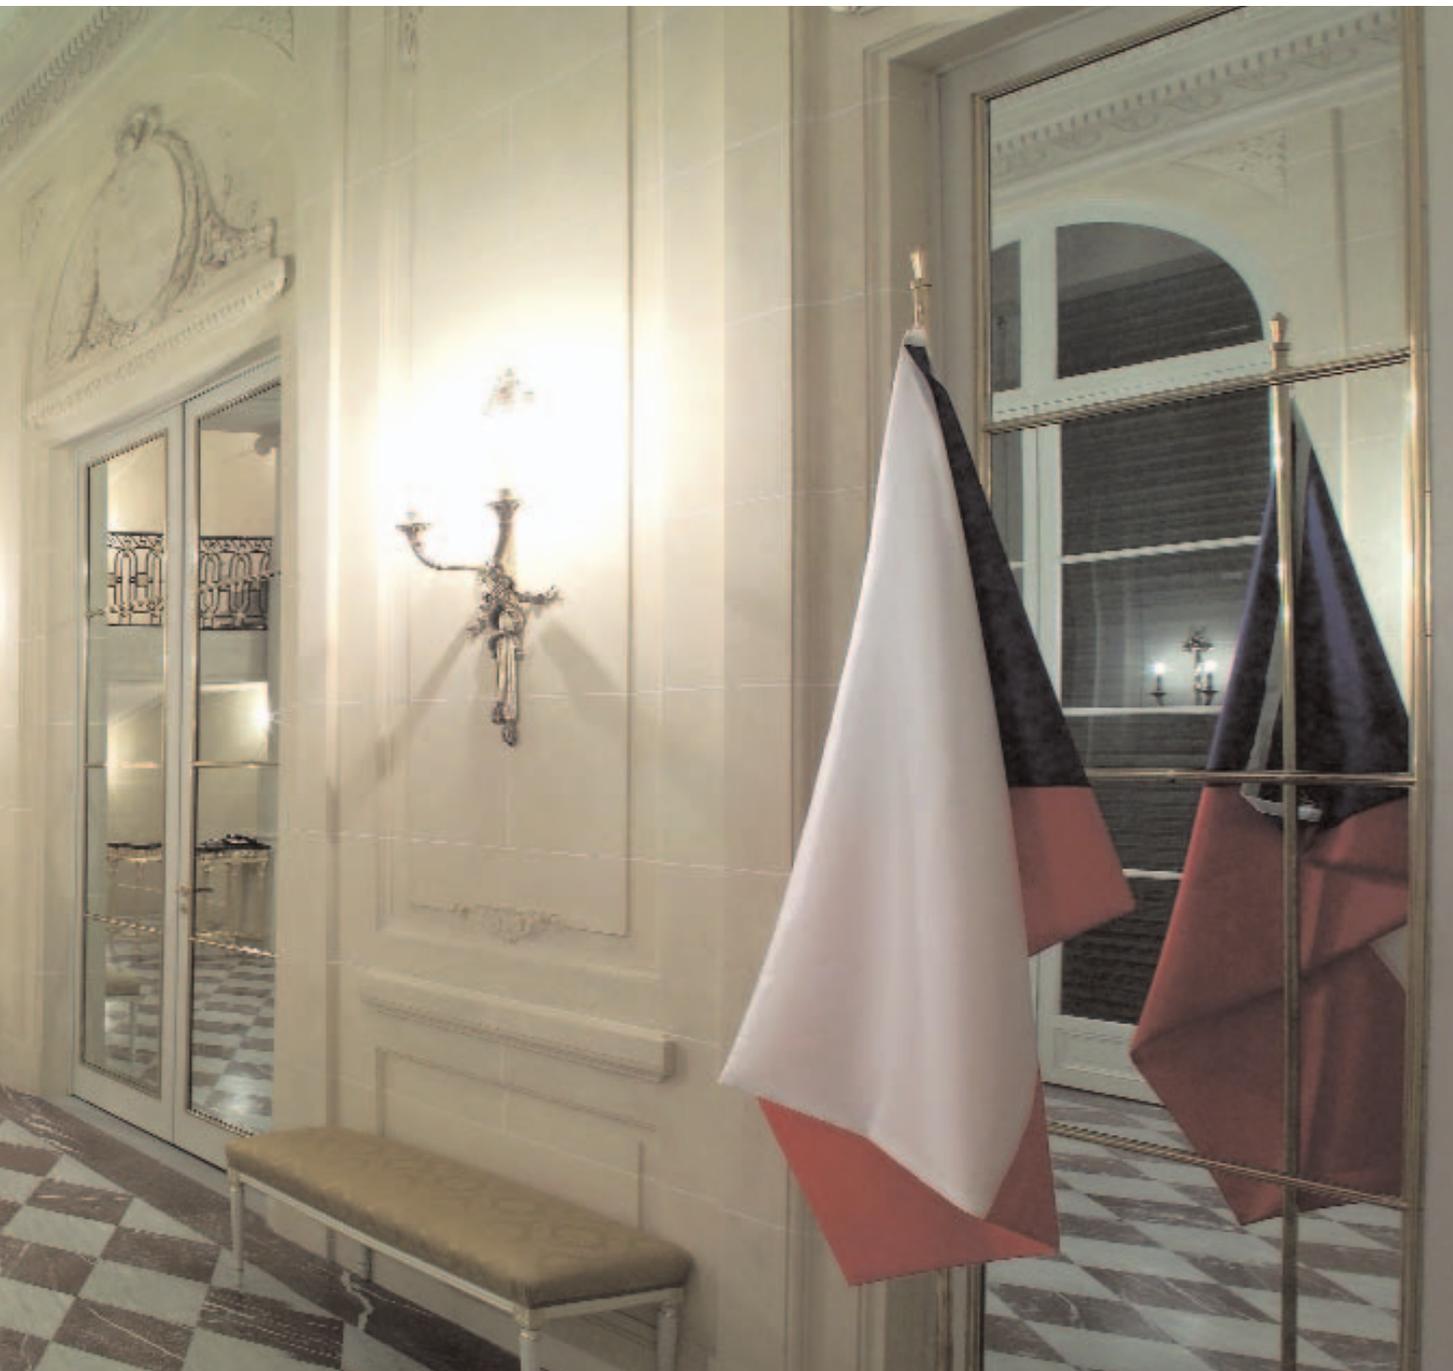
ENTRANCE HALL

After removing the recoats, the artificial stone on the surfaces of the walls was restored.

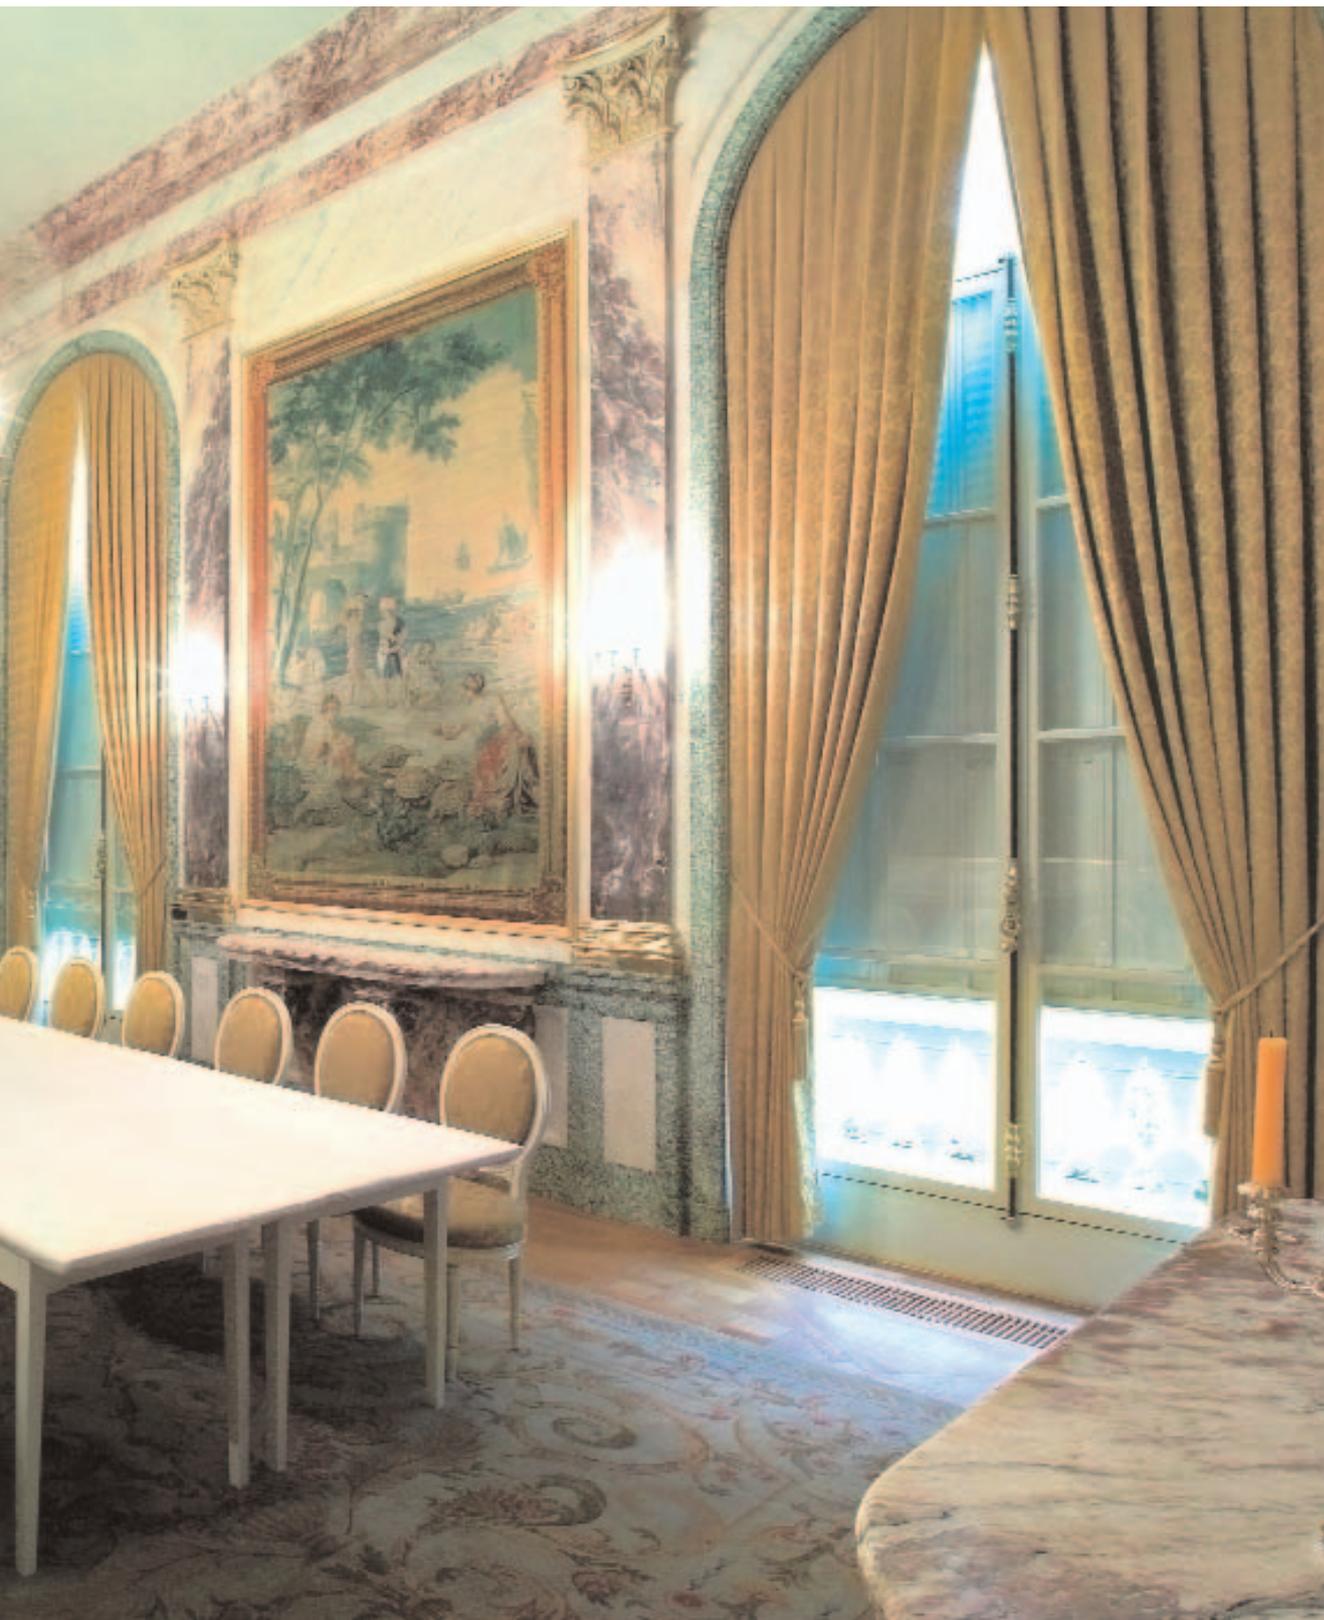
MARBLE HALL

The original surfaces of the hall's artificial marble walls were covered with later repaints. The repaints were removed and everything was restored with original materials. Three original Gobelin tapestries, restored after many years, were returned to the hall, whose furnishings were rounded off with a new carpet, upholstery and draperies.

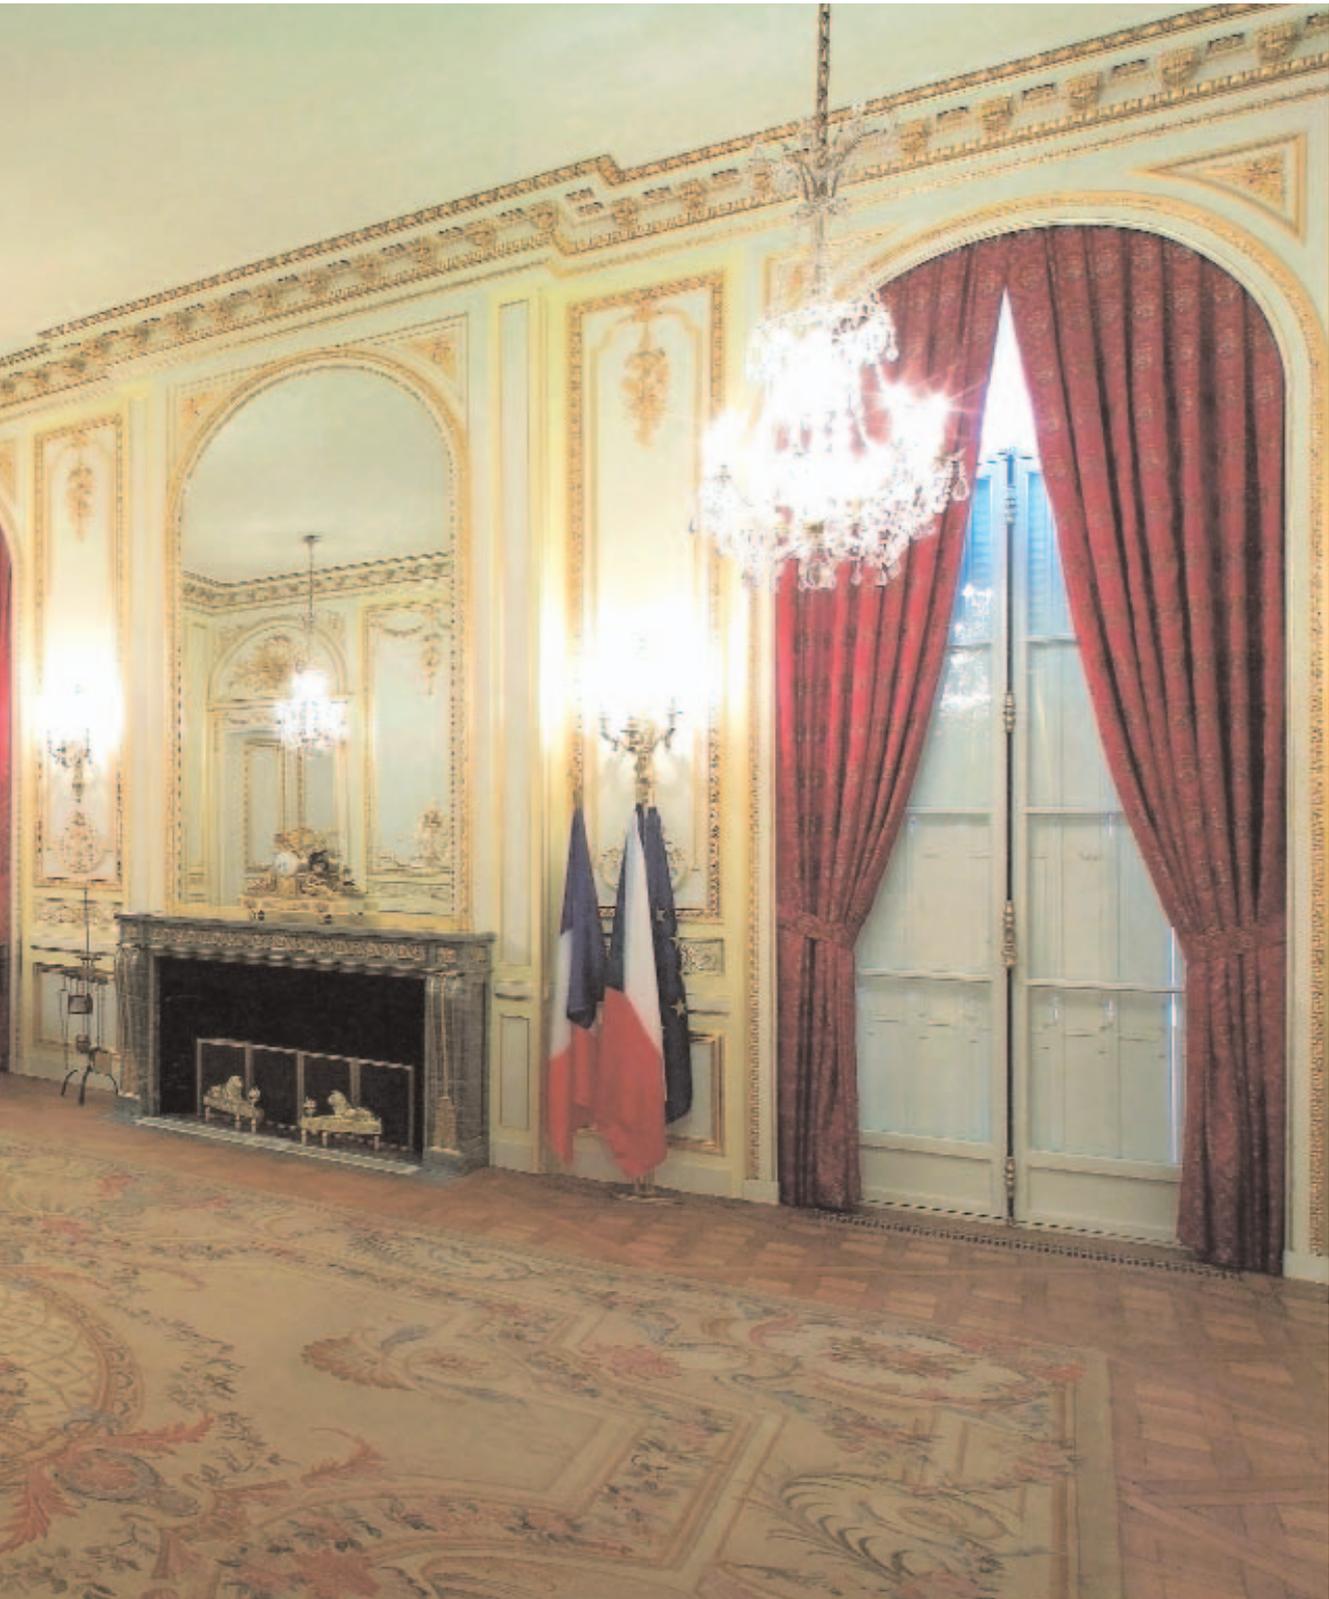
GREAT HALL

The main reception hall was cleared of period modifications. The hall's furnishings were rounded off with a new carpet and draperies.

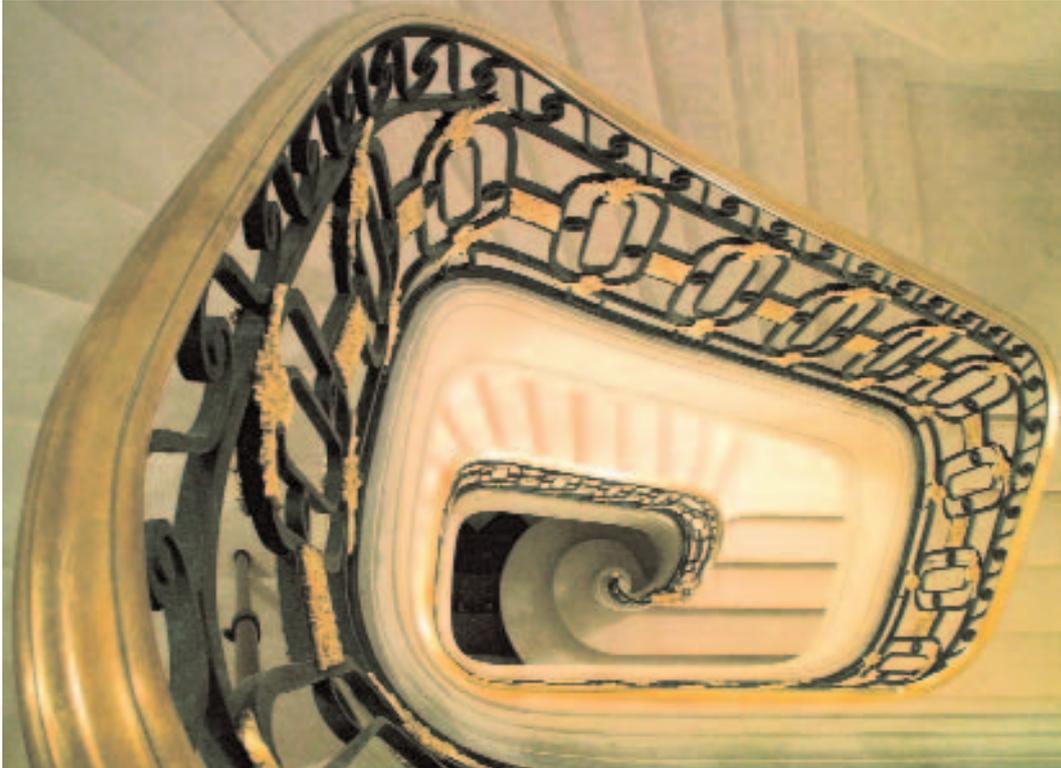
**Banister of the main staircase
and elevator shaft**

The banister of the main staircase is a classicist forged banister with a drawn square profile supplemented with cast and wrought ornamentation and a moulded brass handrail. The formation of the bar repeats the motifs used on all types of banisters.

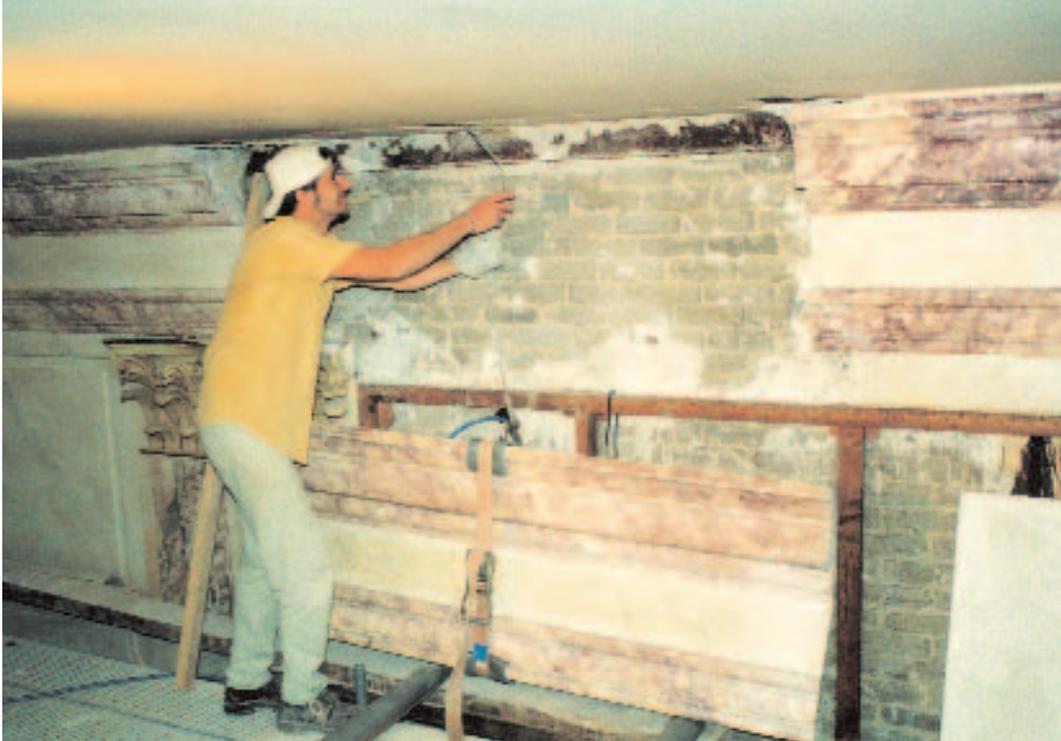
The cavetto cornice was removed and remounted.

The cavetto cornice in the Marble Hall was in a disastrous state.

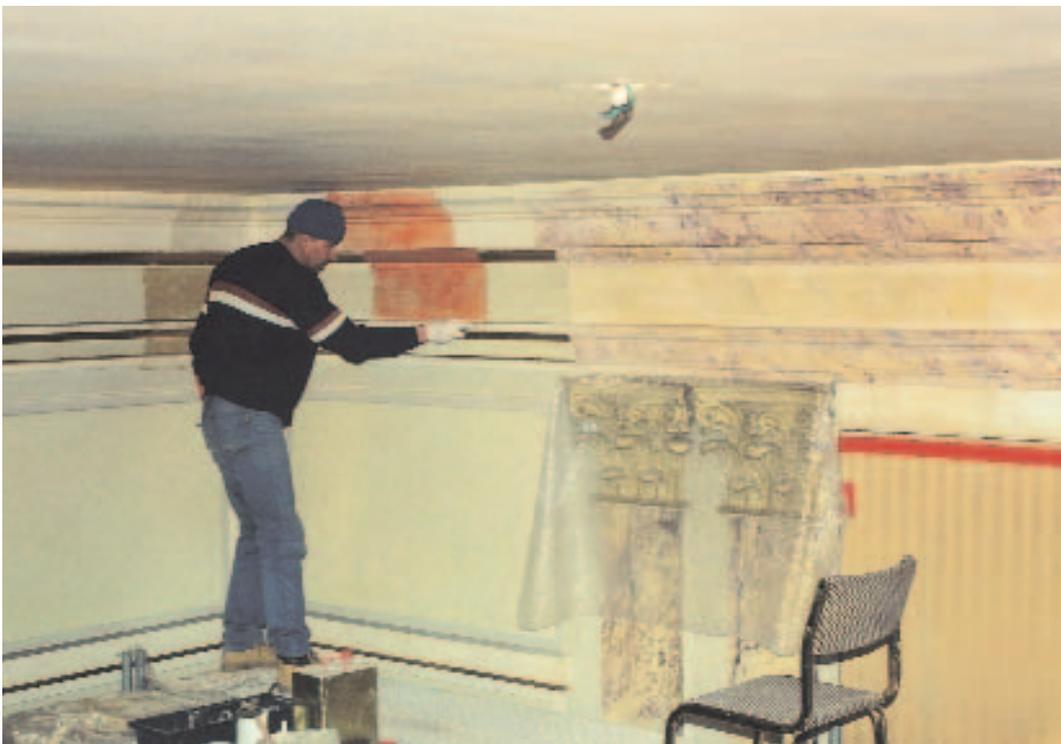
Process of removing the layers of repaints from the artificial marble.

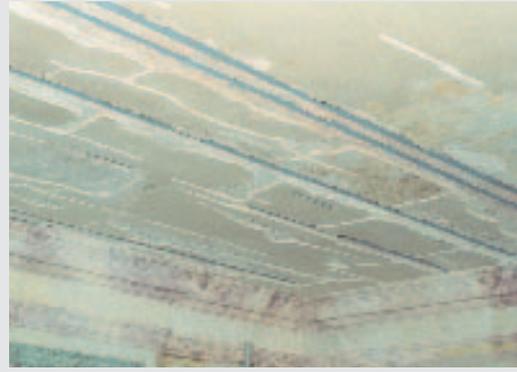
Many defects were revealed in the plaster ceilings after cleaning

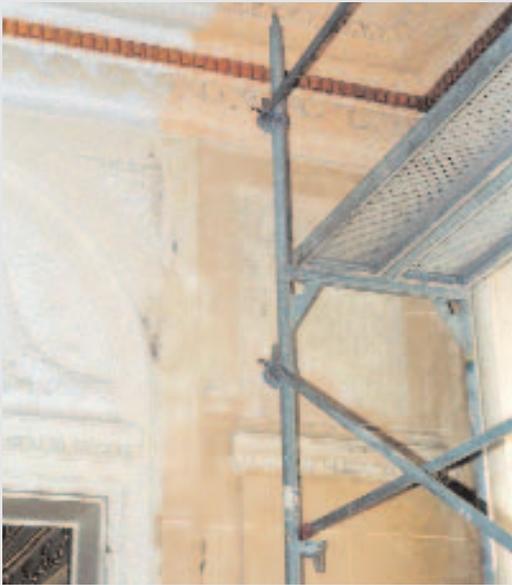
Process of removing twenty-two layers of repaints in entrance hall 1-17
