CATHEDRAL OF SAINT BARBARA IN KUTNÁ HORA

BARBORSKÁ UL., KUTNÁ HORA

CONTRACTOR: GEMA ART GROUP A.S.

IMPLEMENTATION: 07/2003–11/2012

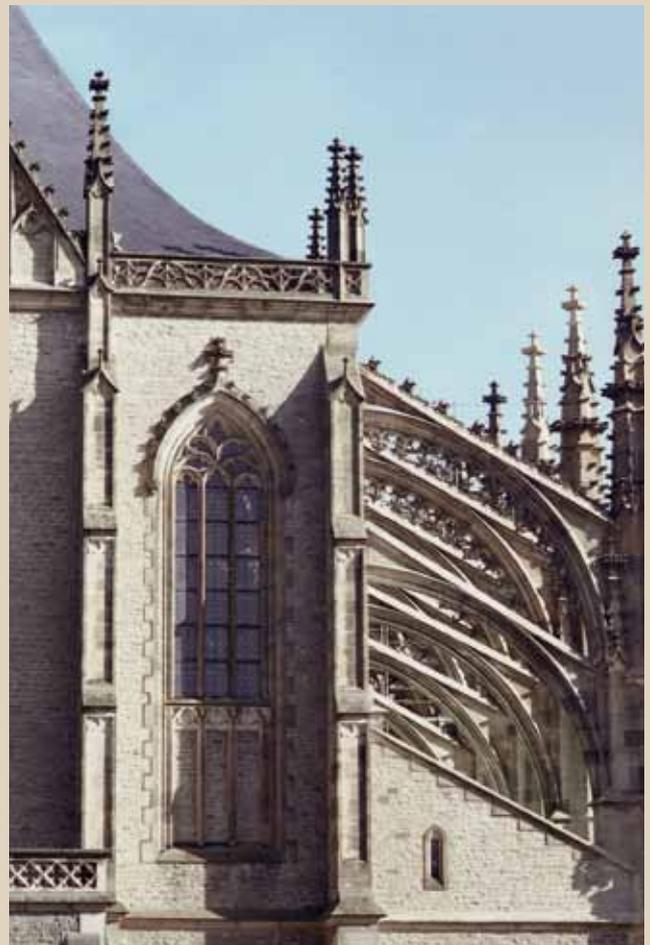
Buttressing system - after restoration

The main aim here was to remedy the precarious state of the support system. Some buttressing was in danger of actual collapse. After consultations with experts in structural analysis the decision was taken to fix the stone with rustproof pegs and individual blocks of the arches were returned to acceptable positions using pulleys and tows. In the case of one of the arches on the north side of the church it was necessary to undertake the complex task of replacing a whole part of the arch with a new one. The bases of some of the flying buttresses were also damaged by stone corrosion and the relevant parts were secured with a sealer.

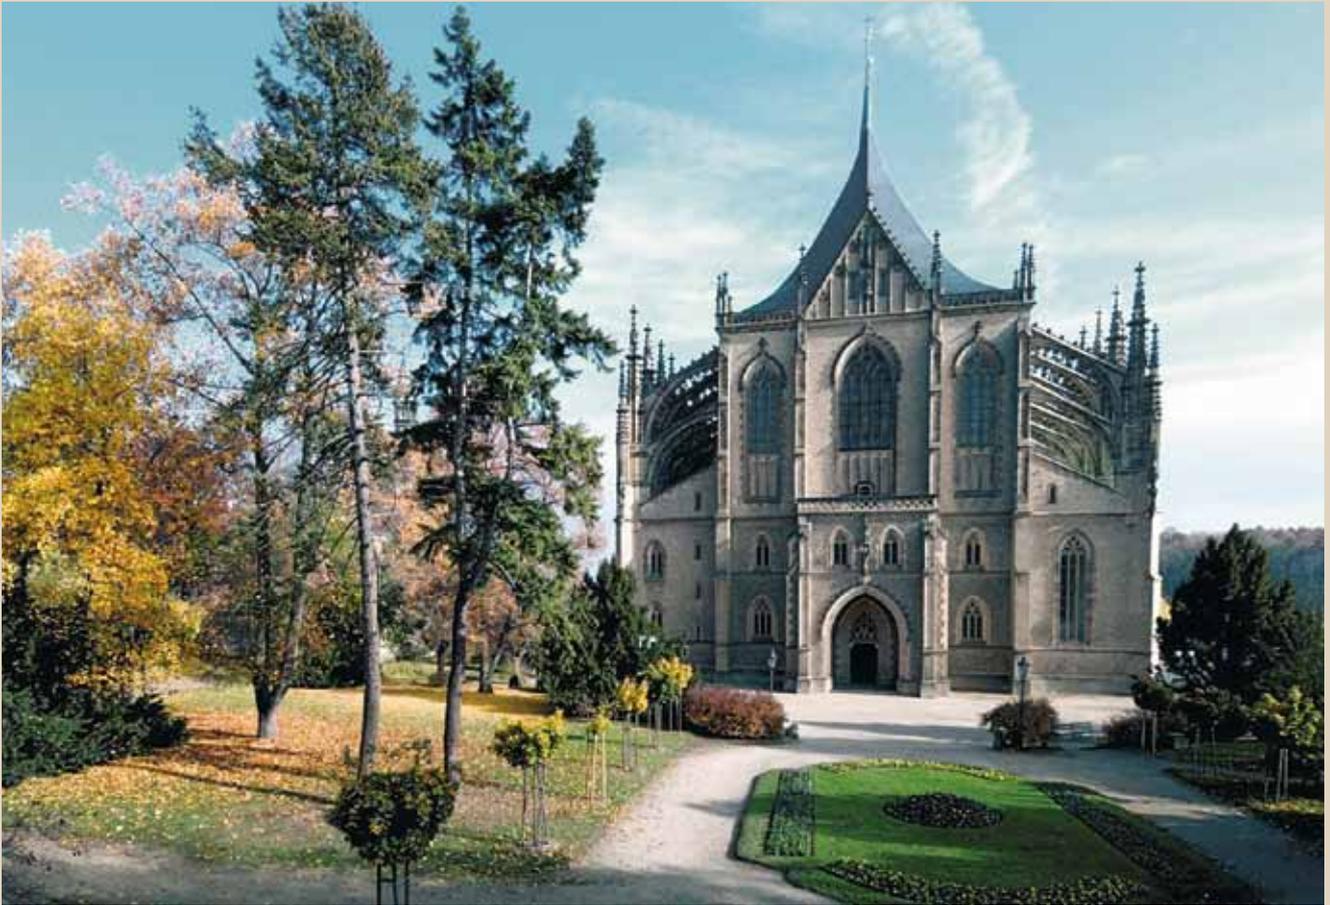
The masonry bore signs of damage such as missing pointing mortar between the stone blocks, cracks, loss of stone mass, gypsum crusts and pollution by moss and lichen.

Overall view of the facade – after reconstruction

The stone was first mechanically rid of dirt and organic matter by water steam jet. Gypsum crusts were eliminated by hand using scalpels and abrasives. At some points the crust was up to 3 mm deep. The interstices where the pointing had crumbled away were re-pointed using more flexible lime mortar. As a preventive measure against further stone loss, some parts of the masonry were injected with a special fortifying substance. After cleaning and re-pointing, localized colour retouching was carried out to achieve visual uniformity of the building.

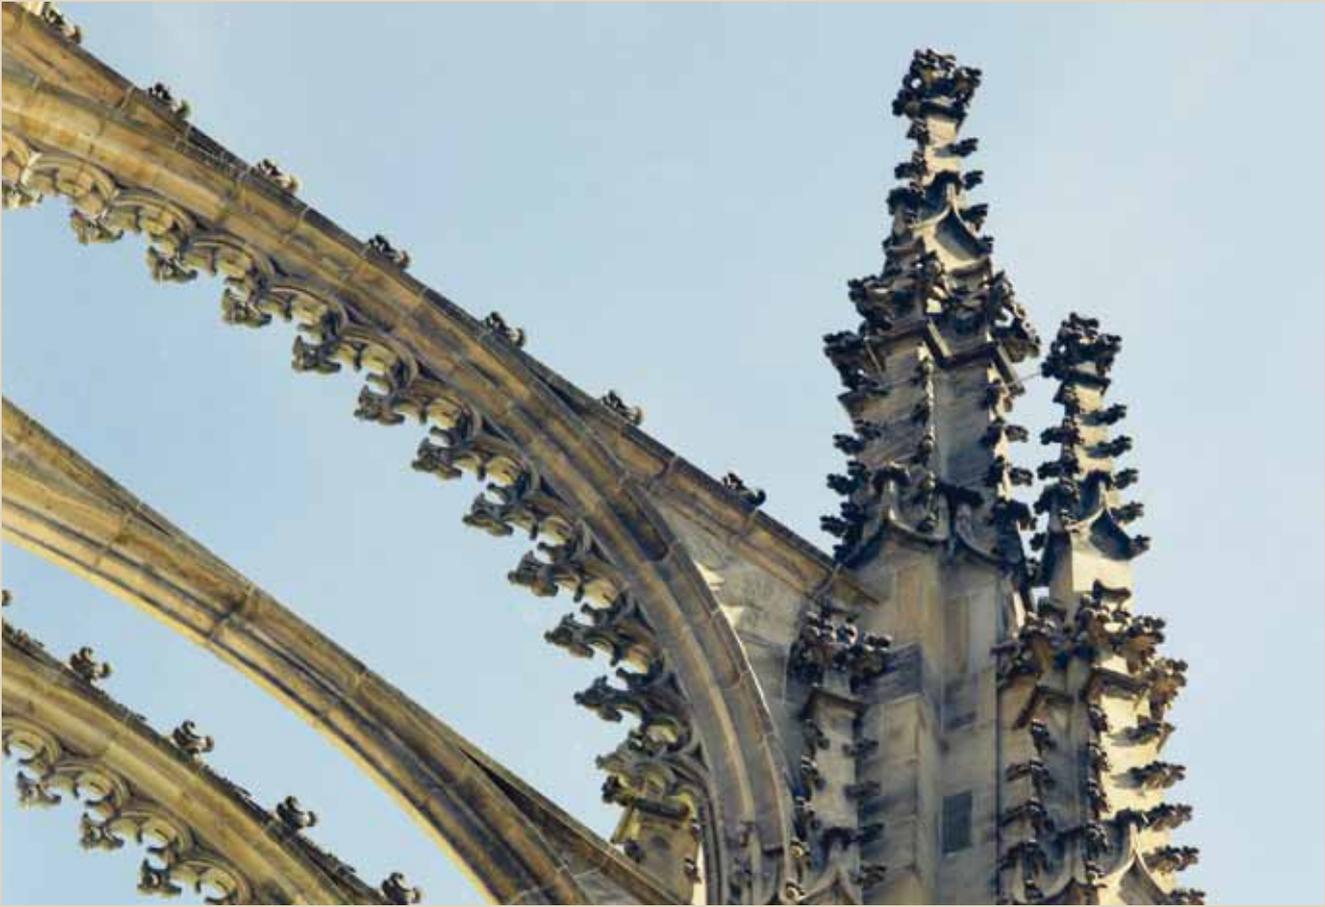
Buttressing system – buttresses and arches

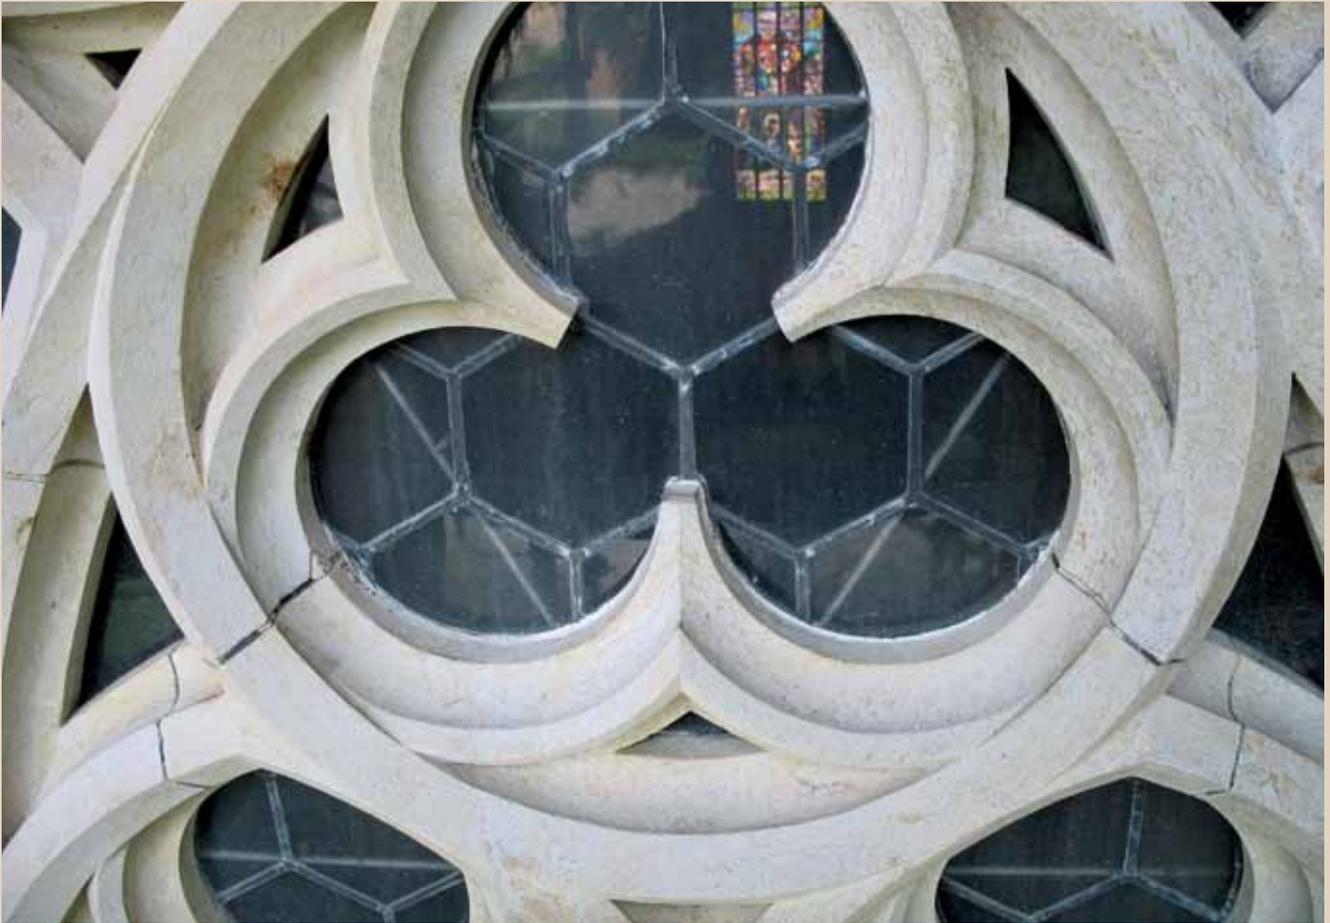
Stone elements of the stained glass – after restoration

While restoring the stone components of the Church of St Barbara's exterior, priority was given to restoration of the parts in a critical state, to conservation of the authentic Gothic elements and to treatment of the stone surface. Gothic originals such as maskarons under the main cornice of one of the aisles as well as the 19th century copies of gargoyles and statues were restored. The last remaining Gothic gargoyle was removed, deposited in a lapidarium and replaced by an exact copy. The surface of the stone was cleaned of organic matter such as moss and lichen and of gypsum crust. Missing and irretrievably decayed stones were in-filled or replaced. As a preventative measure a strengthening substance was inserted into the stone.

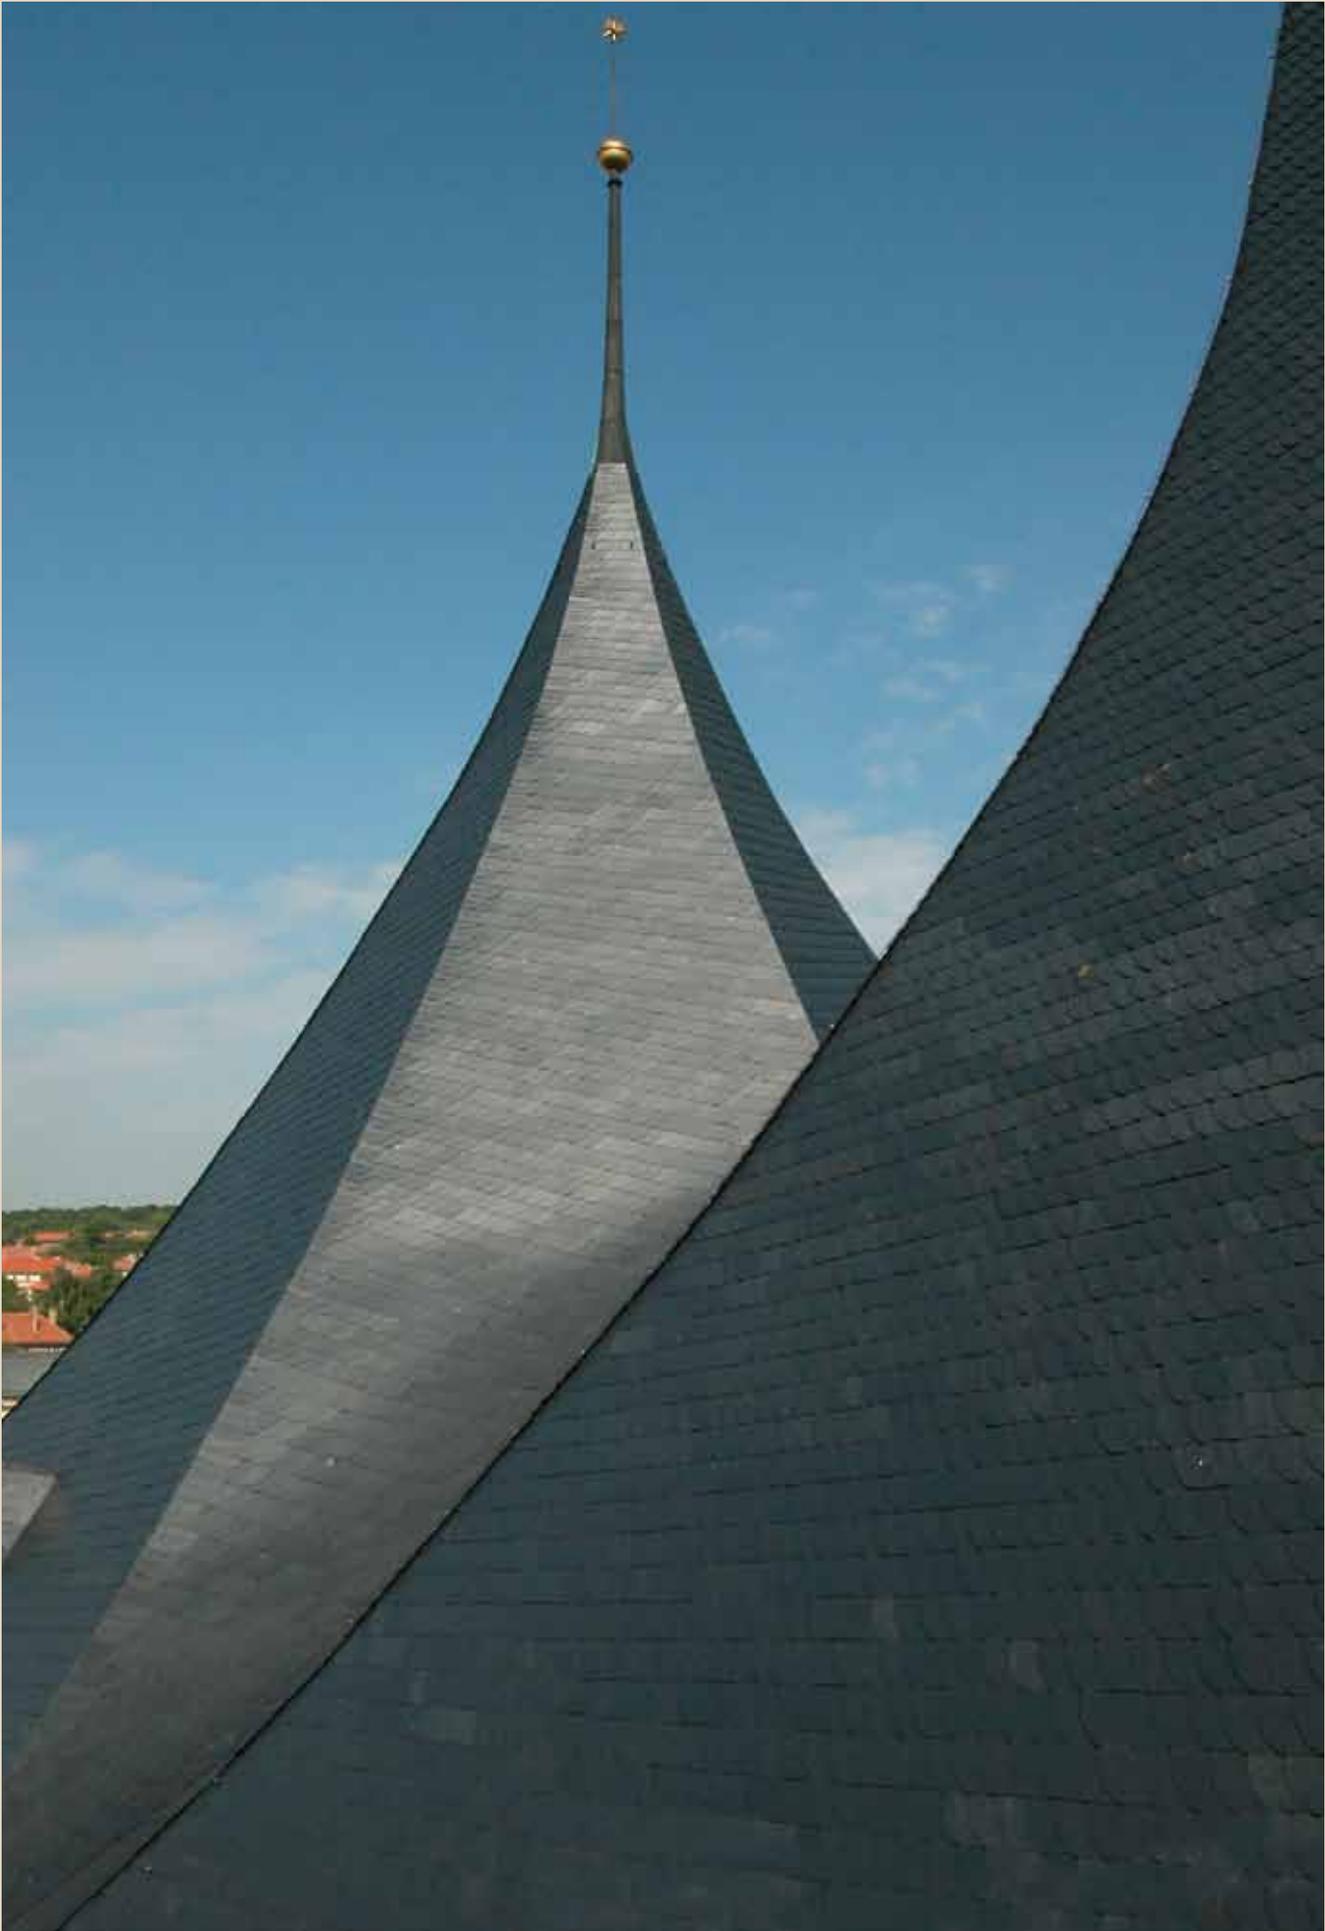
The church roof - after reconstruction

Original slate tiles had to be removed and replaced by new ones, which had to be in a colour and shape consistent with the original material. The removed covering was conserved and deposited in the church's lapidarium. Apart from replacement of the slate tiles the underlying roof structure was repaired, as well as the roof hatches, the inter-roof guttering and the grids for catching roof debris. Restoration work was also carried out on roof ridges and finial points. Roof edges were metal plated with copper.

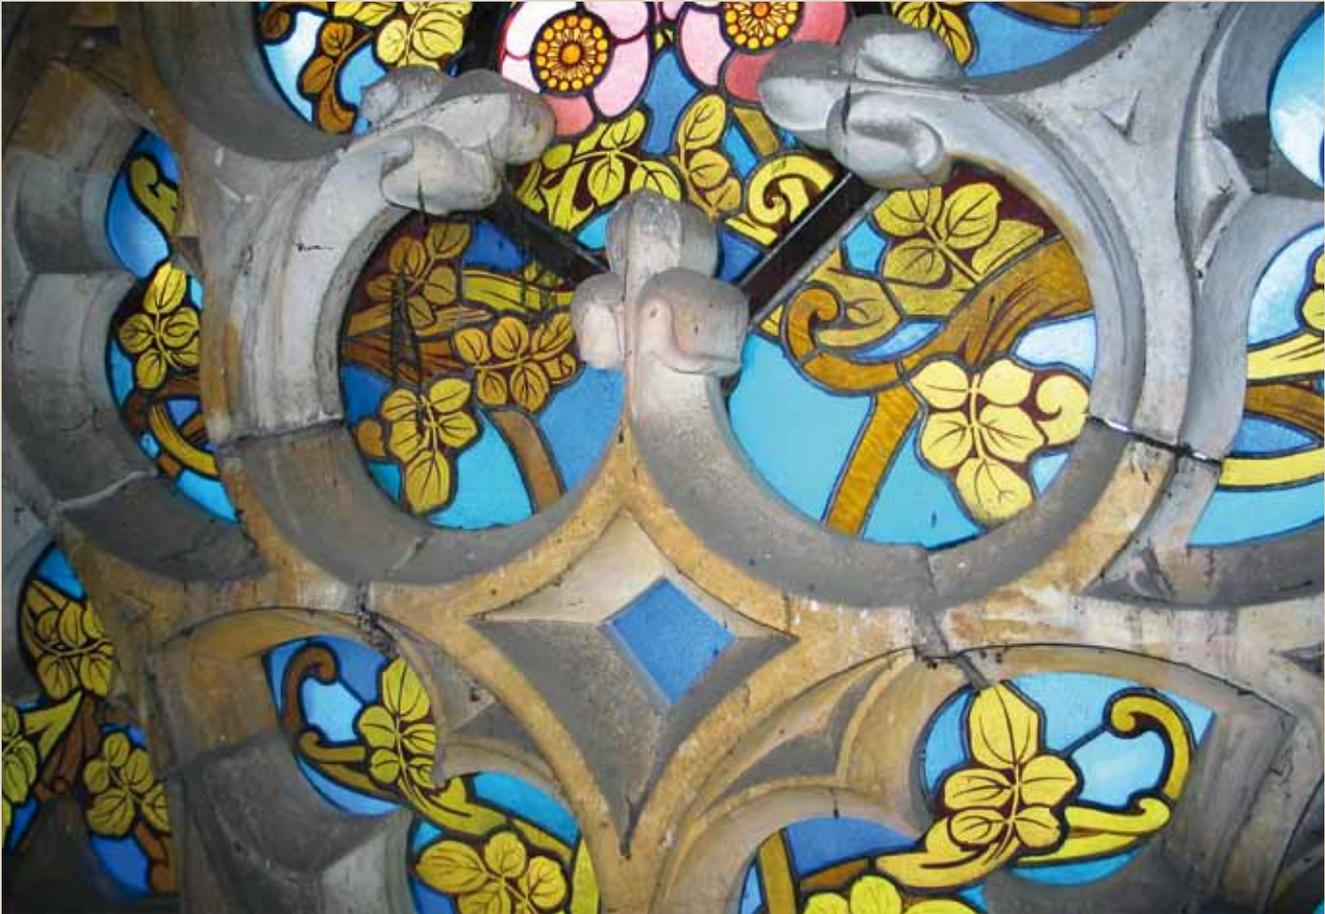
The stained glass in question consisted of hexagonal panes, some clear and some painted with figurative motives. The glass was in poor shape, the glaziers putty considerably worn and in places missing. The lead beading was corroded and the joints cracked, which caused the loosening of some of the glass panes. As a result of long-term exposure to dampness and air pollution there was a loss of glass and paint coverage.

Detail of stained glass in the chapel

Prior to restoration detailed photo documentation was carried out and accurate stencils made, which were used to manufacture exact copies of the damaged glass. To create the authentic uneven surface, drawn sheet glass was used. The panes were put into new lead beading and sealed with powdered chalk. The painted glass panes originating from the years 1913 to 1916 were retouched by paint burnishing. To preserve the glass, a special coating was applied to it.

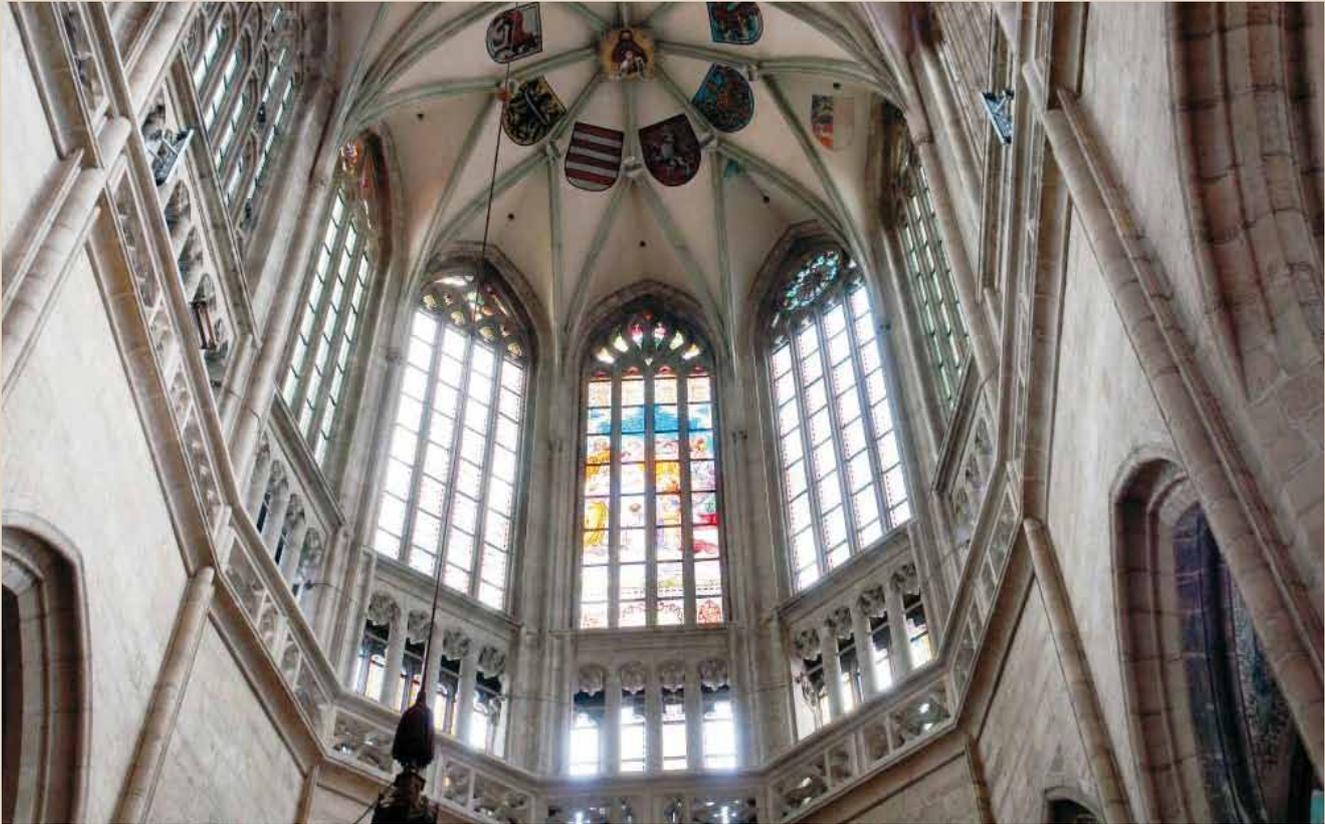
Overall view of the stained glass

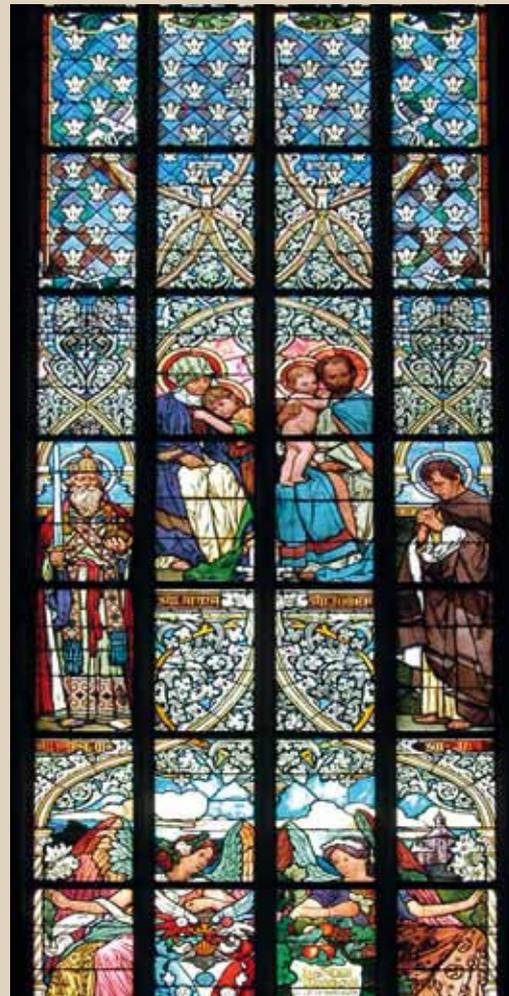
Stained glass – after restoration

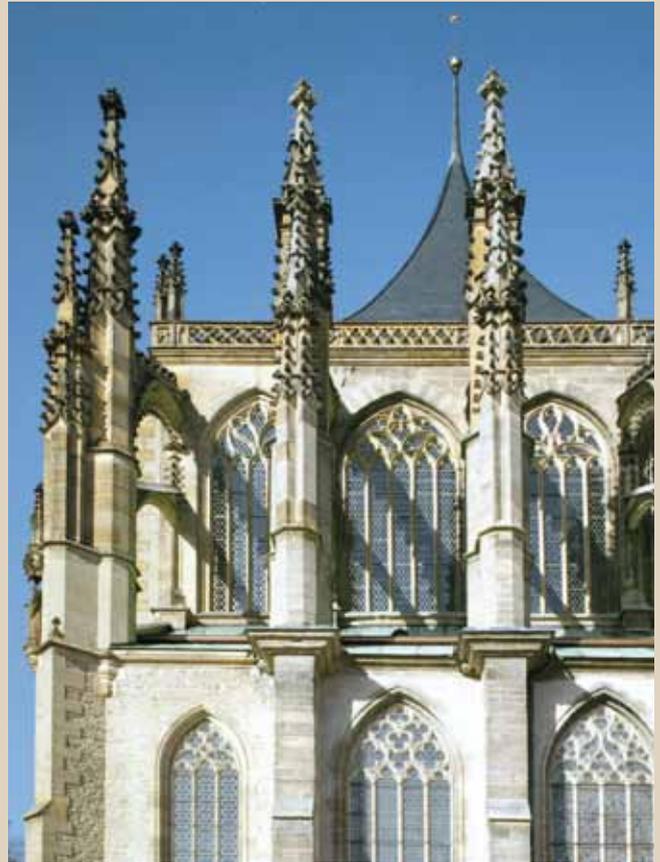
Historical windows – after restoration

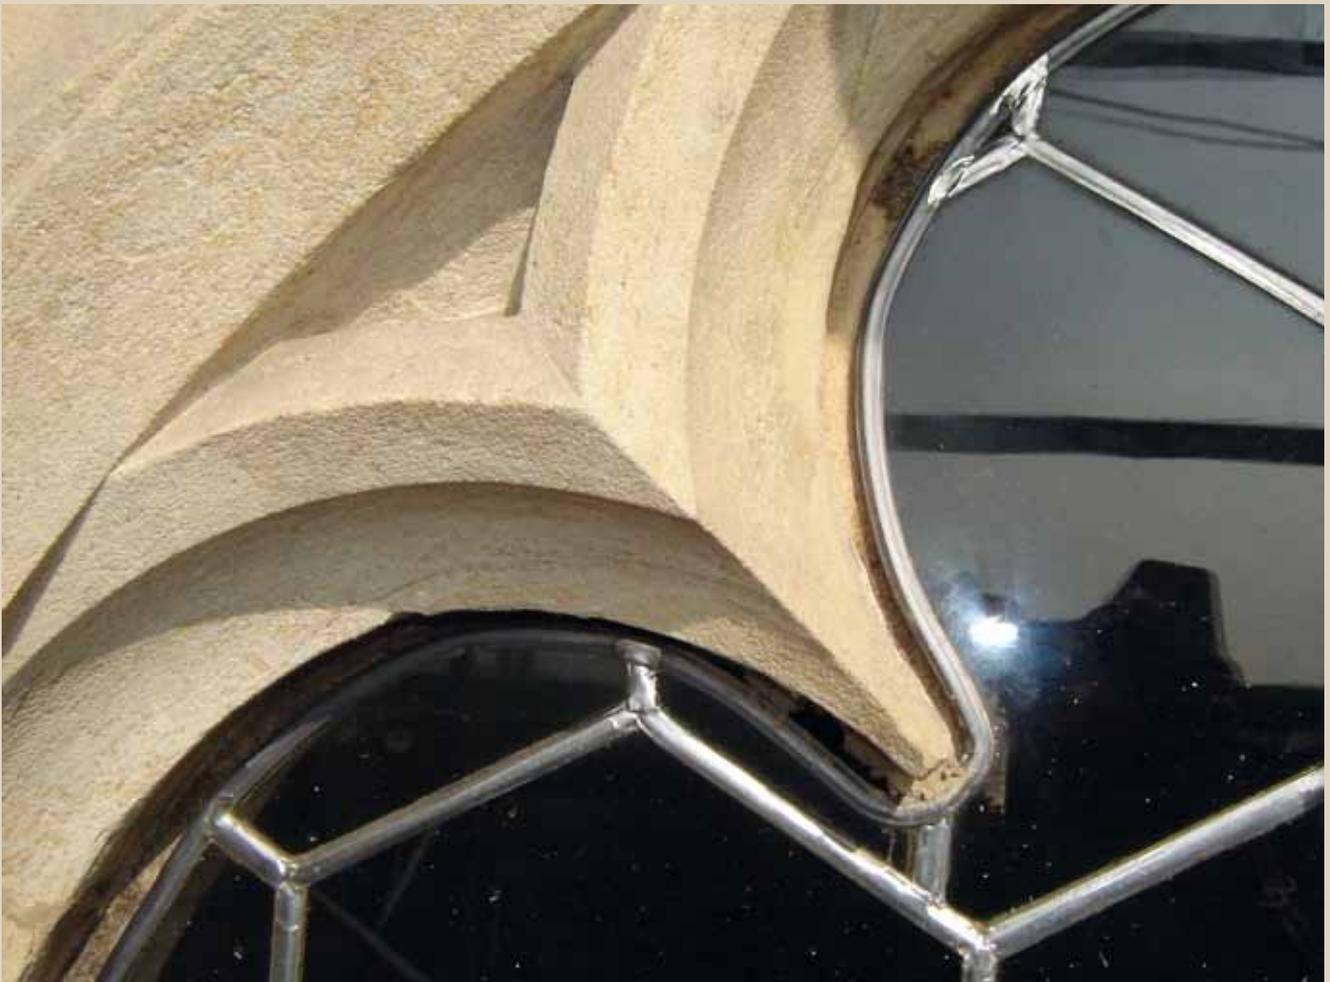
Detail of historical window – after restoration
